**Model:** iR2200/2800/3300 /2200i/3300i**Ref. No. :** FF-T01-L5-000021-01**Date :** August 7, 2002

**Location:** Registration Front Guide Assembly**Subject:** Countermeasure Against Delay Jam 0101**Reason:** At feeding operation, paper leading edge passes above registration front sensor without being detected, sometimes resulting in delay jam 0101.**Detail:**

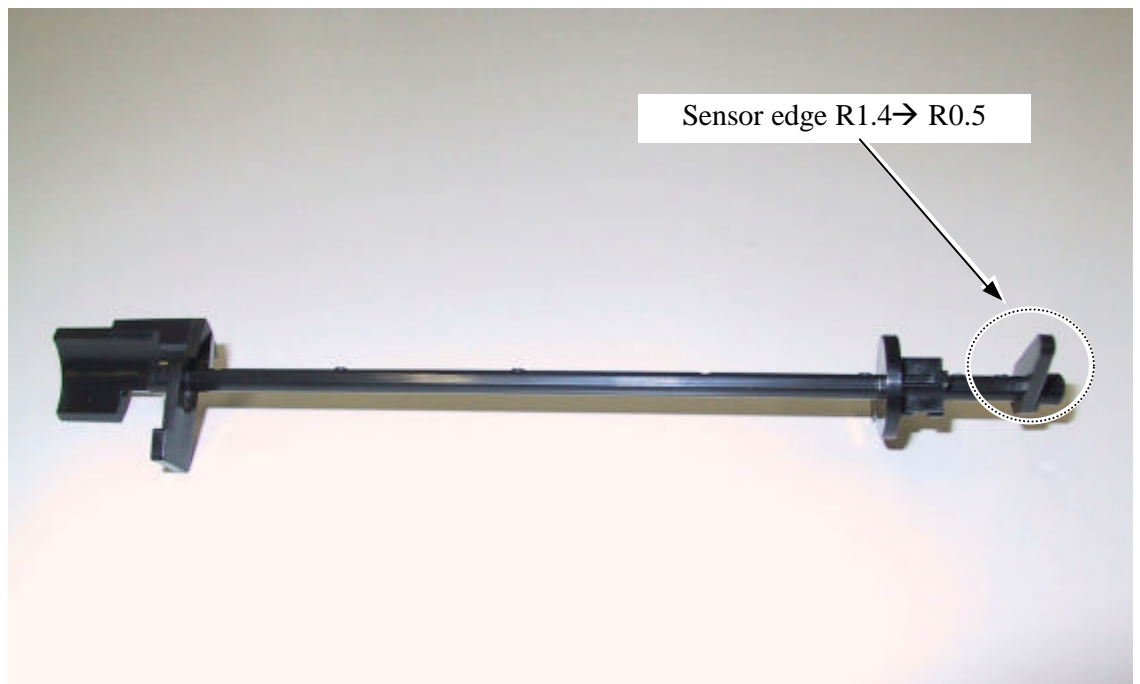
Fig.4 Registration front sensor flag

To prevent paper passing above sensor flag without being detected, the shape of registration front sensor edge is changed from R1.4 to R0.5 (more sharpened)

3. Detach spring from the registration front sensor flag (detached at 2) and attach the spring to another registration front sensor flag (FB5-4713-020). Attach the new registration front sensor flag back to the pick-up assembly by following procedure adversely (2→1). Care should be taken not to distort the spring (FB3-2658) during work.
