**MODEL:** iR2200/ 2800 / 3300

**SUBJECT:** Installing System Software V40.06

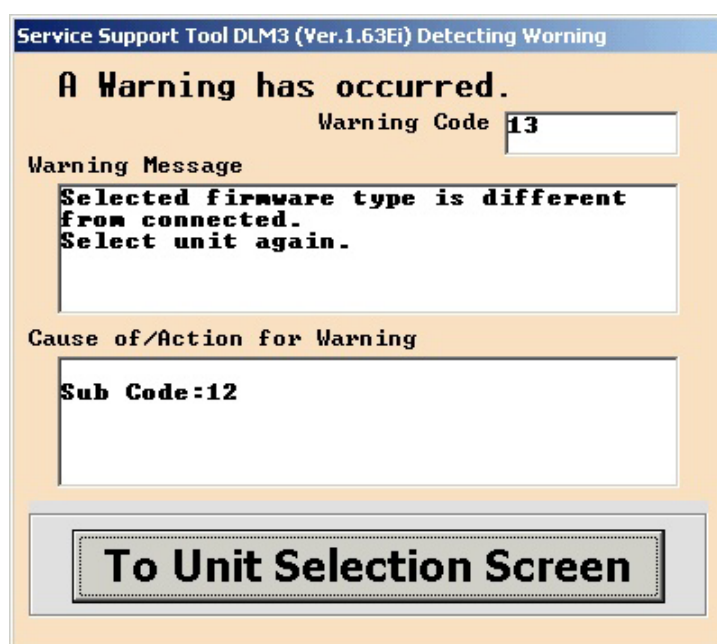
CD-ROM FY9-4082-016 contains file 'iR2200N-USen4006.iff' which causes an error. Due to this error it is impossible to use the system software on 'H' PCL only machines.

The following error is displayed when upgrading is attempted.

To overcome this, a new file has been released and is available to download from Notes / Intranet or Dealernet in the Product Driver Database, under Patches.
