**Model** : GP605  
GP555

**Ref. No. :** FF-T01- K1-000035-01

**Location** : SEPARATION MOTOR ASSEMBLY

**Subject** : COUNTERMEASURE FOR DOCUMENT JAMS CAUSED BY DAMAGE TO SPRING,  
TENSION.

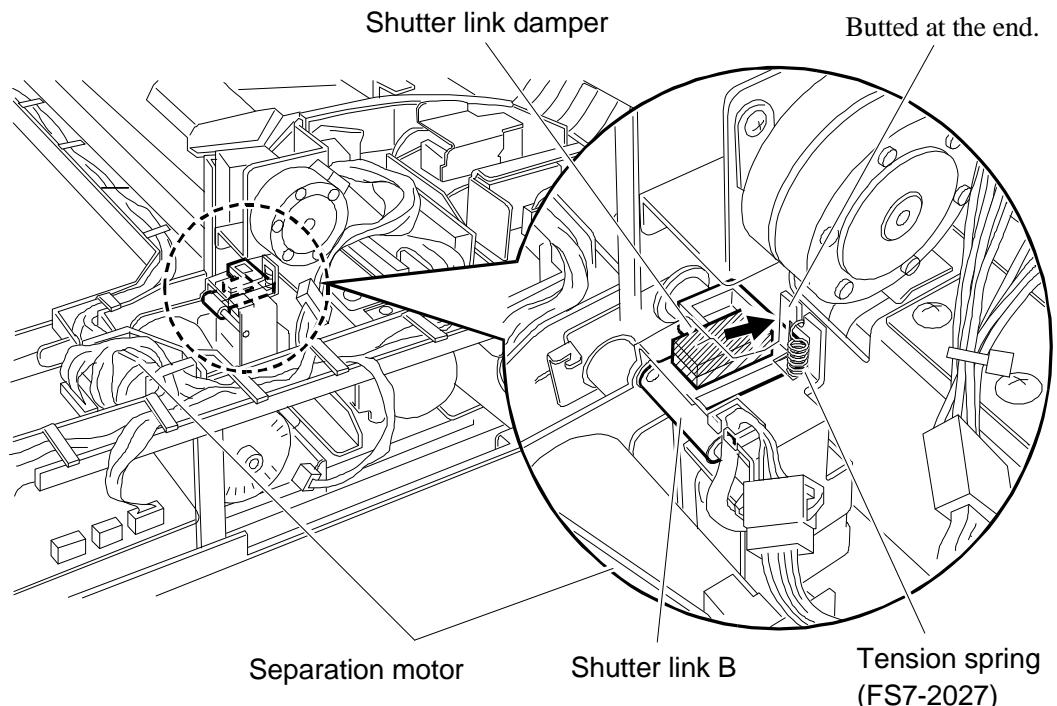
Figure

**Details** : <Symptom>  
With older parts, when paper is being fed by the ADF, the document stopper guide sometimes fails to lower properly, causing a document jam.

<Cause>  
The tension spring inside the ADF separation motor assembly gets weaker with age and may snap. This causes the document stopper guide to be unable to lower, resulting in a document jam.

- 1) Remove the ADF outer cover.
- 2) Replace the old tension spring (FS7-2027) at the back of the ADF separation motor assembly with the new tension spring (FS7-2027). (Parts catalogue FY8-31DV-00, page 21-5)
- 3) Peel off the backing tape from the double sided tape and align the shutter link damper (FB4-8068) with the edge of the shutter link B (FB4-7769) and affix it.
- 4) Attach the ADF cover in the reverse order.
