Use of Infrared Thermography as a Standard in the Quality Assurance and Quality Control of Grouted Masonry Construction

J.Eric Peterson, P.E., and Matthew J. Innocenzi, EIT

Whitlock Dalrymple Poston and Associates

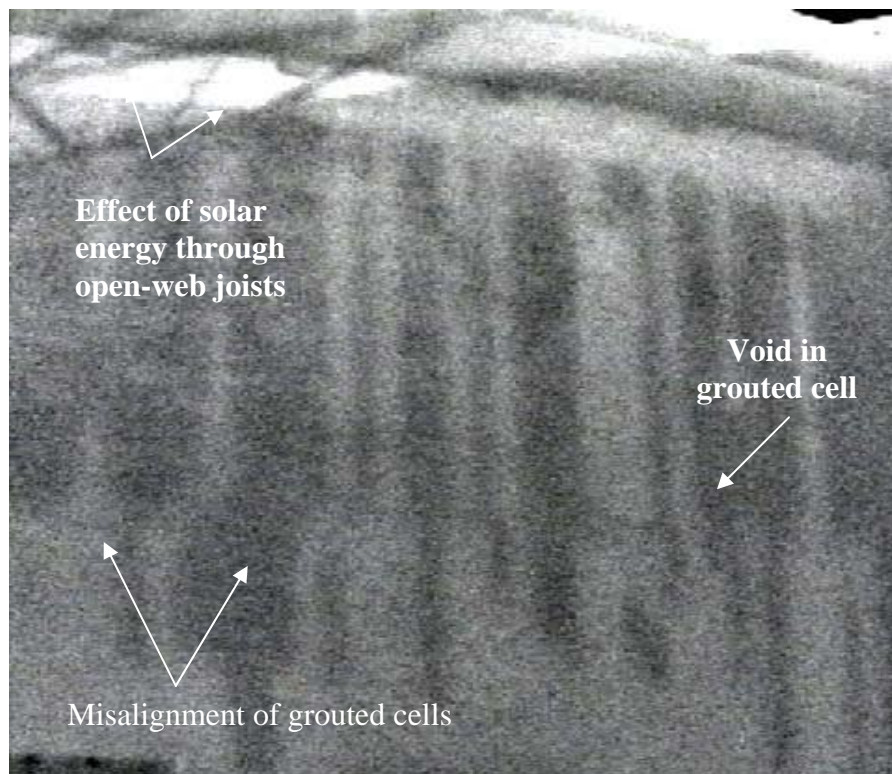
Figure 2 is an thermal image of a portion of the masonry wall surveyed. The grout within the wall is characterized by the lighter vertical patterns regularly spaced intermittently across the wall. The voided areas can be clearly seen as a break in the vertical pattern. Also of interest is the change in the vertical pattern at the approximate mid height of the wall. This pattern was created by a change in the type of masonry unit from the lower level to the upper level as well as a change in the spacing pattern of the vertically grouted cells.

Figure 2 – Infrared Image of a Partially Grouted Concrete Masonry Wall.

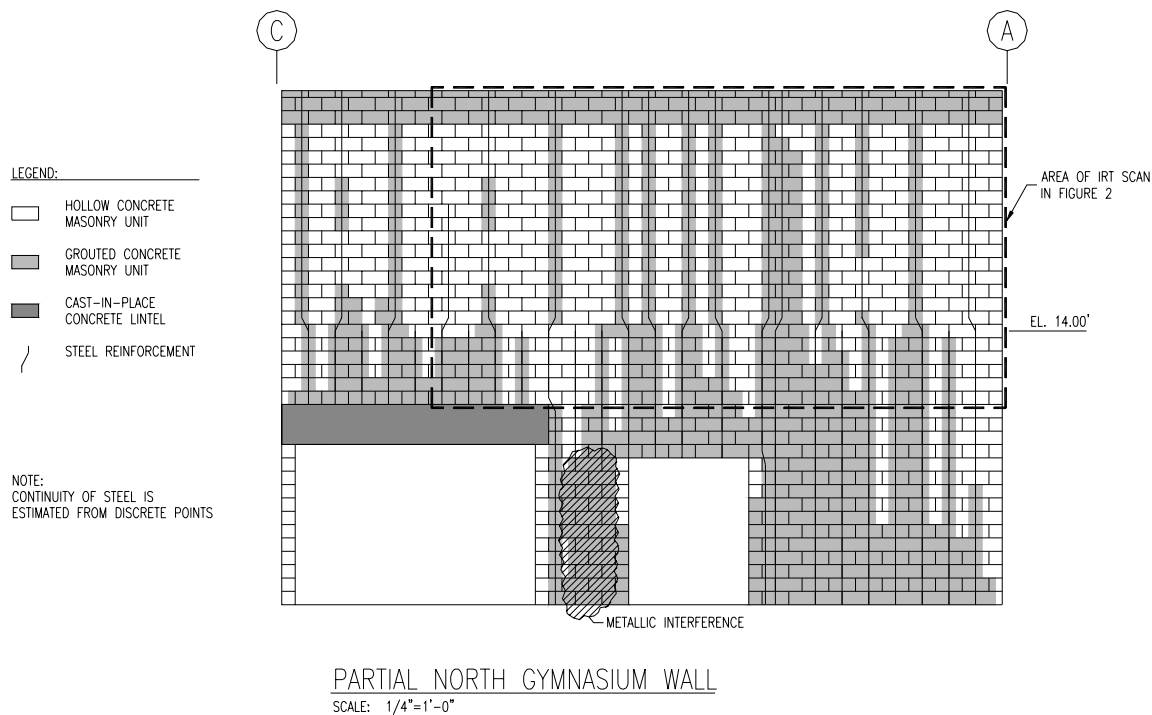
The data acquired in the field was recorded on digital videotape format and recreated in the office on a CAD drawing to produce an as-built rendering of the field conditions. **Figure 3** depicts the translated thermal image produced. This information was provided to the contractor to assist the masons in correcting the observed problems.

Figure 3 – CADD Drawing Illustrating Interpretation of Infrared Image for the Partially Grouted Concrete Masonry Wall. Note: Dashed box represents the area of IRT scan in Figure 2.
