## The Use of Infrared Thermal Imaging in Indoor Environmental Investigations

Mary A. Finn,  
The Finn Group

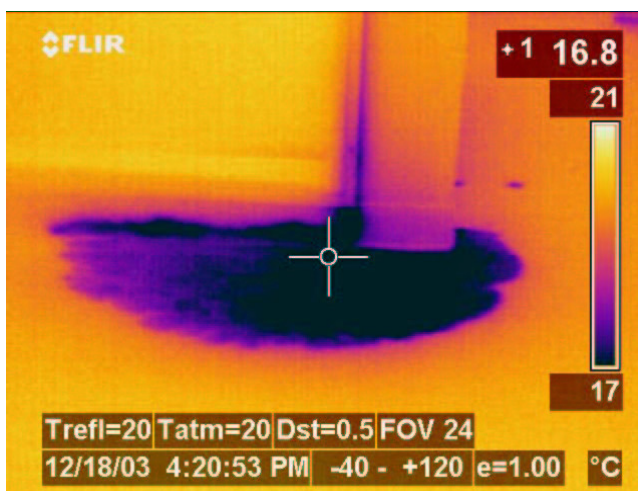
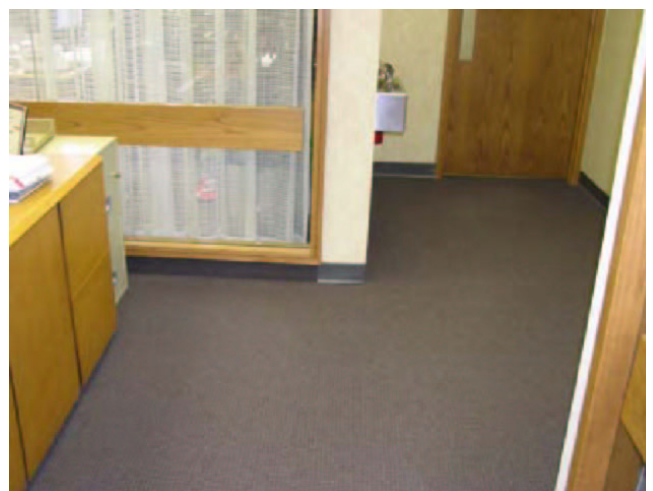
Figure 1 is the IR image and photo showing water intrusion into the wall and carpeting from a plumbing leak within the wall cavity.

Figure 1. Thermogram/photo showing water intrusion from plumbing leak inside wall behind fountain

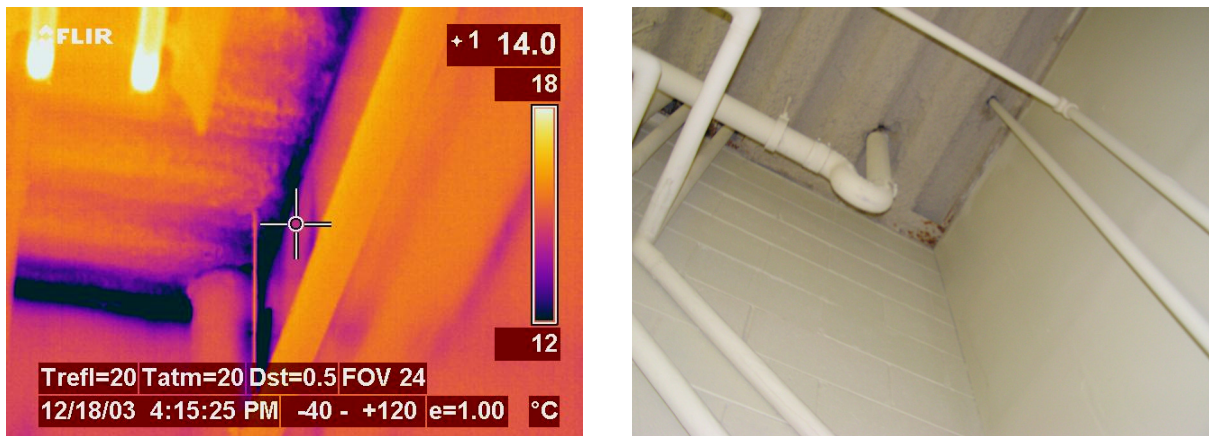
Figure 2 is the IR image and photo showing water intrusion into the basement that was obscured by the fireproofing. Failures in the sealant in the sill plate were identified that were resulting in the entrance of water and uncontrolled air into the building.

*Figure 2. Thermogram/photo showing water intrusion into basement due to failure in sealant of sill plate*

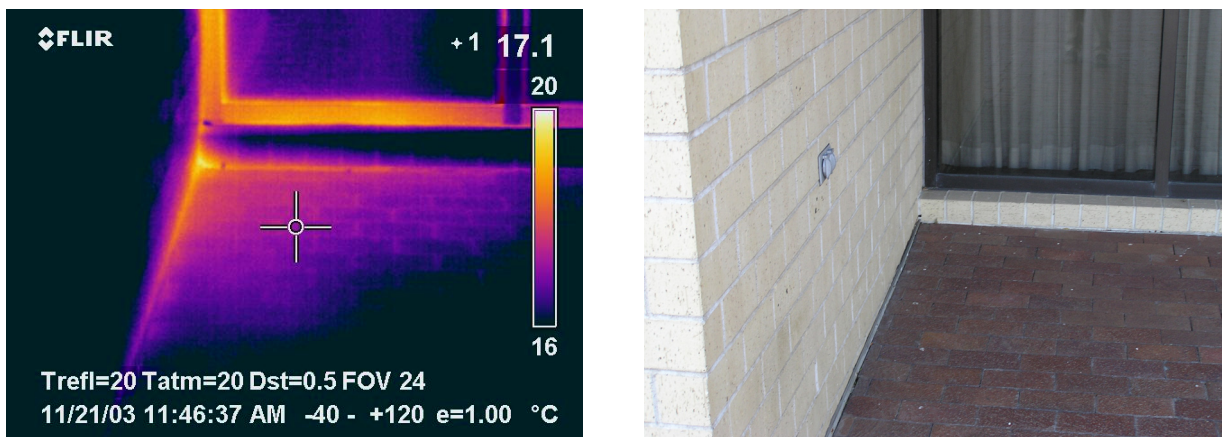
Figure 3 is the IR image and photo from the grade level of the exterior of the building. Failures in the sealant were identified through the IR pattern of heat loss from indoors. The air pressure inside the building was negative, and this failure was an entry point for uncontrolled air.

*Figure 3. Thermogram/photo showing loss of heat from inside building due to failure in sealant*

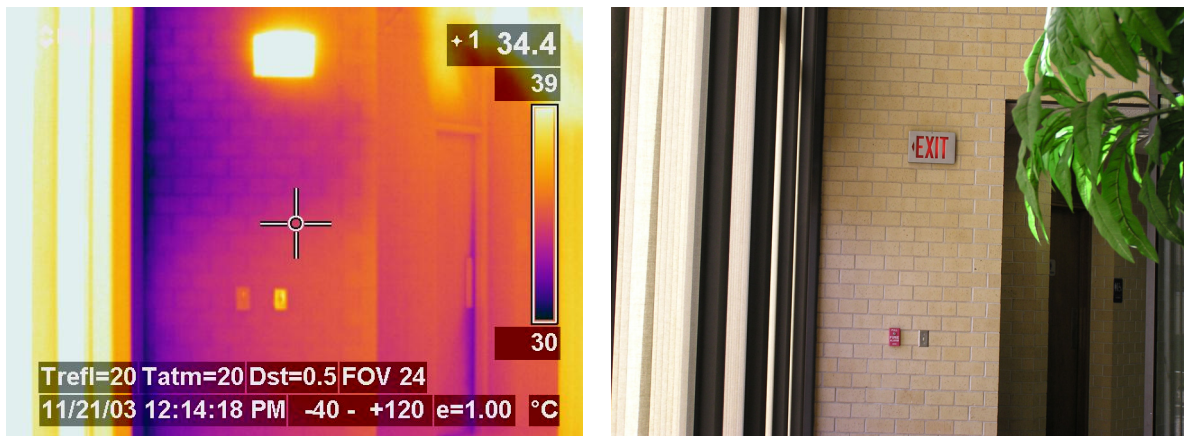
Figures 4 and 5 are the IR images and photos showing the entrance of uncontrolled cold air due to the unbalanced operation of the HVAC system, which resulted in a negative air pressure inside the building with respect to outdoors.

*Figure 4. Thermogram/photo showing entrance of uncontrolled cold air due to negative air pressure inside building from unbalanced operation of HVAC system*

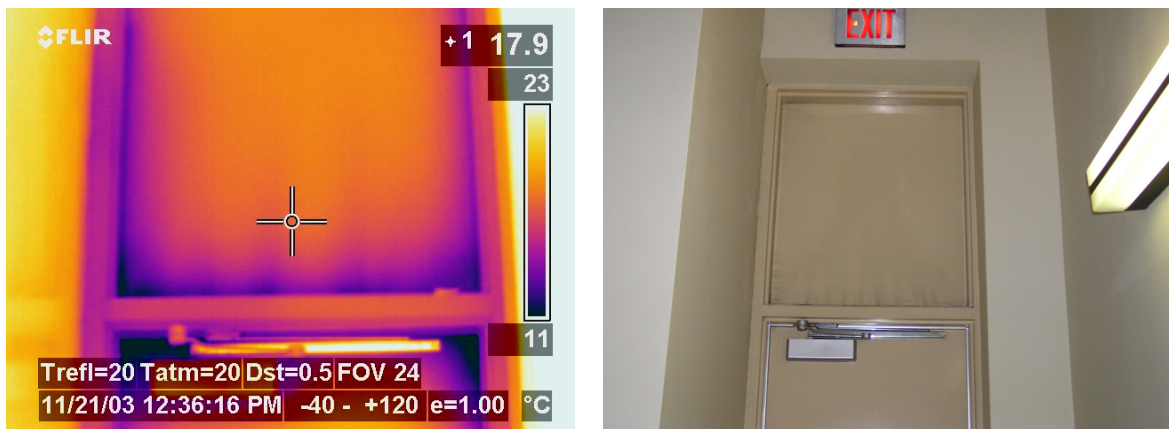
*Figure 5. Thermogram/photo showing entrance of uncontrolled cold air due to negative air pressure inside building from unbalanced operation of HVAC system.*

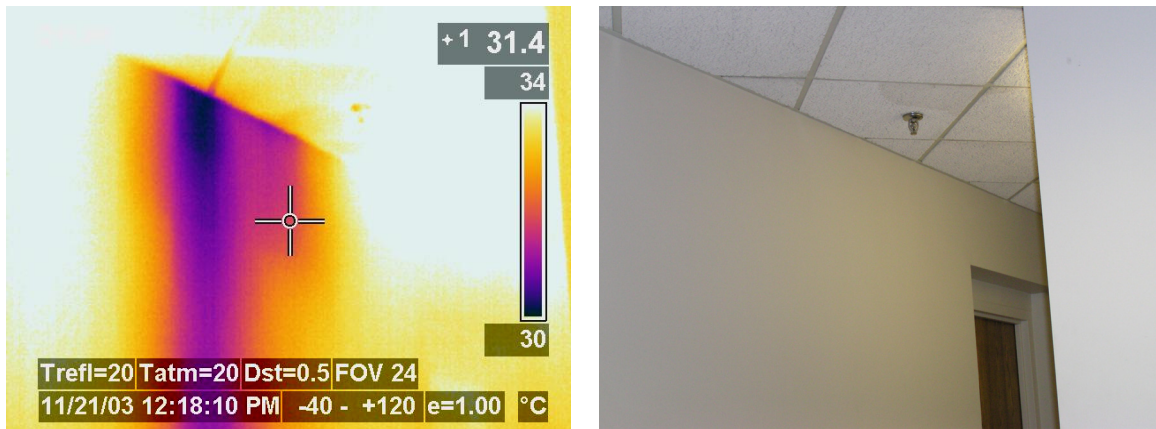
Figure 6 is the IR image and photo showing temperature differentials resulting from cooler air from the plenum space entering the occupied space. This indicates that the plenum space is under positive pressure with respect to the occupied space due to the unbalanced operation of the HVAC system.

*Figure 6. Thermogram/photo showing entrance of cooler air from plenum due to positive air pressure in plenum from unbalanced operation of HVAC system*

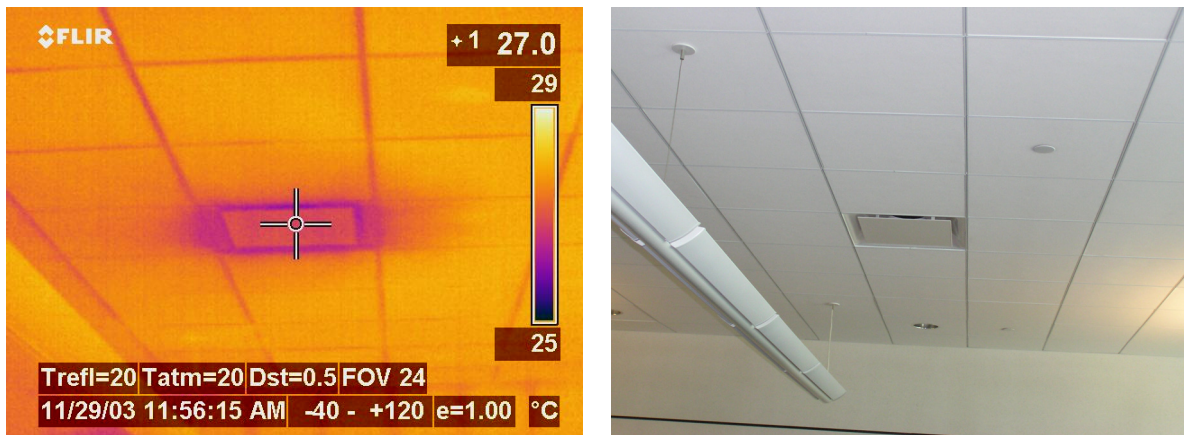
*Figure 7. Thermogram/photo showing uniform air distribution pattern from supply register*

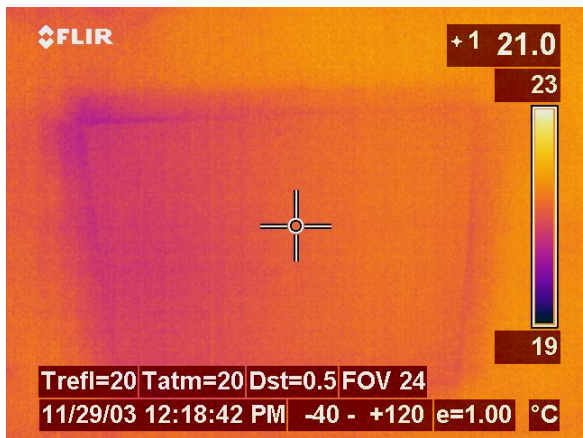
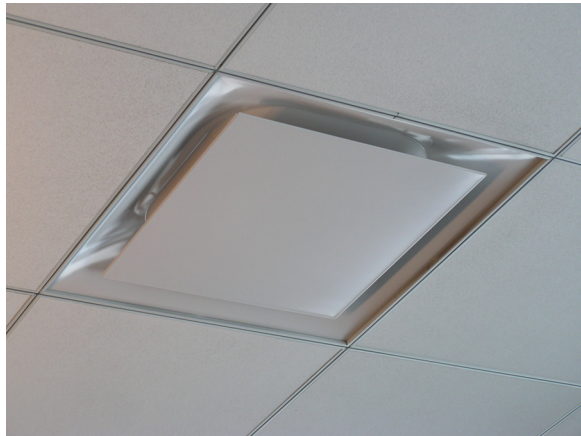
Figure 8. Thermogram/photo showing non-uniform air distribution pattern from supply register

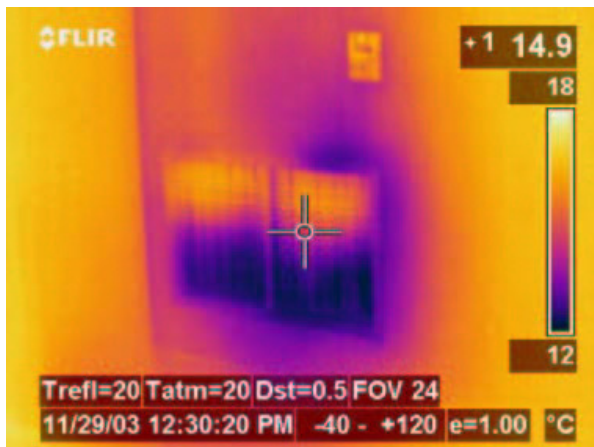
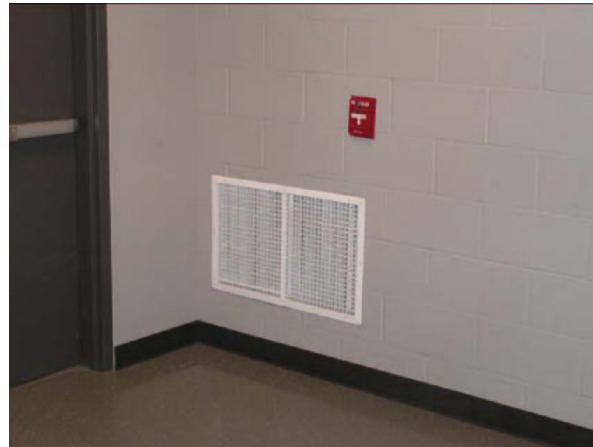
Figure 9. Thermogram/photo showing non-uniform air distribution pattern from supply register
