# Service Information Bulletins

## 1997

**GRUNDIG**  
*made for you*

# Table of Contents

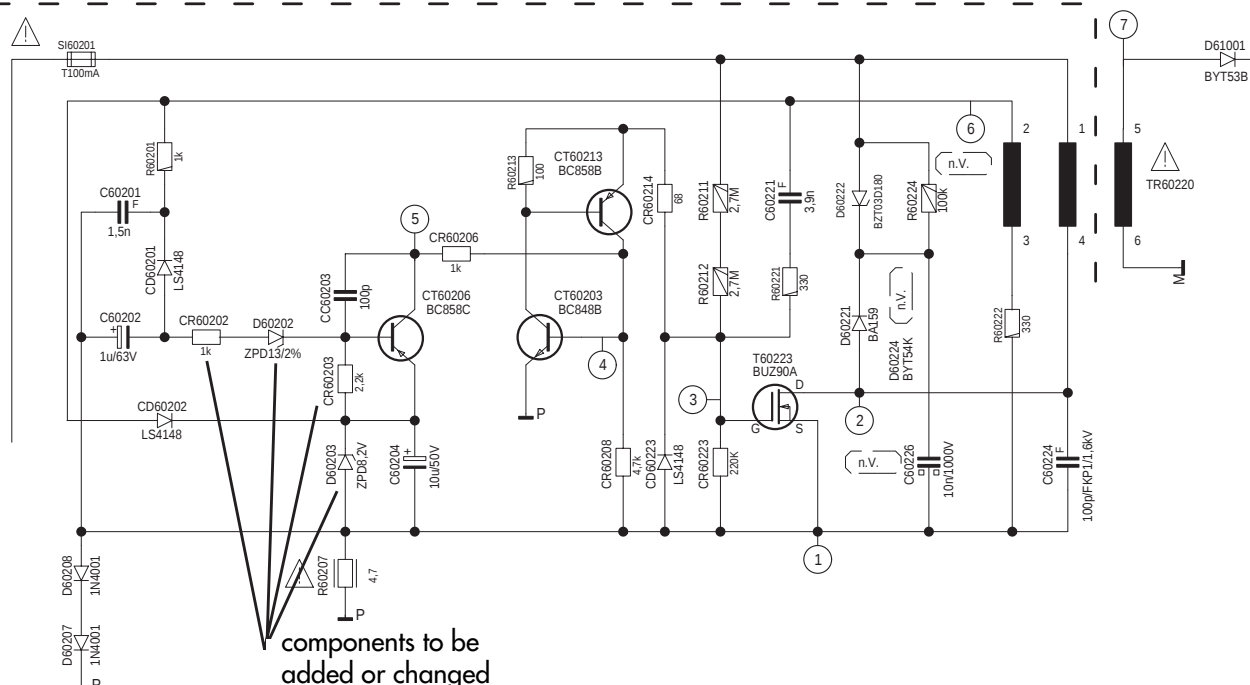
Brown colouration of the circuit board near the diode D 60222 BZT 03D180. Simultaneously the "+Eco" voltage is approx. 5V too high.

Coincidence of unfavourable component tolerances.

Carry out the following changes in the stand-by mains stage:

- Change the Z-diode D 60203 from ZPD 9.1V to 8.2V.
- Change R 60202 from 68 k $\Omega$  to 1 k $\Omega$ .
- Connect an additional Z-diode ZPD 13 in series with R 60202. Connect the cathode of the diode to the base of the transistor CT 60206.
- Check the rating of the resistor CR 60203 to be 2.2 k $\Omega$ .

Check the "+Eco" voltage. Carry out the changes if this voltage is higher than +17 V.

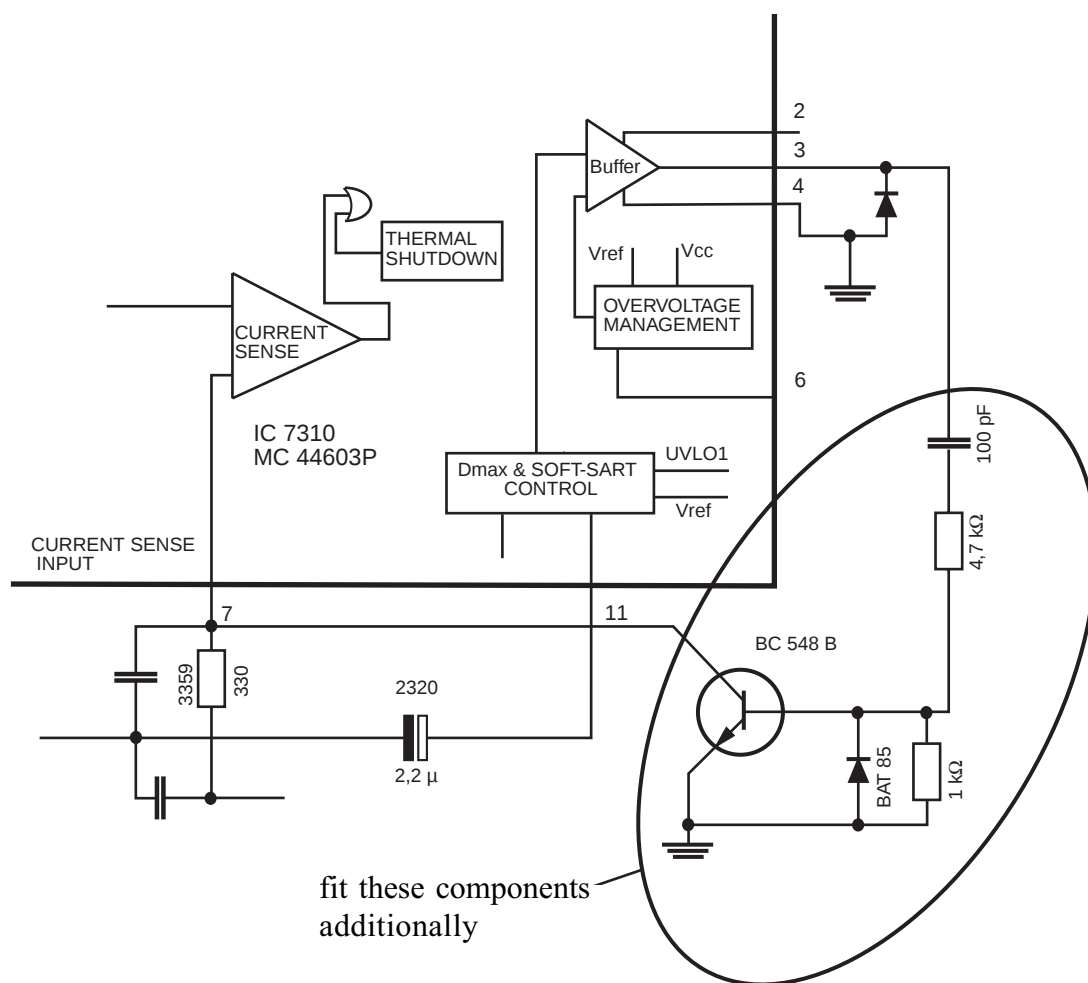
Mains voltage dependent chirp audible in stand-by mode.

Fit an additional transistor stage as shown below into the power supply unit at IC 7310 (MC 44603 P).

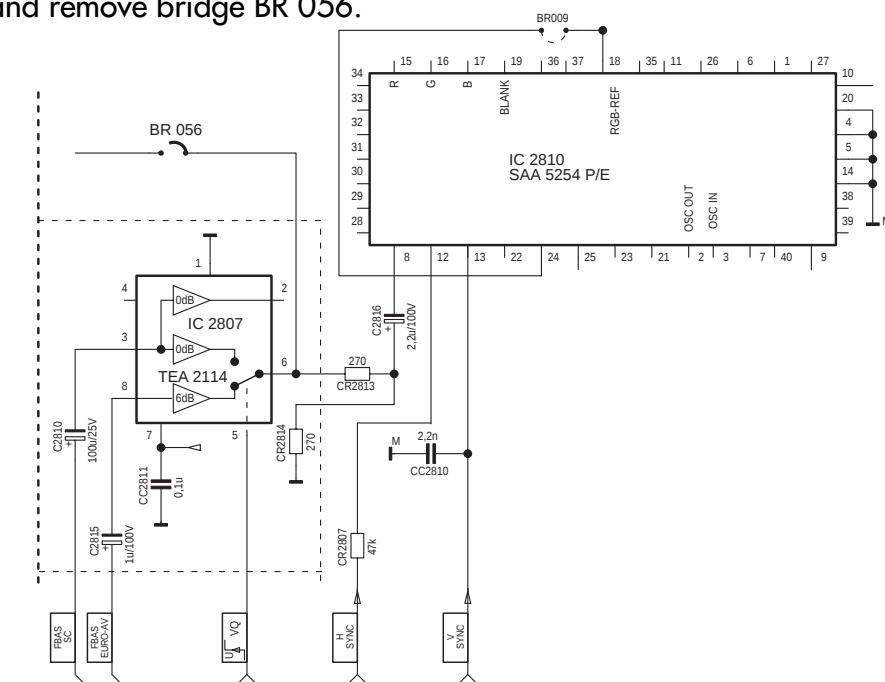
Teletext operation is not possible in "AV" programme position.

The video switch-IC 2807 (TEA 2114) is not fitted in 37 cm television receivers.

Retrofit the following components:

In addition, change the polarity of 2.2  $\mu$ F electrolytic capacitor C 2816 (negative terminal to pin 8 of IC 2810) and remove bridge BR 056.

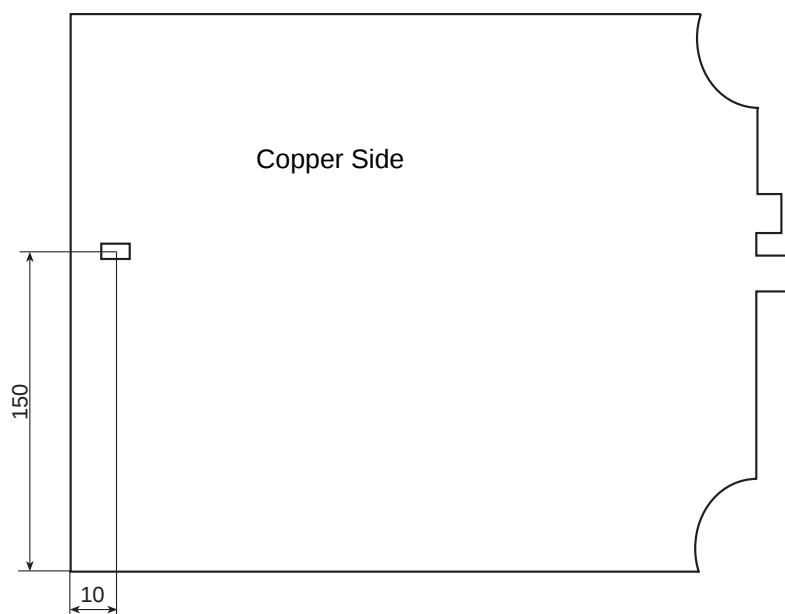
Despite the modifications carried out according to our TV Service Information 9/96 the television sets switch occasionally to Standby after a prolonged time of operation.

Temperature drift of the +E operating voltage by about 0.2 to 0.3V caused by Z-diode CD 61023. Consequently, IC 34015 TDA 8374 switches off with sudden black/white changes in the picture content or changing scenes.

The position of the Z-diode is X=10, Y=150. Unsolder this diode and insert a SMD resistor 1206 1.2Ω 1% in this place.

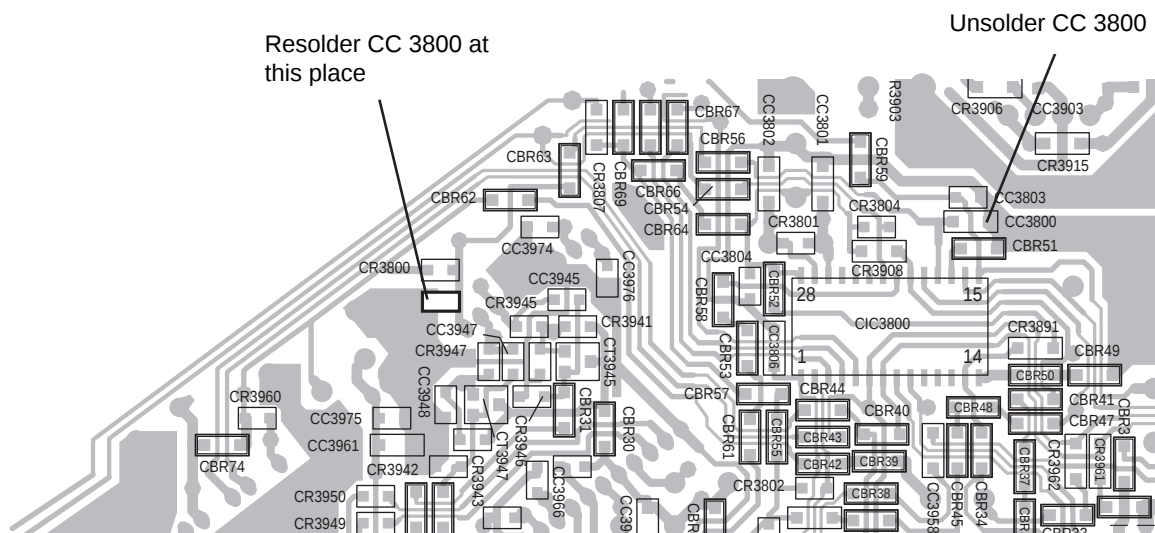
The sound disappears suddenly during the reception of a satellite programme and is audible again only when changing the programme or switching the TV off and on again.

IC MSP 3400 on the SAT Module hangs up by static charges entering the Reset input of the IC.

Unsolder the SMD capacitor CC 3800 from its place on the SAT Module and resolder it at the place indicated on the figure below.

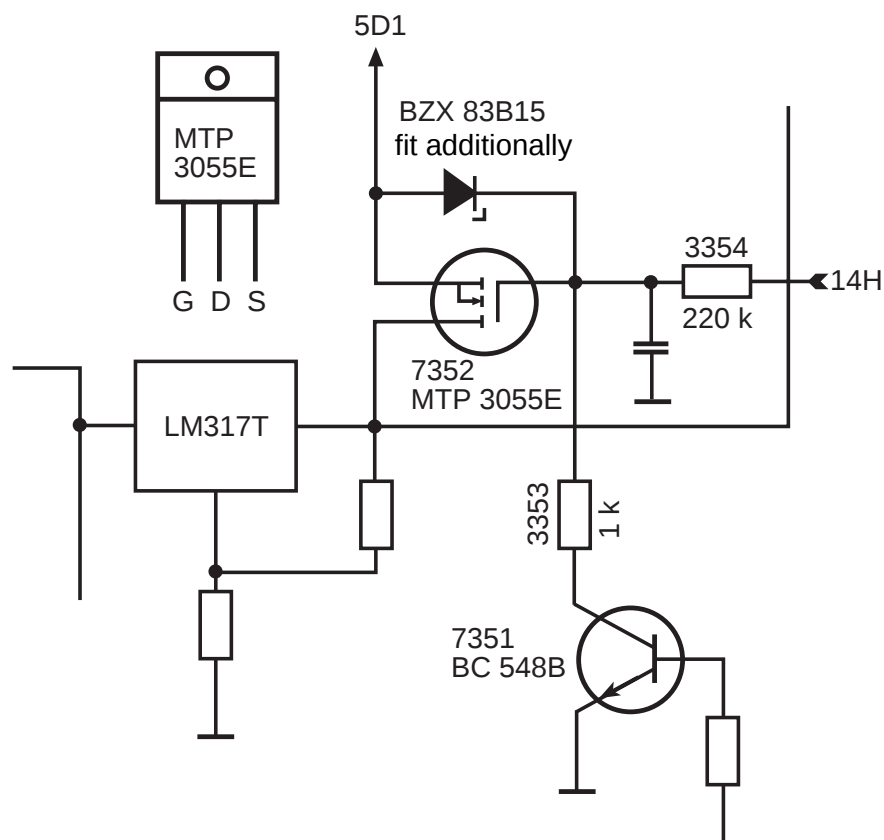
TV Recorder does not operate.

Defect in transistor 7352 (MTP 3055E) caused by static discharges in the TV Recorder.

Fit an additional Z-diode BZX 83B15 between gate and source to suppress voltage peaks at the gate.

The Z-diode must strictly be retrofitted if the transistor 7352 fails. This change is carried out already in the factory.

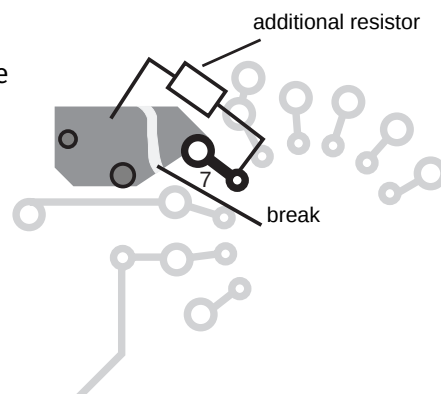
Failure of the RGB output stages (picture tube panels 29305-022.16 and -022.17) or of the teletext function.

Refit the resistor in any case if the above mentioned semiconductors failed.

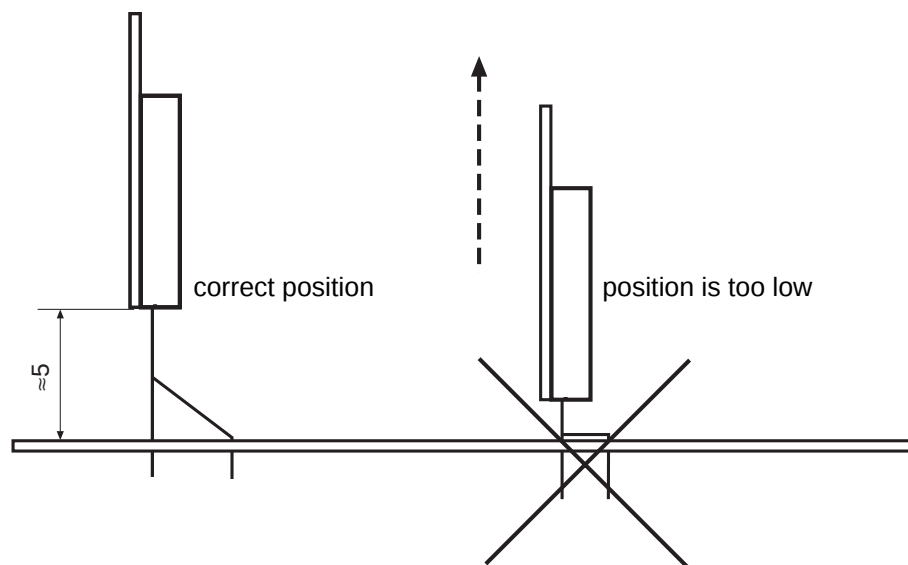
Vertical output stage TDA 4173 fails or thin white lines similar to retrace stripes are visible.

- Should above mentioned symptoms appear do not fail to exchange TDA 4173 AF and solder additionally a 1 nF foil capacitor from pin 1 and from pin 7 each to pin 4 (-K voltage) on the copper side.
- Check the mounting position of the vertical output-IC. If the position of the IC is too low, the pins may temporarily come into contact with the chassis connection on the upper side causing the IC to fail. Additionally, the circuit may already be damaged by the building up force of pressure resulting in a long-term failure. Therefore replace TDA 4173 AF also if it has not been fitted correctly!

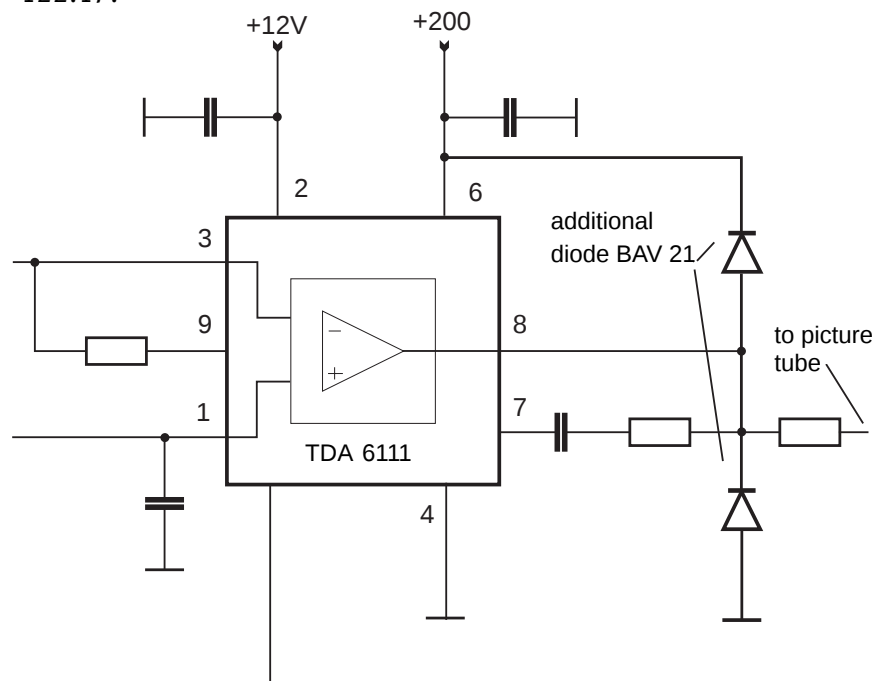
Failure of the RGB output IC's TDA 6111.

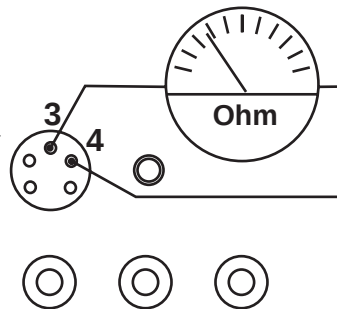
Good = 1-2 MOhm approximately

Bad = 5 kOhm approximately

Check the 5-pin Edit socket (from pin 3 to pin 4)
