# Service Information Bulletins

## 1997

**GRUNDIG**  
*made for you*

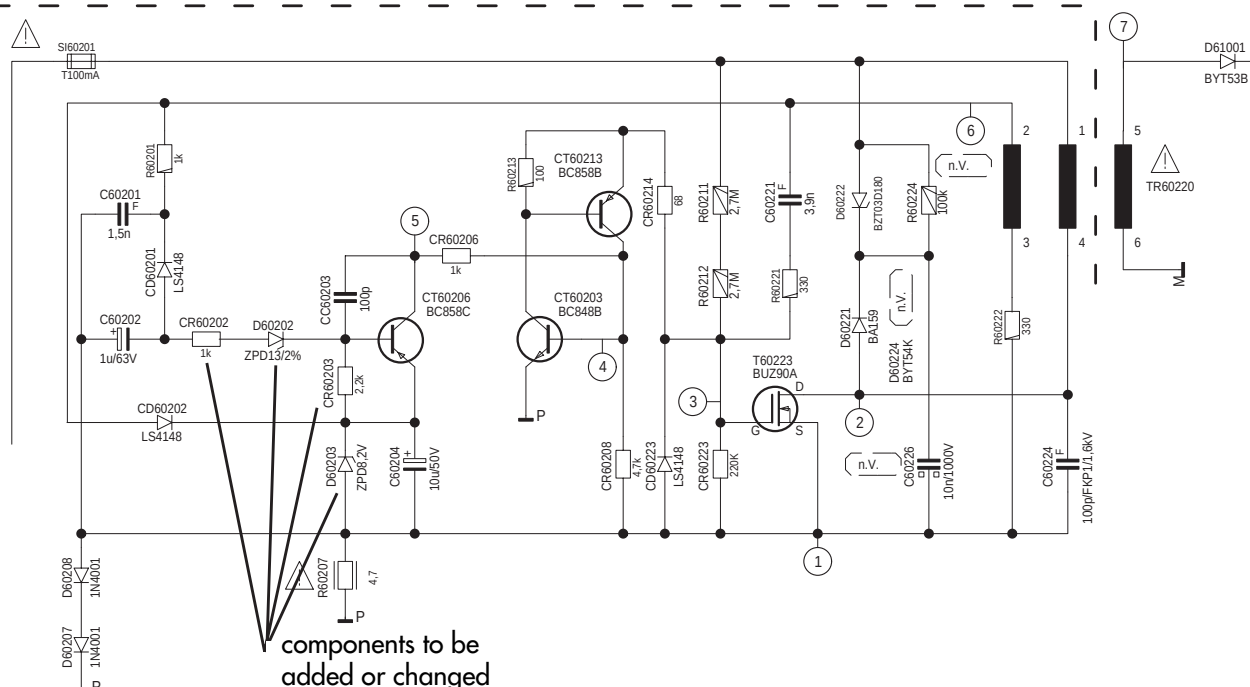
Brown colouration of the circuit board near the diode D 60222 BZT 03D180. Simultaneously the "+Eco" voltage is approx. 5V too high.

Coincidence of unfavourable component tolerances.

Carry out the following changes in the stand-by mains stage:

- Change the Z-diode D 60203 from ZPD 9.1V to 8.2V.
- Change R 60202 from 68 k $\Omega$  to 1 k $\Omega$ .
- Connect an additional Z-diode ZPD 13 in series with R 60202. Connect the cathode of the diode to the base of the transistor CT 60206.
- Check the rating of the resistor CR 60203 to be 2.2 k $\Omega$ .

Check the "+Eco" voltage. Carry out the changes if this voltage is higher than +17 V.

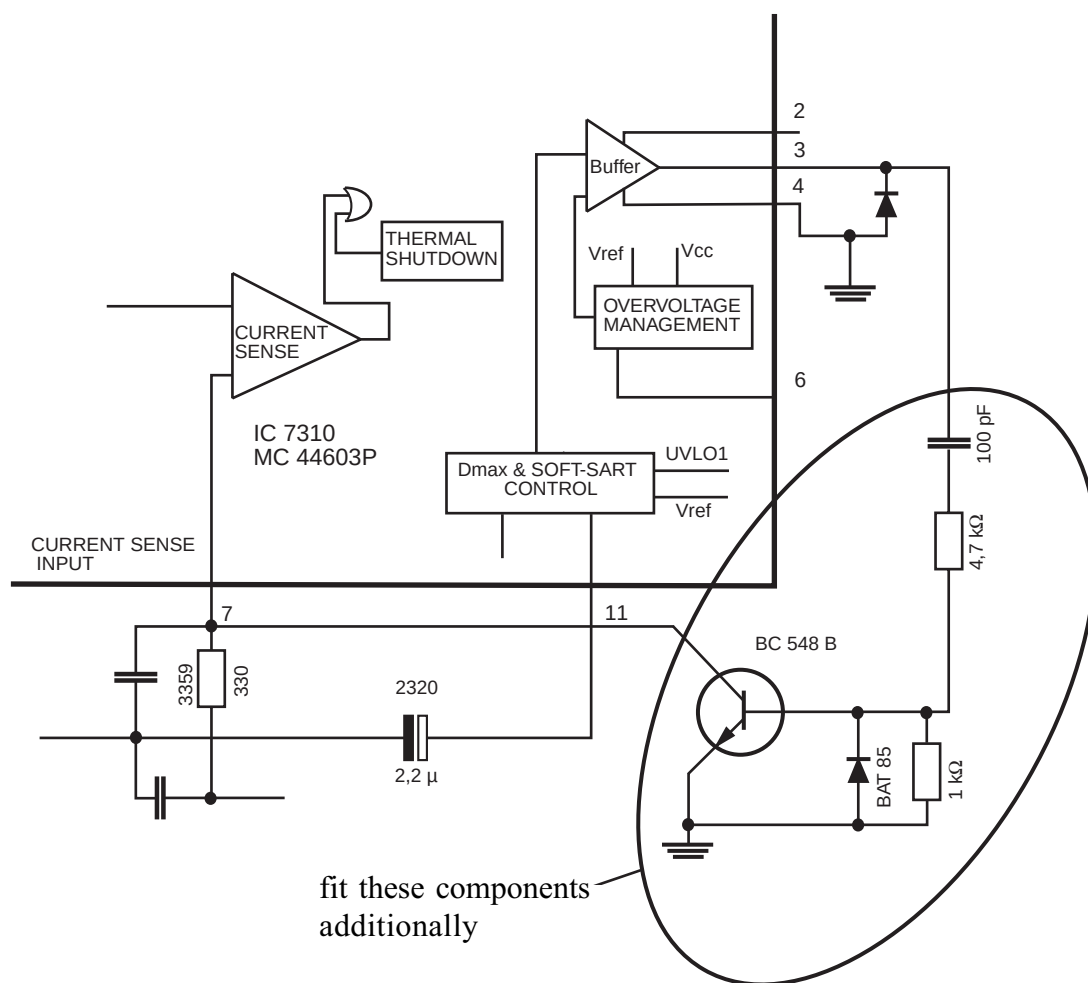
Mains voltage dependent chirp audible in stand-by mode.

Fit an additional transistor stage as shown below into the power supply unit at IC 7310 (MC 44603 P).

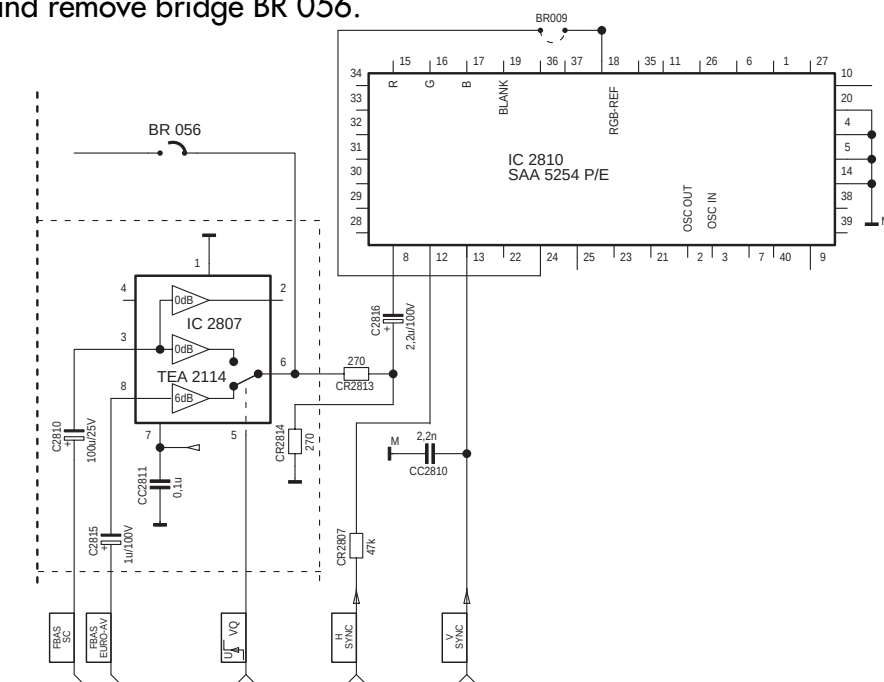
Teletext operation is not possible in "AV" programme position.

The video switch-IC 2807 (TEA 2114) is not fitted in 37 cm television receivers.

Retrofit the following components:

In addition, change the polarity of 2.2  $\mu$ F electrolytic capacitor C 2816 (negative terminal to pin 8 of IC 2810) and remove bridge BR 056.

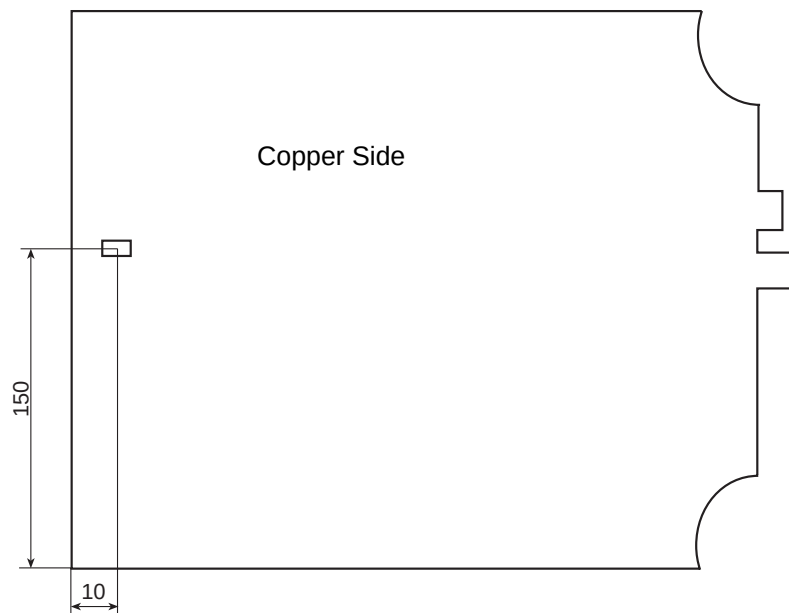
Despite the modifications carried out according to our TV Service Information 9/96 the television sets switch occasionally to Standby after a prolonged time of operation.

Temperature drift of the +E operating voltage by about 0.2 to 0.3V caused by Z-diode CD 61023. Consequently, IC 34015 TDA 8374 switches off with sudden black/white changes in the picture content or changing scenes.

The position of the Z-diode is X=10, Y=150. Unsolder this diode and insert a SMD resistor 1206 1.2Ω 1% in this place.

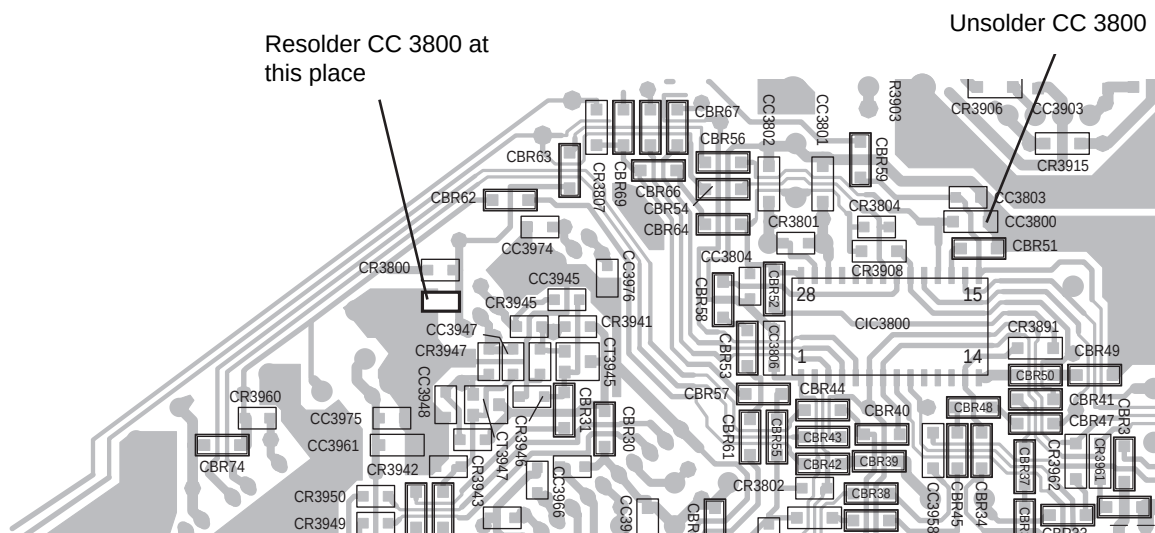
The sound disappears suddenly during the reception of a satellite programme and is audible again only when changing the programme or switching the TV off and on again.

IC MSP 3400 on the SAT Module hangs up by static charges entering the Reset input of the IC.

Unsolder the SMD capacitor CC 3800 from its place on the SAT Module and resolder it at the place indicated on the figure below.

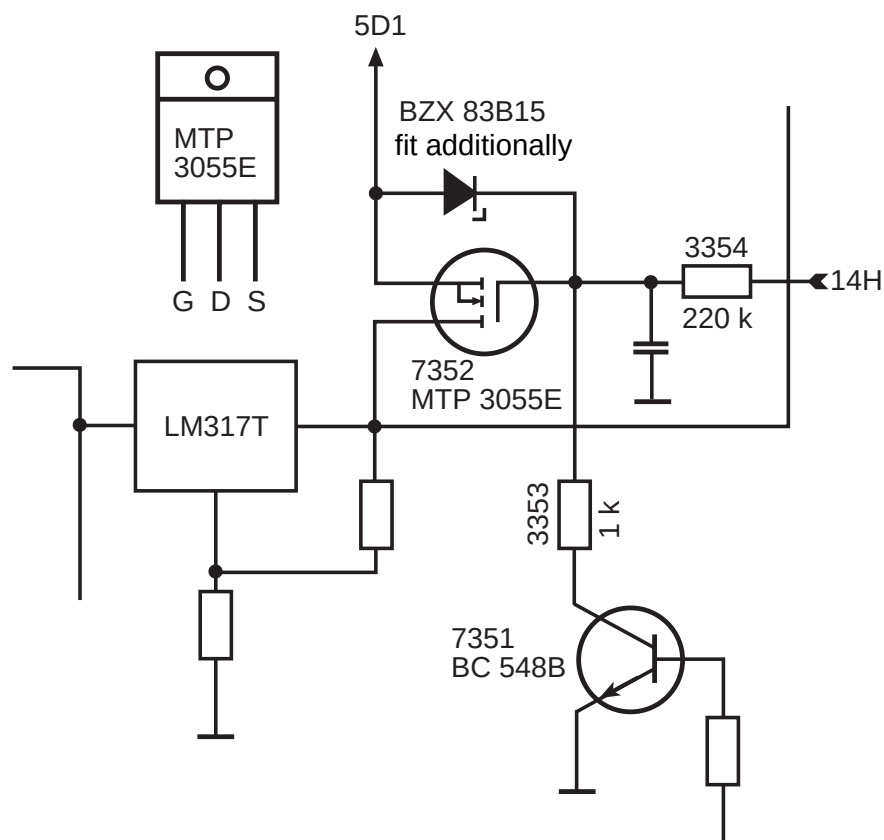
TV Recorder does not operate.

Defect in transistor 7352 (MTP 3055E) caused by static discharges in the TV Recorder.

Fit an additional Z-diode BZX 83B15 between gate and source to suppress voltage peaks at the gate.

The Z-diode must strictly be retrofitted if the transistor 7352 fails. This change is carried out already in the factory.

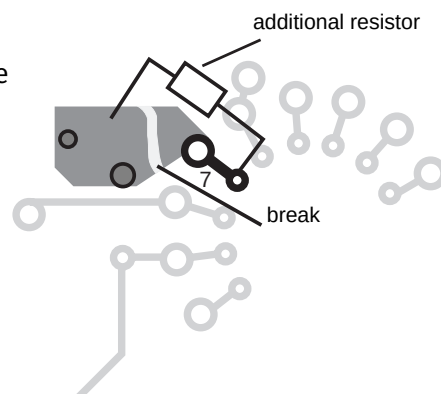
Failure of the RGB output stages (picture tube panels 29305-022.16 and -022.17) or of the teletext function.

Refit the resistor in any case if the above mentioned semiconductors failed.

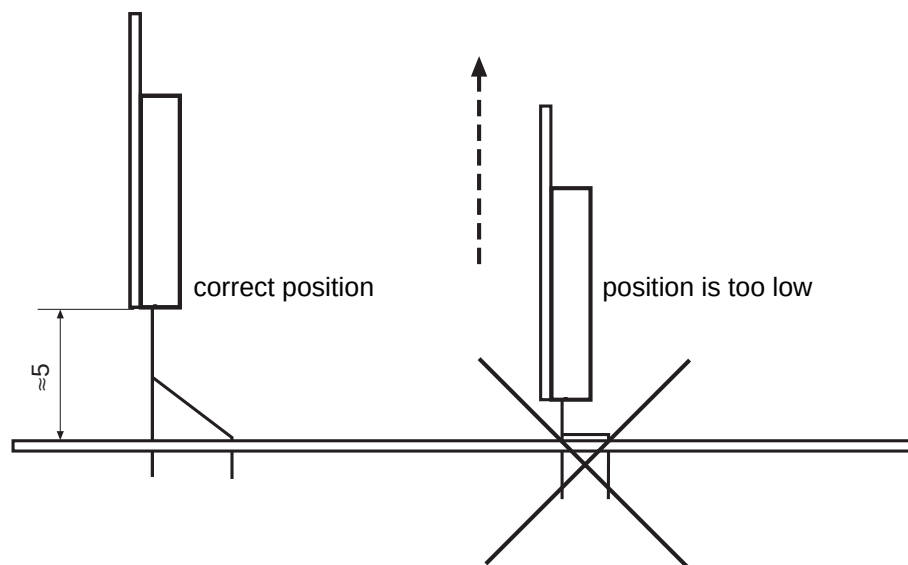
Vertical output stage TDA 4173 fails or thin white lines similar to retrace stripes are visible.

- Should above mentioned symptoms appear do not fail to exchange TDA 4173 AF and solder additionally a 1 nF foil capacitor from pin 1 and from pin 7 each to pin 4 (-K voltage) on the copper side.
- Check the mounting position of the vertical output-IC. If the position of the IC is too low, the pins may temporarily come into contact with the chassis connection on the upper side causing the IC to fail. Additionally, the circuit may already be damaged by the building up force of pressure resulting in a long-term failure. Therefore replace TDA 4173 AF also if it has not been fitted correctly!

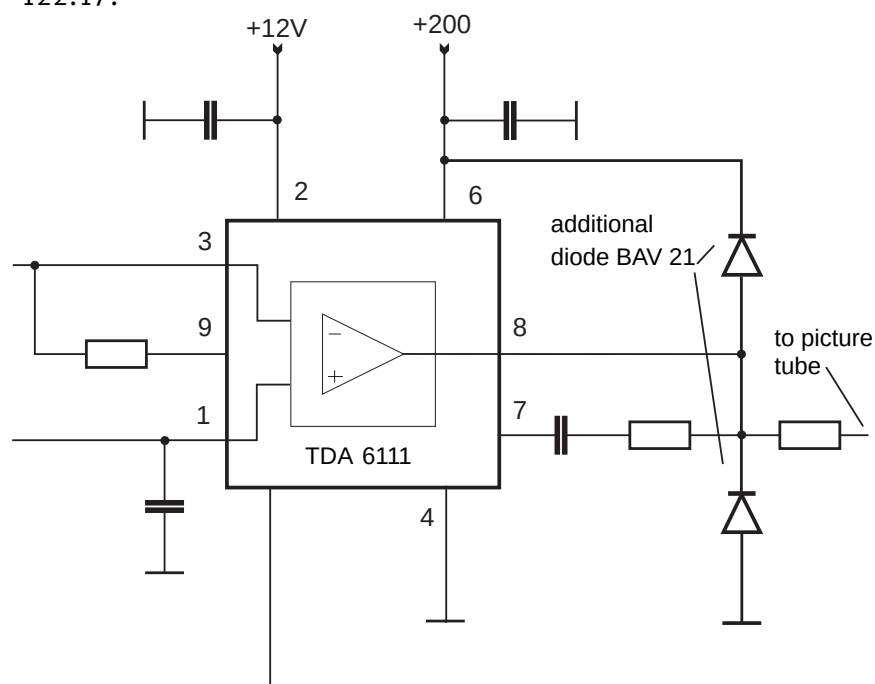
Failure of the RGB output IC's TDA 6111.

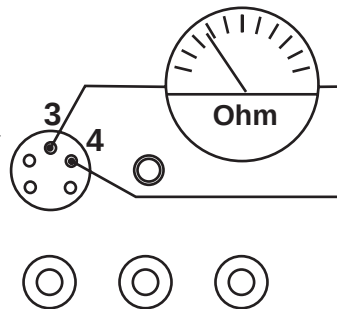
Good = 1-2 MOhm approximately

Bad = 5 kOhm approximately

Check the 5-pin Edit socket (from pin 3 to pin 4)
