**E4419B-16**

# S E R V I C E N O T E

## Agilent E4419B EPM Average Power Meter

### Front Panel Dimension Might Not Be Suitable For Rack Mounting Solutions

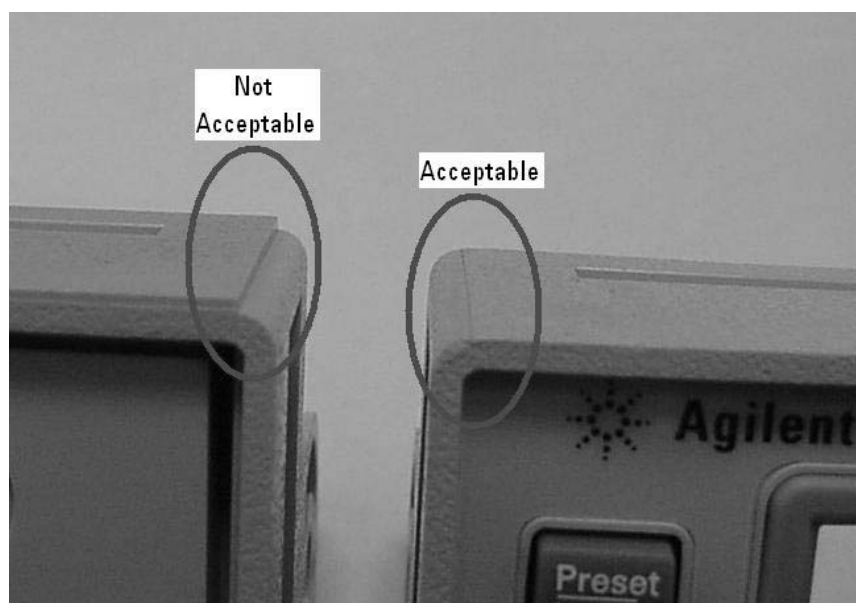
A tooling issue has resulted in some E4419B power meters being shipped with excess material on the top edge of the Front Panel Assembly. The height of this excess material varies, but it has been noted that when it exceeds 0.5mm the meter may no longer be suitable for rack mounting solutions.

Figure 1 shows the physical difference between an acceptable and an unacceptable Front Panel Assembly.

If the height of the excess material is 0.5mm (or less), then no further action is necessary.

If the height of the material exceeds 0.5mm, then the Front Panel Sub-assembly must be replaced (refer to Service Note E4419B-14 for instructions on how to remove & replace the Front Panel Sub-Assembly).
