Model: Iris/Lilac (Controller Interface Type E)	Date: 15-Nov-99	No.: RA258014a
---	-----------------	----------------

Subject: SC326 / Abnormal Image		Prepared by: T. Itoh	
From: Technical Service Dept., GTS Division			
Classification:	<input checked="" type="checkbox"/> Troubleshooting	<input type="checkbox"/> Part information	<input type="checkbox"/> Action required
	<input type="checkbox"/> Mechanical	<input type="checkbox"/> Electrical	<input type="checkbox"/> Service manual revision
	<input type="checkbox"/> Paper path	<input type="checkbox"/> Transmit/receive	<input type="checkbox"/> Retrofit information
	<input type="checkbox"/> Other ()

It was reported in the Japanese market that image quality problems or SC326 occur due to a defective BUSSW board in the Interface Kit. This RTB outlines the troubleshooting procedure.

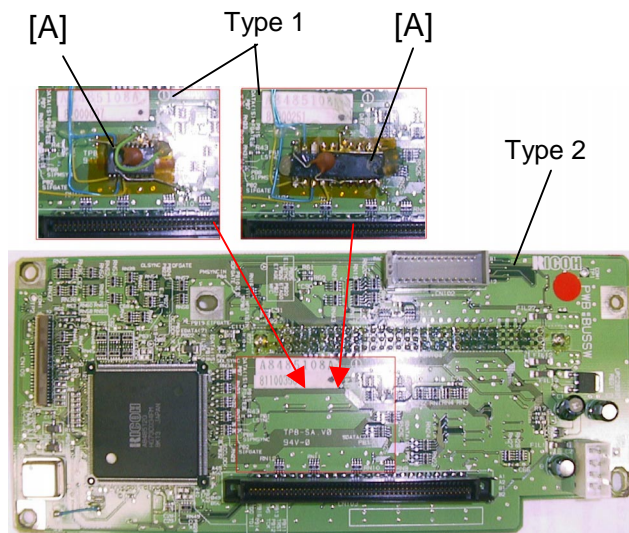
As shown in the picture, there are two types of BUSSW board (P/N #A8485108). Type 1 is the board on which an IC [A] has been manually soldered. Type 2 contains an IC18 soldered onto the circuit pattern by machine.

Type 1 is the board that was modified in the production (from #A8485105). This board contains one of the two ICs as shown in the picture to the right [A]. The only difference is in the size.

The function of the additional IC and IC18 is exactly the same. IC18 is soldered onto the reverse side of the Type 2 board.

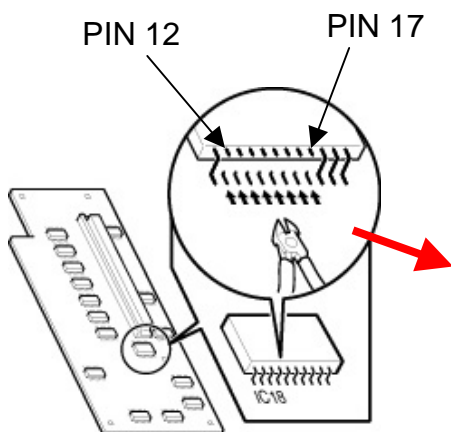
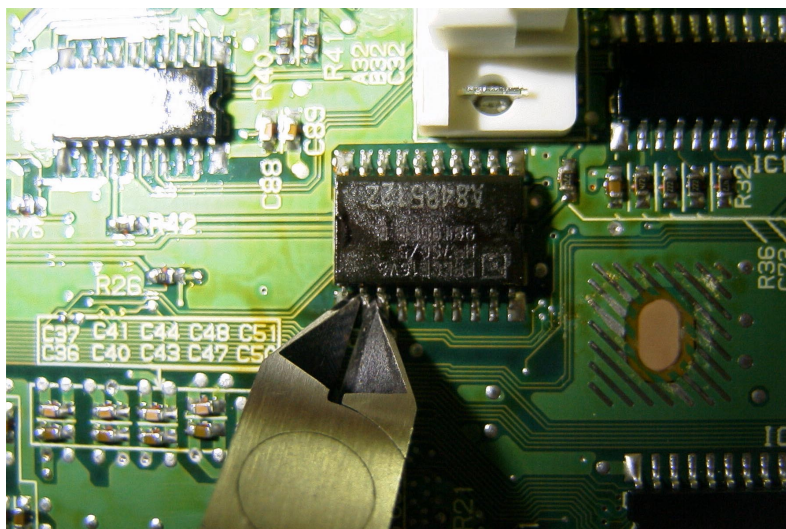
If the BUSSW board contains an IC [A], that has been manually soldered on, the procedure described below is not applicable. The BUSSW board would need to be replaced with #A8485112 when the problem occurs.

[2] Follow the procedure below at installation or next visit to prevent any future occurrence.

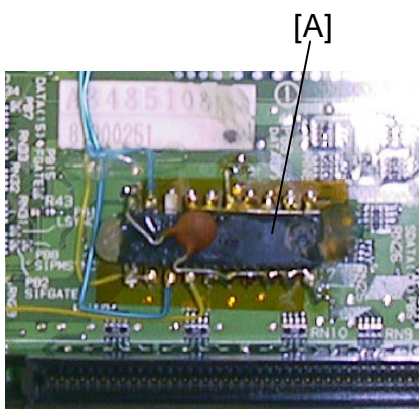
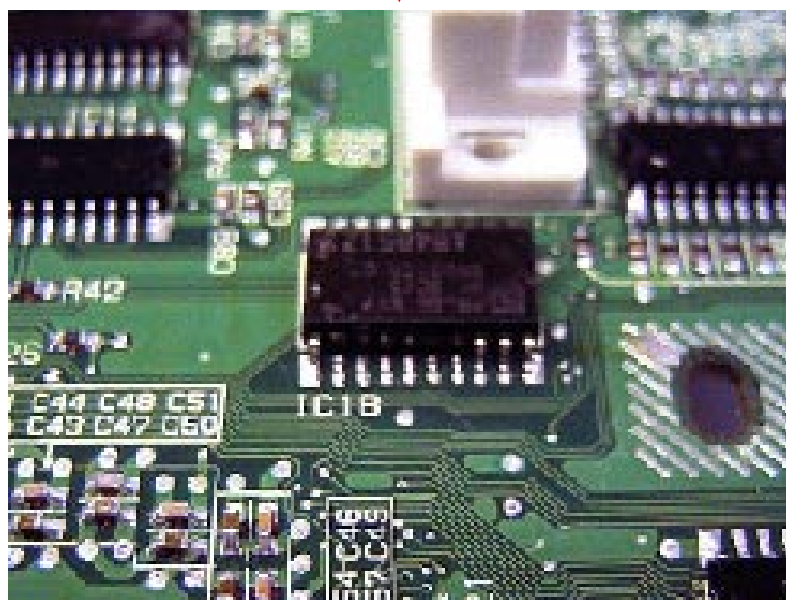
NOTE: Be careful not to damage the PCB pattern or cut other pins. If pins #11 or 18 are cut, this will cause SC326.

1. Remove the BUSSW board by following the procedure described on the previous page.
2. Using small cutting pliers, cut pins #12 to 17 so that they do not touch other pins or patterns. This will prevent a short circuit.
3. Remove the cut pins from the board surface.
