Model: Kingfisher2		Date: 28-Dec-00	No.: RA298006
Subject: DF Harness damage		Prepared by: M.Ishihara	
From: Technical Services Dept., GTS Division			
Classification:	<input checked="" type="checkbox"/> Troubleshooting	<input type="checkbox"/> Part information	<input type="checkbox"/> Action required
	<input type="checkbox"/> Mechanical	<input type="checkbox"/> Electrical	<input type="checkbox"/> Service manual revision
	<input type="checkbox"/> Paper path	<input type="checkbox"/> Transmit/receive	<input type="checkbox"/> Retrofit information
	<input type="checkbox"/> Other ()

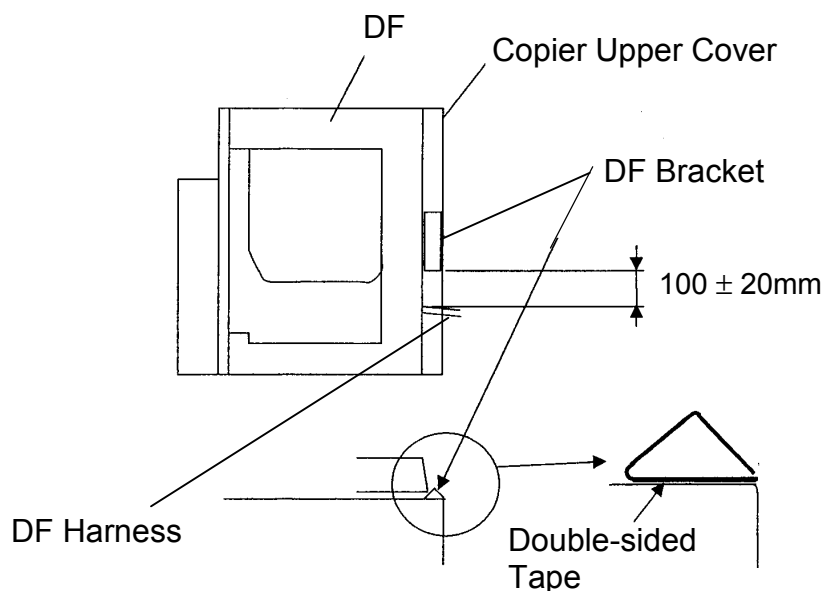
Damage to the harness connecting the DF44 and the copier.

Sometimes, the DF is forced past its normal stop position when it is opened. If this happens many times, the harness may be damaged.

A DF bracket (PN A2989500) has been registered as a service part. Place it on the copier upper cover as shown below to prevent the DF unit from being forced too far back.
