SUBJECT: ARDF Original misfeed.

☒ Troubleshooting

N440 Series

(A085/A087/A088)

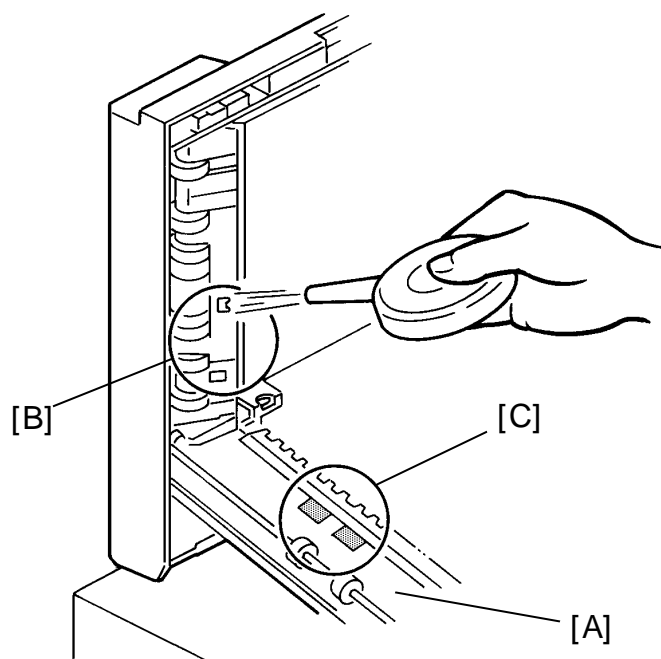
Original misfeed occurs intermittently.

1. The DF registration sensor is activated by paper dust on the sensor pad, affecting its color.
2. When the original feed roller starts rotating, the DF upper guide plate is warped slightly downward. The clearance between the DF registration sensor and the sensor pad is reduced. When this happens, the DF registration sensor (reflective type) can receive the reflective light from the sensor pad, even though its color is black.

(For cause 1)

1. Open the feed-in unit [A].
2. Clean the DF registration sensor surface [B] and the sensor pad [C].

NOTE: To remove the paper dust from the sensor pad, it is better to use scotch tape.
