Model: Iris2/Lilac2 (Controller E-310)		Date: 21-Mar-01	No.: RB017008
Subject: E-310 Ver.1.1 (128MB) model release		Prepared by: Chisato Tsuji	
From: Technical Services Dept., GTS Division			
Classification:	<input type="checkbox"/> Troubleshooting <input checked="" type="checkbox"/> Part information <input type="checkbox"/> Action required <input type="checkbox"/> Mechanical <input type="checkbox"/> Electrical <input checked="" type="checkbox"/> Service manual revision <input type="checkbox"/> Paper path <input type="checkbox"/> Transmit/receive <input type="checkbox"/> Retrofit information <input type="checkbox"/> Other ()

Model: Iris2/Lilac2 Controller E-310		Date: 15-Nov-01	No.: RG938001
Subject: "Please Wait", White Line Scans, etc.		Prepared by: Chisato Tsuji	
From: Technical Services Dept., GTS Division			
Classification:	<input checked="" type="checkbox"/> Troubleshooting <input type="checkbox"/> Part information <input type="checkbox"/> Action required <input type="checkbox"/> Mechanical <input type="checkbox"/> Electrical <input type="checkbox"/> Service manual revision <input type="checkbox"/> Paper path <input type="checkbox"/> Transmit/receive <input type="checkbox"/>

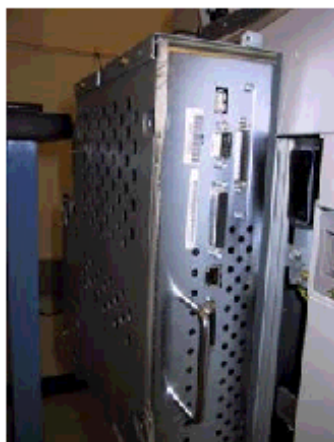
Figure 1 Front view – not fully seated

1. Some units were shipped from the factory with the connector in the condition shown in Fig. A below, i.e. the connector was not sticking out at least 4.2mm from the unit (as it should).
2. The connector clears the unit side face by at least 4.2mm, but the controller unit was not inserted far enough into the interface unit at installation (Fig. 1-4 below).

1. Shut down the Fiery system and turn off the copier main power.
2. Pull out the Fiery controller unit and check to see if the video interface connector sticks out from the unit 4.2mm or more (Fig. A). If not, then follow the instructions in Fig. B below.
3. Fully reseat the controller all the way into the interface unit until the connector fully engages (Fig. 5, 6).
4. Turn on the copier main power.
