Model: Iris2/Lilac2		Date: 24-Nov-00	No.: RB017001
Subject: Relay Harness of the Fax Unit		Prepared by: N. Kaiya	
From: Technical Services Dept., GTS Division			
Classification:	<input type="checkbox"/> Troubleshooting <input type="checkbox"/> Part information <input checked="" type="checkbox"/> Action required <input type="checkbox"/> Mechanical <input type="checkbox"/> Electrical <input type="checkbox"/> Service manual revision <input type="checkbox"/> Paper path <input type="checkbox"/> Transmit/receive <input type="checkbox"/> Retrofit information <input type="checkbox"/> Other ()

Model: Iris2/Lilac2 (Fax Option)		Date: 31-Jan-01	No.: RB017004
Subject: Message when install fax unit		Prepared by: M. Tsuyuki	
From: Technical Services Dept., GTS Division			
Classification:	<input type="checkbox"/> Troubleshooting	<input type="checkbox"/> Part information	<input type="checkbox"/> Action required
	<input type="checkbox"/> Mechanical	<input type="checkbox"/> Electrical	<input type="checkbox"/> Service manual revision
	<input type="checkbox"/> Paper path	<input type="checkbox"/> Transmit/receive	<input type="checkbox"/> Retrofit information
	<input checked="" type="checkbox"/> Other

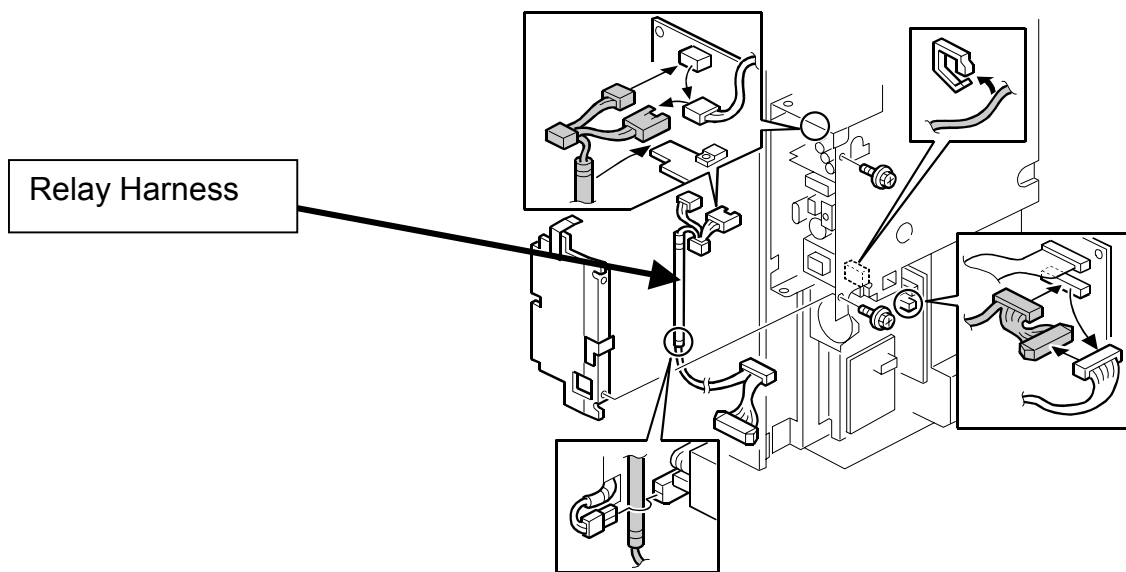
When installing the fax unit (machine code B383), it is not necessary to install the relay harness shown in the below figure.

The relay harness is packed with some of the August and September production lots of the fax unit to fix a problem with the domestic version product. The harness is not mentioned in the service manual.

The purpose of the relay harness was to stabilize +5VE power for the FCU by obtaining 5V power directly from the interface unit power supply unit. This was necessary because +5VE may drop and reset the CPU when the machine goes back to stand-by mode from energy saver mode. However, even if the CPU is reset when the machine goes back to stand-by mode from energy saver mode, no problem will appear with the overseas version products. Instead, the relay harness may cause the documents stored in the fax memory to disappear when the main switch is turned off and then on. This is because +5VE is supplied slightly after +5V when the main switch is turned on, and the battery back up to the memory is momentarily cut.
