Model: Stella-F1		Date: 21-Feb-02	No.: RH555001
Subject: Optional Printer Controller		Prepared by: A. Ishiyama	
From: Technical Services Dept., GTS Division			
Classification:	<input checked="" type="checkbox"/> Troubleshooting <input type="checkbox"/> Part information <input checked="" type="checkbox"/> Action required <input type="checkbox"/> Mechanical <input type="checkbox"/> Electrical <input type="checkbox"/> Service manual revision <input type="checkbox"/> Paper path <input type="checkbox"/> Transmit/receive <input type="checkbox"/> Retrofit information <input type="checkbox"/> Other ()

Please note the following when installing the optional Printer Controller in the model S-F1.

Subject: Printer Controller Firmware History		Prepared by: A.Ishiyama	
From: 1st Tech. Support Sec. Service Support Dept.			
Classification:	<input type="checkbox"/> Troubleshooting	<input type="checkbox"/> Part information	<input checked="" type="checkbox"/> Action required
	<input type="checkbox"/> Mechanical	<input type="checkbox"/> Electrical	<input type="checkbox"/> Service manual revision
	<input type="checkbox"/> Paper path	<input type="checkbox"/> Transmit/receive	<input type="checkbox"/> Re

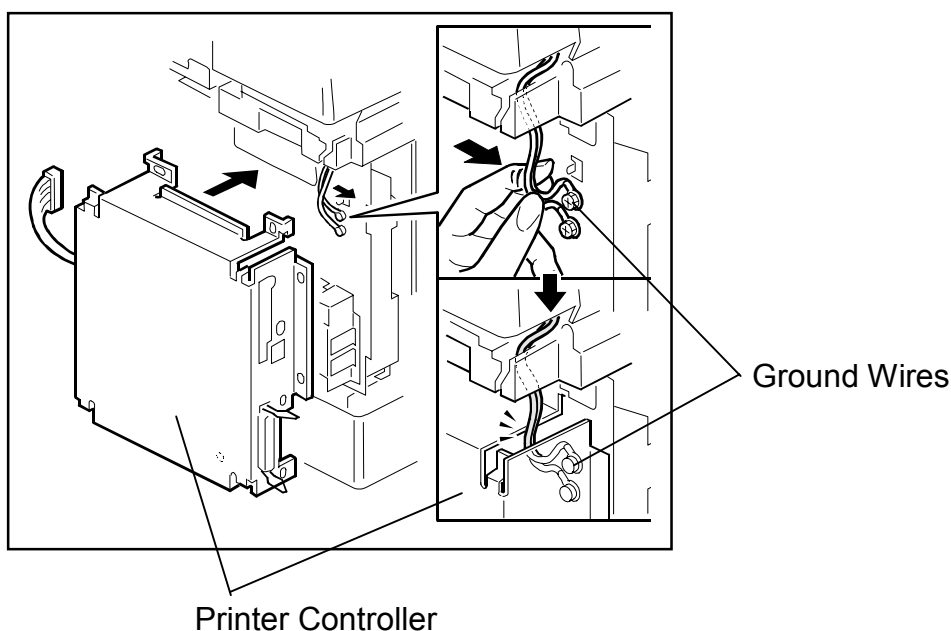
After installing the printer controller in Step 5 of the Installation Procedure, the ADF unit does not open all the way.

When the Controller was installed, the 2 ground wires were not led through the inlet (opening) in the upper right corner of the controller bracket, causing excess tension on the wires.

When installing the Printer Controller, be sure to set the wires into the opening in the upper right of the bracket as shown below. This will prevent excess tension on the wires and allow the DF to fully open.

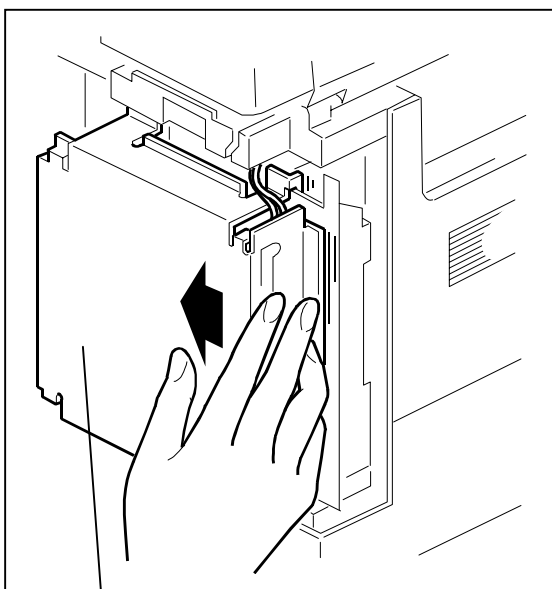
After installing the Printer Controller in Step 5 of the Installation Procedure, the 3 screw holes on the main face of the Rear Cover do not line up with the mainframe holes, making it difficult to reattach the cover.

When the Controller is attached slightly right of center, the width and circular (top) screw holes of the Rear Cover do not provide enough clearance for left/right cover adjustment, and the two contact one another.

When attaching the Controller, hold it flush against the left while tightening the bracket screws as shown in the illustration below.

The shape of the upper screw holes on the main face of the Rear Cover will be changed from circular to elliptical (running change) to allow for any necessary left/right adjustment.
