**RTB Correction**Reissue date: **15- Jun -97**

Model: AD-1		Date: 19-Mar-97	No: 26A
Subject: Paper jam		Prepared by: M.Horiike	
From: QAC 2nd Field Information Dept.			
Classification:	<input type="checkbox"/> Troubleshooting	<input checked="" type="checkbox"/> Part information	<input type="checkbox"/> Action required
	<input type="checkbox"/> Mechanical	<input type="checkbox"/> Electrical	<input type="checkbox"/> Service manual revision
	<input type="checkbox"/> Paper path	<input type="checkbox"/> Transmit/receive	<input type="checkbox"/> Retrofit information
	<input type="checkbox"/> Other (    )

Model: AD1-Paper Tray Unit ( PS330 )		Date: 23-Jul-97	No: 36
Subject: Noise		Prepared by: K.Ugaeri	
From: QAC 2nd Field Information Dept.			
Classification:	<input type="checkbox"/> Troubleshooting	<input type="checkbox"/> Part information	<input checked="" type="checkbox"/> Action required
	<input type="checkbox"/> Mechanical	<input type="checkbox"/> Electrical	<input type="checkbox"/> Service manual revision
	<input type="checkbox"/> Paper path	<input type="checkbox"/> Transmit/receive	<input type="checkbox"/> Retrofit information
	<input type="checkbox"/> Other (       )

Model: PS

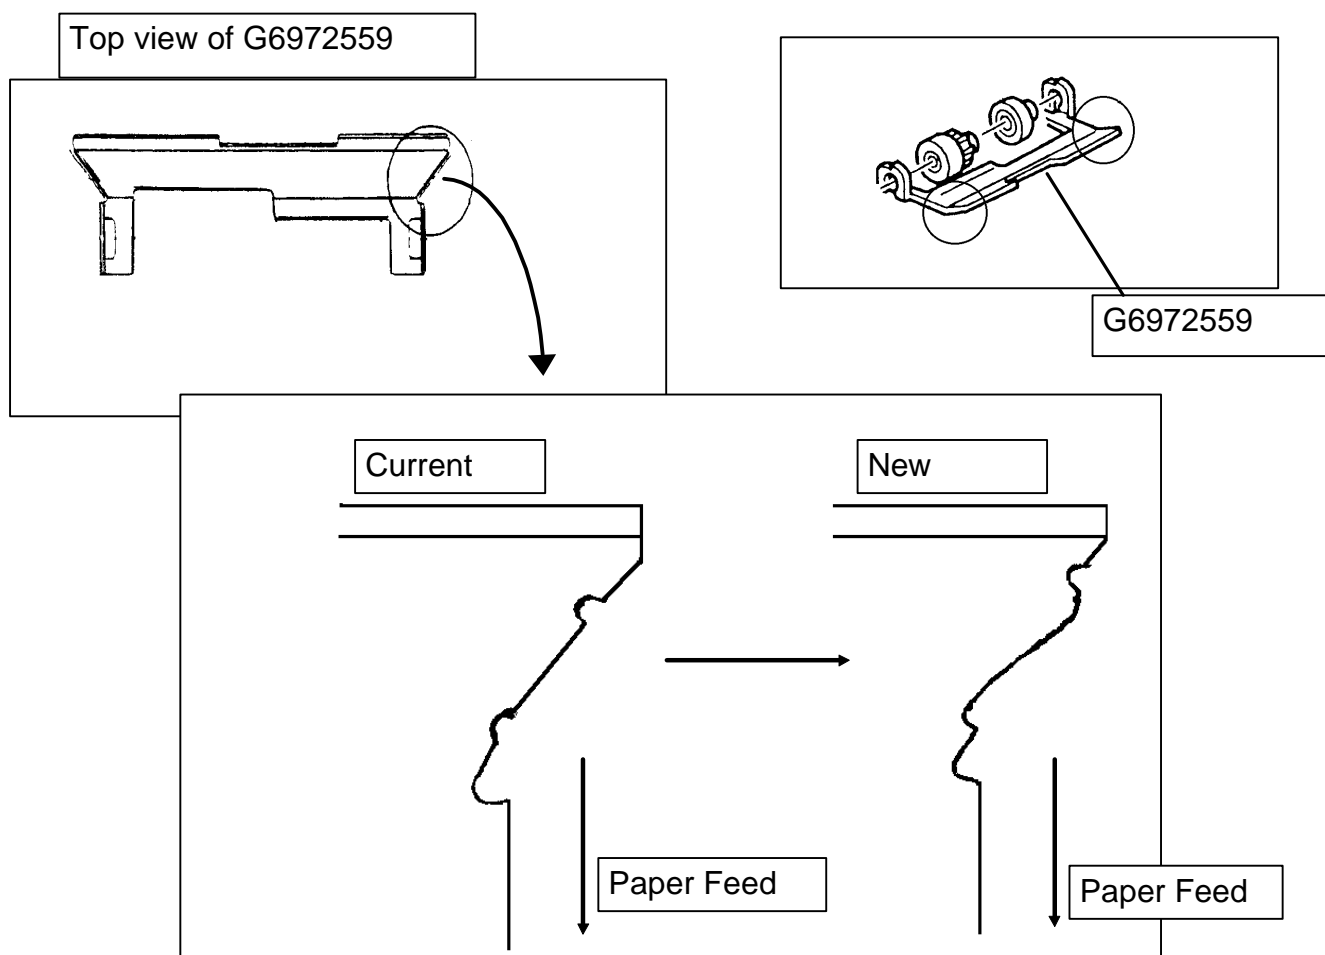
Paper jam from the ***paper tray unit (PS 330)***.

The paper contacted the uneven edge of the upper guide paper feed.

The shape of the upper guide - paper feed has been changed from January Production '97.

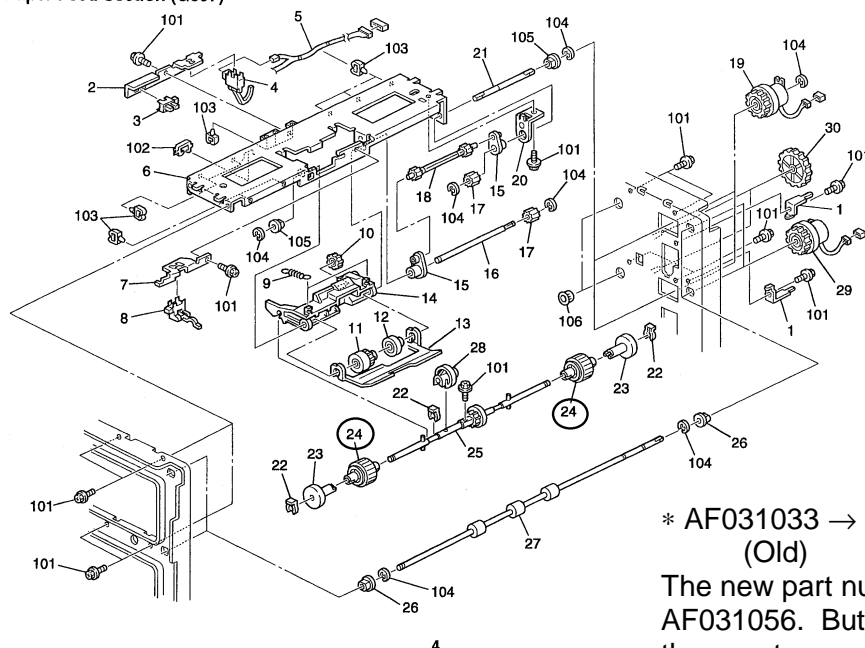
2. Paper Feed Section (G697)

**SYMPTOM:** Paper jam

**CAUSE:** Paper skewing or no feed from PS330 (Paper Tray)

**Countermeasure:** The diameter of the paper feed roller has been modified from 30φ to 32φ to improve paper feed.

\* AF031033 → AF031056  
(Old) (New)

The new part number of the feed roller is AF031056. But do not order this part until the countermeasure kit is out of stock.
