RTB Correction

Model: AD1(LCT Option)		Date: 31-Jan-98	No: 48A
Subject: Paper jam and Noise		Prepared by: K.Ugaeri	
From: QAC Field Information Dept.			
Classification:	<input checked="" type="checkbox"/> Troubleshooting	<input checked="" type="checkbox"/> Part information	<input type="checkbox"/> Action required
	<input type="checkbox"/> Mechanical	<input type="checkbox"/> Electrical	<input type="checkbox"/> Service manual revision
	<input type="checkbox"/> Paper path	<input type="checkbox"/> Transmit/receive	<input type="checkbox"/> Retrofit information
	<input type="checkbox"/> Other ()

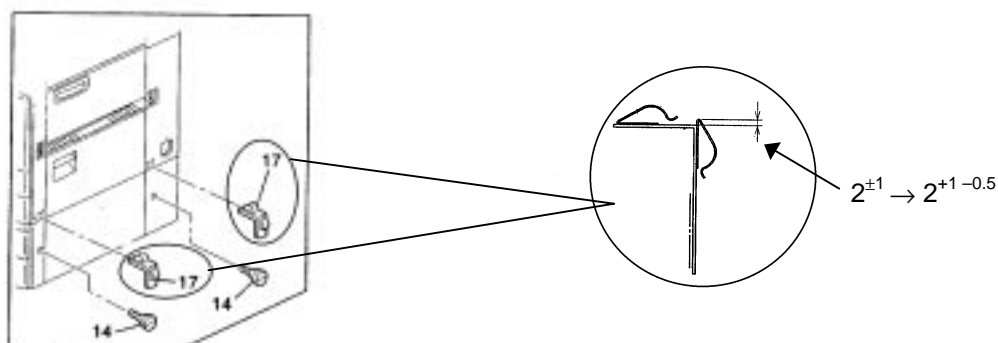
1.LCT UNIT 1(A667)

1. The grounding plate (A6676151) was broken at installation.
2. Paper jam
3. Noise

1. When the LCT is installed on the main frame, the spring plate might be cracked.
2. When the dust rubbed off the timing belt gets between the timing pulley and the drive shaft, the rotation of the pulley is affected and paper jams might occur.
3. Rotation noise from the relay roller (but the noise level is still within specification)

1. When installing the LCT, take care not to press the grounding plate too hard.

The shape of the grounding plate has been modified (A6676151->A6676151A) and RCL will supply the countermeasure parts to each subsidiary.
