| RIGOH | Technical Bulletin | | | No. RTB-014 | | |
| SUBJECT: FINISHER ENTRAN | ICE GUIDE | | | DATE:Jan. 31, '93 PAGE: 1 of 6 | | |

SUBJECT: FINISHER ENTRANCE GUIDE

| RIGOH | Technical Bulletin | | | No. RTB-027 | | |
|---|---|---|---|---|--|--|
| SUBJECT: SC733 | | | | DATE:Mar. 15 '94 PAGE: 1 of 3 | | |

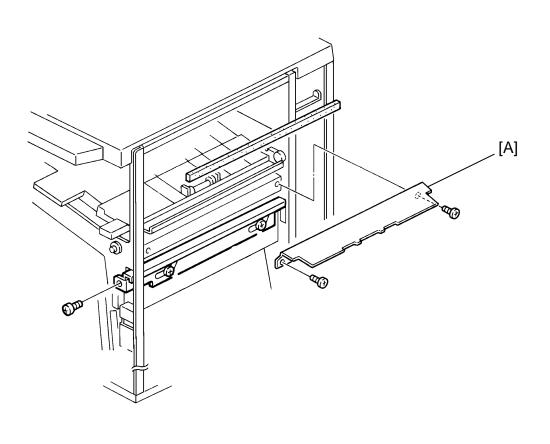
| RIGOH | Technical Bulletin | | | No. RTB-014 | | |
|--|---|---|---|---|--|--|
| It has been reported that several sorter stapler (A377) entrance guide become deformed. (This is introduced in F400/F410 RTB No.13, please refer to it for details) Since the F400 finisher has the same type of guide plate, the entrance guide plate [A] is | | | | | | |
| separated from the finisher and kept in the accessory bag. This is implemented from the first February 1994 production machine. | | | | | | |

Whenever transporting the sorter stapler after taking out of the carton box, separate the guide plate from the finisher. Reset it just before you dock the finisher to the copier.

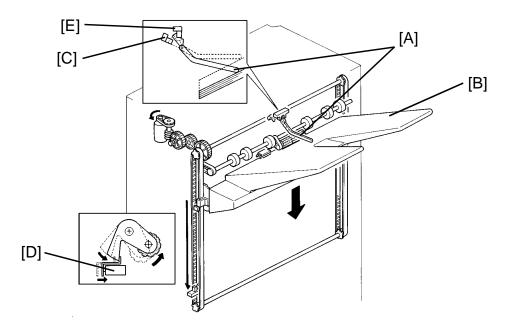
If the paper level actuator [A] is out of the position (See the illustration on page 2 of 3), the machine may sense that the shift tray [B] has not arrived at the proper level even though the shift tray [B] is at the maximum position (the stack height sensor 2 [C] is not actuated).

The fail safe mechanism (there is a safety switch [D] to detect the shift tray overrun condition) stops the shift tray lift motor from trying to raise the shift tray any more.

Under this condition, the machine indicates the "R2" jam indication. If the front door of the finisher is opened and closed and if the paper level actuator is still out of position, the machine indicates SC733.

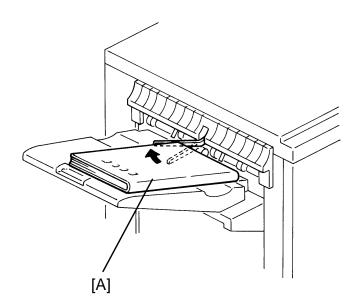
The paper level actuator may be out of the position under the following situation:

1) The customer places something (for example, book, copies, etc.) [A] on the shift tray, it pushes the actuator out of the position.

2) When the copy sets are delivered on the shift tray, the customer removes the copies. If the operator reaches for the copies from just in front of the operation panel the operator will not be able to see the actuator. It is possible for the operator to push the actuator out of position when removing the copies.

- 1. Instruct the customer to return the actuator to the correct position (so that the actuator becomes straight) and turn off then on the main switch.
- 2. The shift tray level actuator shape has been changed so that it cannot be bent easily. This modification will be implemented from April 1994 production.
