Model: NAD 30S/30/40 (3000-sheet Finisher)		Date: 30-Jun-98	No: 7
Subject: Paper rolled-up on the shift tray		Prepared by: M.Mimura	
From: QAC Field Information Dept.			
Classification:	<input checked="" type="checkbox"/> Troubleshooting	<input type="checkbox"/> Part information	<input type="checkbox"/> Action required
	<input type="checkbox"/> Mechanical	<input type="checkbox"/> Electrical	<input type="checkbox"/> Service manual revision
	<input type="checkbox"/> Paper path	<input type="checkbox"/> Transmit/receive	<input type="checkbox"/> Retrofit information
	<input type="checkbox"/> Other ()

Model: NAD 30S/30/40 (3000 Finisher)		Date: 31-Mar-99	No.: 30
Subject: Software Replacement Information		Prepared by: E. Fukuyama	
From: GTSS Field Information Dept.			
Classification:	<input type="checkbox"/> Troubleshooting <input type="checkbox"/> Part information <input type="checkbox"/> Action required <input type="checkbox"/> Mechanical <input type="checkbox"/> Electrical <input type="checkbox"/> Service manual revision <input type="checkbox"/> Paper path <input type="checkbox"/> Transmit/receive <input type="checkbox"/> Retrofit information <input checked="" type="checkbox"/> Other

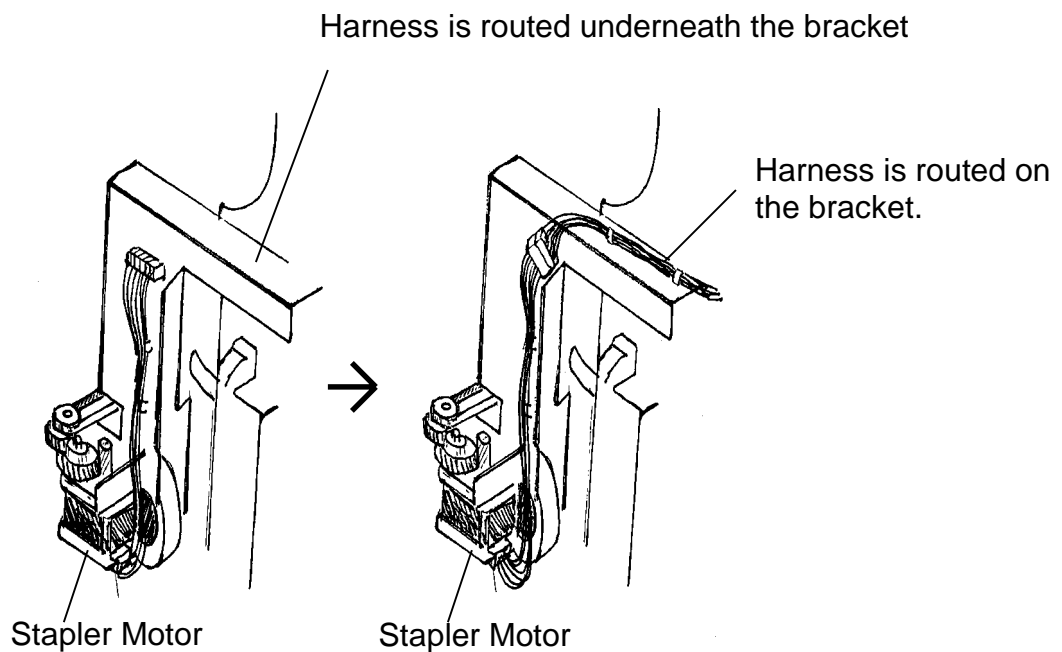
To prevent the stapler motor harness from being damaged, the harness route has been changed as shown in the illustration below:

Cut-in serial number for the harness route change:

- A697 - 15 : 1B59030221~
- 17 : A7779030001~
- 22 : AR39030001~
- 26 : 3R10390001~
- 55 : L0329032032~

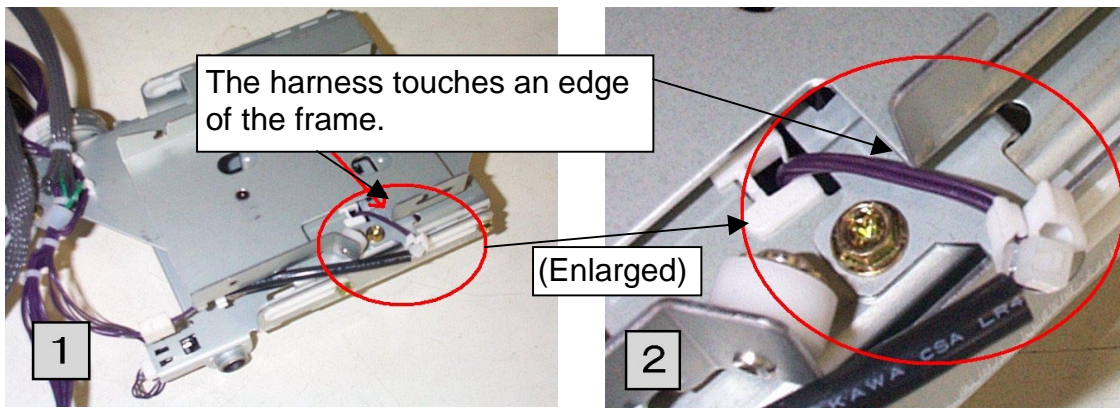
SC621 is generated during copy cycle.

The stapler rotation HP sensor harness shorts to the frame

The routing of the harness has been changed as shown in the photo. This can be done in the field.
