Model: Pomelo	Date: 30-Apr-99	No.: RG033001a
---------------	-----------------	----------------

Subject: Detailed Self -diagnostics Error		Prepared by: H. Someya	
From: Technical Service Dept., GTS Division			
Classification:	<input checked="" type="checkbox"/> Troubleshooting	<input type="checkbox"/> Part information	<input type="checkbox"/> Action required
	<input type="checkbox"/> Mechanical	<input type="checkbox"/> Electrical	<input type="checkbox"/> Service manual revision
	<input type="checkbox"/> Paper path	<input type="checkbox"/> Transmit/receive	<input type="checkbox"/> Retrofit information
	<input type="checkbox"/> Other ()

Model: Pomelo		Date: 15-Aug-99	No.: RG033003
Subject: Uneven or faint image / SC41		Prepared by: H. Someya	
From: Technical Service Dept., GTS Division			
Classification:	<input checked="" type="checkbox"/> Troubleshooting <input type="checkbox"/> Part information <input type="checkbox"/> Action required <input type="checkbox"/> Mechanical <input type="checkbox"/> Electrical <input type="checkbox"/> Service manual revision <input type="checkbox"/> Paper path <input type="checkbox"/> Transmit/receive <input type="checkbox"/> Retrofit information <inp

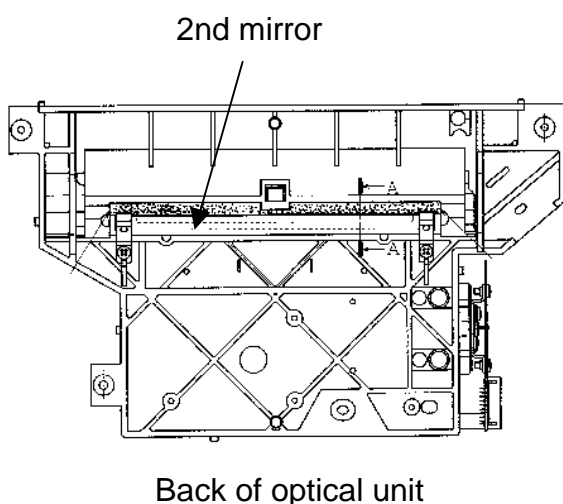
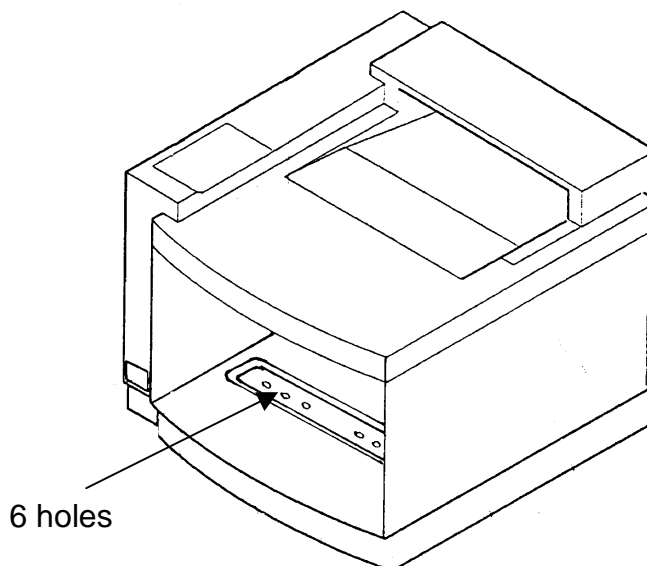
- Uneven or faint image
- SC41 appears.

Dust entering from the holes in the base adheres to the 2nd mirror over time.

1. Remove the optical unit and clean the 2nd mirror with an optical cloth.
2. Use tape to block the 6 holes in the base.
3. Reassemble the machine.

Polyester tape has been attached to block the 6 holes in the base (effective as of February production runs).

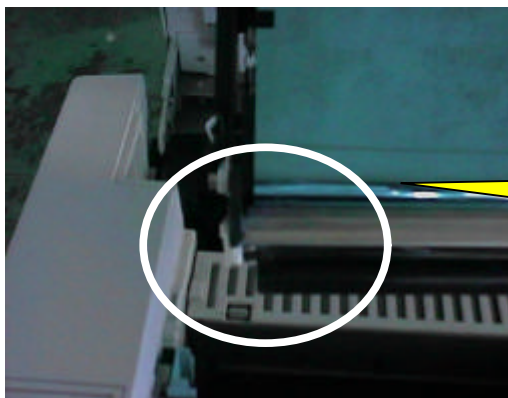
Diagram 1

If SC76 occurs, take the following action:

1. Remove the belt cartridge.
2. Measure the gap L between side plate and OPC belt as shown in diagram 1.
3. Do one of the following actions depending the length of gap L:

Gap L (mm)	Required action
0 – 3	Attach one spacer to the bearing on side A as shown in diagrams 2 & 3.
3 – 7	No action necessary
7 - 10	Attach one spacer on the bearing on side B as shown in diagrams 2 & 3.

4. Install the belt cartridge and the turn on the machine.
5. Measure gap L after the machine has finished warming up.
6. If gap L is 3 mm to 7 mm, this procedure is complete. If gap L is less than 3 mm or more than 7 mm, repeat this procedure from step 3 (attach one more spacer).

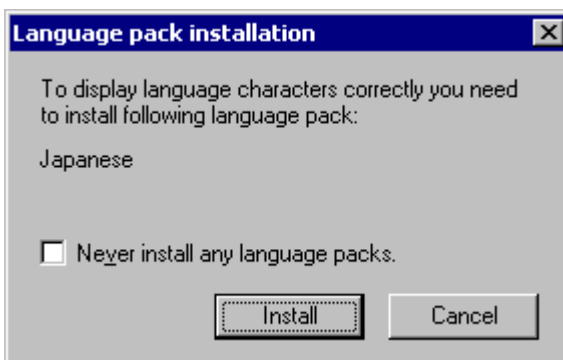
When you browse the Pomelo and FresaWIN printers with Microsoft Internet Explorer 5.x (IE 5.x), IE 5.x requires installing a Japanese font even if the HTML does not have a Japanese font.

i.e., if browsing http://Printer IP Address/en/cgi-bin/sts_index.cgi, the following message appears:

Maybe the message is different because of a minor variation in the IE version or Windows OS. The above message appears when using IE 5.00.2920.0000 with Windows 2000. In this case, IE requires a Japanese font every time.

This line means that HTML declares this file's code is Japanese. Therefore IE 5.x requires installing a Japanese font even if all HTMLs do not have a Japanese font.

If the NIB version is 3.8.7 or earlier, please get the latest Ricoh NIB firmware and install the new one in the NIB.

Install a Japanese font in Windows. There are a few ways to install Japanese fonts.

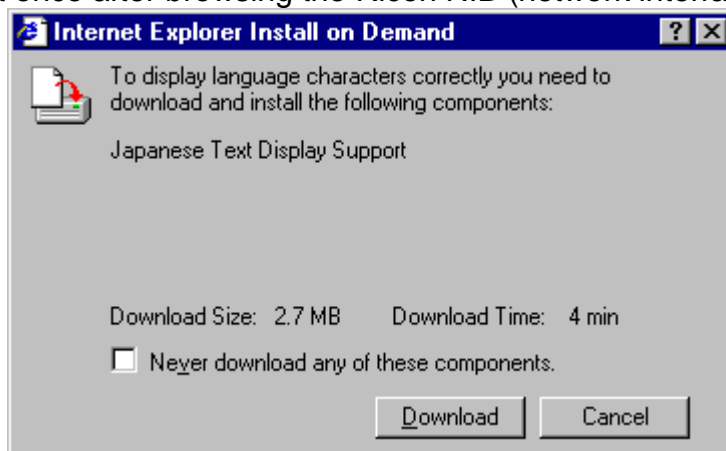
IE 5.00.2314.10003 with Windows NT 4.0 is shown below. In this case, IE requires a Japanese font once after browsing the Ricoh NIB (network interface board).
