Model: General RTB	Date: 4-Feb-03	No.: RGene013b
--------------------	----------------	----------------

Subject: Service remarks at installation		Prepared by: T. Itoh	
From: Technical Service Sec. Service Planning Dept.			
Classification:	<input type="checkbox"/> Troubleshooting <input type="checkbox"/> Part information <input type="checkbox"/> Action required		
	<input type="checkbox"/> Mechanical <input type="checkbox"/> Electrical <input type="checkbox"/> Service manual revision		
	<input type="checkbox"/> Paper path <input type="checkbox"/> Transmit/receive <input type="checkbox"/> Retrofit information		
	<input checked="" type="checkbox"/> Other (Specification change)

Model: Model AR-P1		Date: 29-Jun-05	No.: RG081007
Subject: Vertical thin line problem		Prepared by: K. Moriizumi	
From: 1st Tech. Support Sec. Service Support Dept.			
Classification:	<input checked="" type="checkbox"/> Troubleshooting	<input type="checkbox"/> Part information	<input type="checkbox"/> Action required
	<input type="checkbox"/> Mechanical	<input type="checkbox"/> Electrical	<input type="checkbox"/> Service manual revision
	<input type="checkbox"/> Paper path	<input type="checkbox"/> Transmit/rece

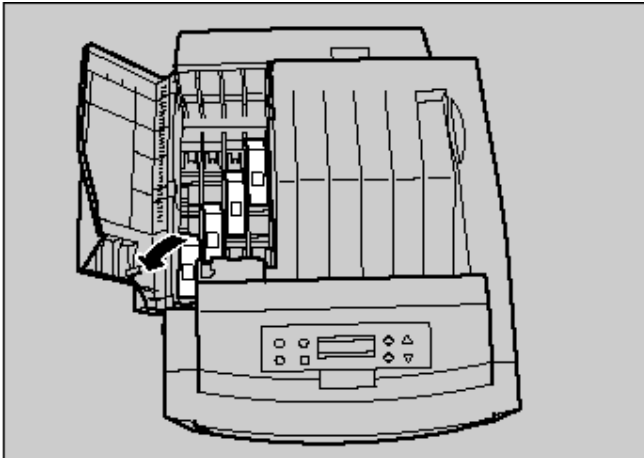
Case 2

The toner is not supplied. The protection sheets for the toner supply holes must be removed at installation, as shown in the following drawing. If the protection sheet is not removed and the toner bottle is installed, the toner cannot be supplied. The low toner condition will damage the PCU surface.

Replace the PCU and add toner.

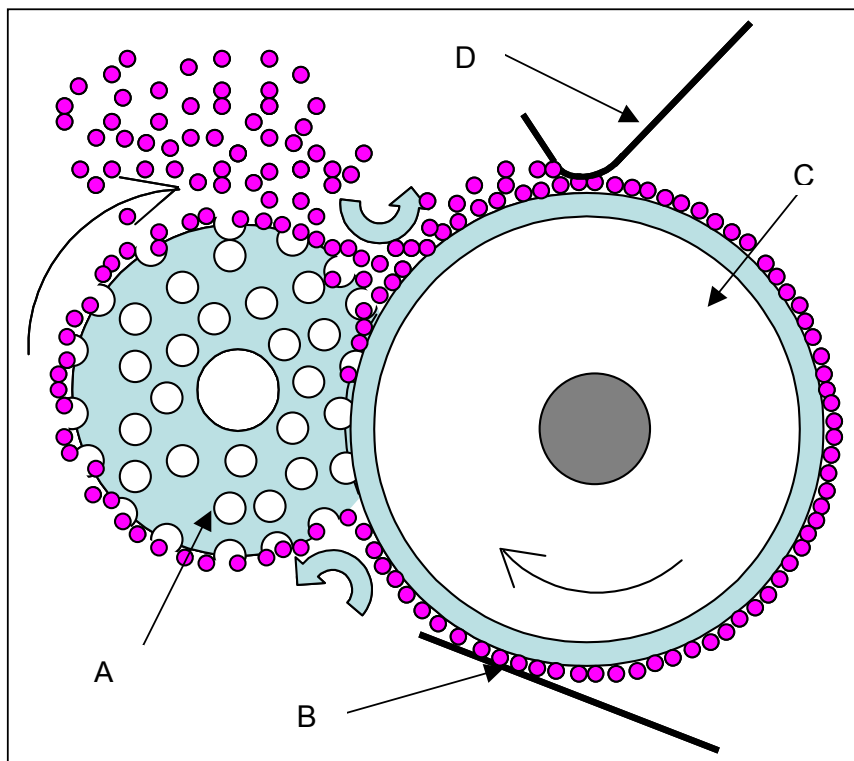
A: Toner supply roller, B: Quenching sheet
C: Development roller, D: Doctor blade

Scratches or indentations develop on the quenching sheet due to foreign particles stuck to the sheet, after which toner fills in these areas. This in turn scratches the development roller surface and shows up on the outputs as vertical lines.

The diagram on the right shows the inside of the PCU.

There is a potential difference of about 63V between the development roller and the quenching sheet because of a zener diode (Tz).

The toner will be gathered on the surface of the quenching sheet because of the potential difference. Then, the toner will be fixed on the quenching sheet.

This toner scratches the development roller surface.

Replace the PCU.
