Model: PRIPORT PINKGOLD		Date: 20-May-02	No: R-C238-001
Subject: PINKGOLD firmware history		Prepared by: H. Onodera, Priport Service Planning Section	
Classification: <input type="checkbox"/> Troubleshooting <input checked="" type="checkbox"/> Part information <input type="checkbox"/> Action required <input type="checkbox"/> Mechanical <input type="checkbox"/> Electrical <input type="checkbox"/> Service manual revision <input type="checkbox"/> Paper path <input type="checkbox"/> Transmit/receive <input type="checkbox"/> Retrofit information <input type="checkbox"/> Other ()			
Model Name: Ricoh JP3000/JP3800, Gestetner 5430/5428C, RexRotary 1330, nashuatec CP430, Savin 3260DNP, Standard SD370

Model: PRIPORT PINKGOLD		Date: 20-May-02	No: R-C238-002
Subject: Image shift problem		Prepared by: H. Onodera, Priport Service Planning Section	
Classification:	<input checked="" type="checkbox"/> Troubleshooting <input type="checkbox"/> Part information <input type="checkbox"/> Action required <input type="checkbox"/> Mechanical <input type="checkbox"/> Electrical <input type="checkbox"/> Service manual revision <input type="checkbox"/> Paper path <input type="checkbox"/> Transmit/receive <i

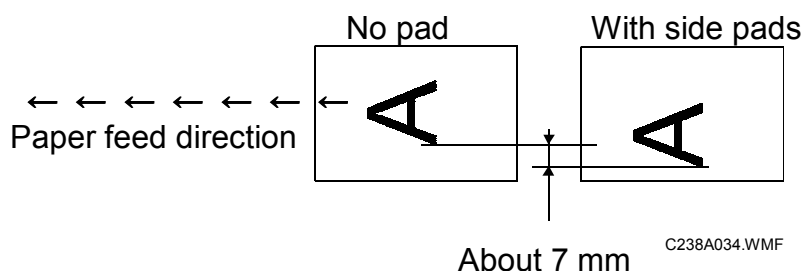
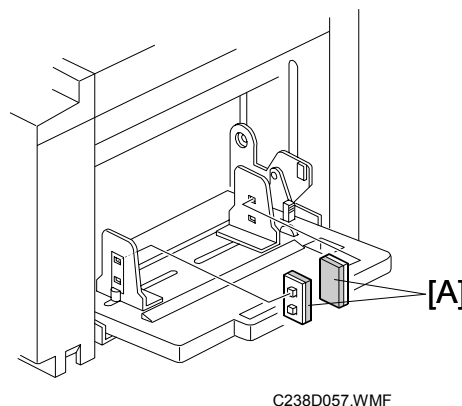
The image shifts approximately 7mm when the side fence friction pads [A] are used.

The area that the image scanning system reads is determined by the size detected in the paper tray (not by an original detection sensor). However, the machine does not adjust for the thickness of the side pads. As a result, the machine then scans an area larger than the paper's actual size, shifting the image writing start position with respect to the paper edge.

1. The width of the pads has been decreased (see MB #MC238001).
2. Main firmware suffix D has been modified so that the machine takes into account the thickness of these new pads – i.e. size detection range has been increased (see RTB #RC238001 and Table 2 below).

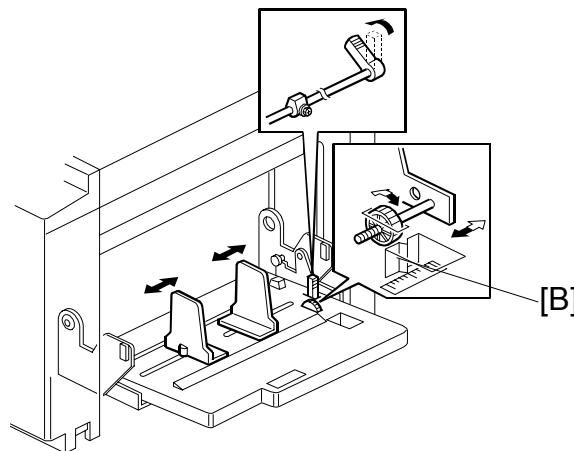
C238D056.WMF

Note: As shown in Table 1 below, a shift may still occur when using suffix D with the old pads.

Note: "Possible shift" – although the size detection range has been increased with suffix D, the width may be near the upper limit when using the old pads if the pads are not set tight against the stack, or the actual paper width is greater than the target. It is therefore not recommended to use the old pads, even with suffix D.

As stated above, the effective width of the paper + old pads is at or very near the upper limit of the suffix D detection range. Therefore, if pads need to be used, it is recommended to use the new pads together with the suffix D firmware.

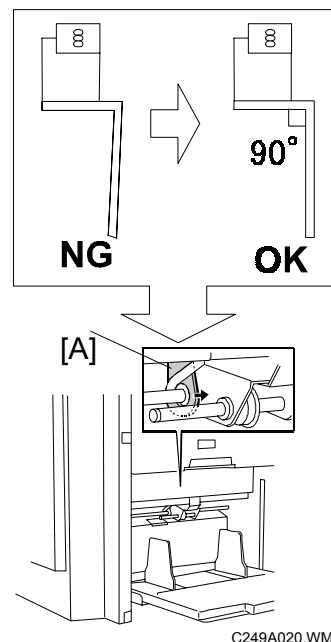
A bent retainer [A] causes extra play in the bushing/roller shaft connection, which can cause the bushing to come loose.

NOTE: If this does not solve the problem, replace the Sleeve with P/N #07078105B (see MB #MC238011).

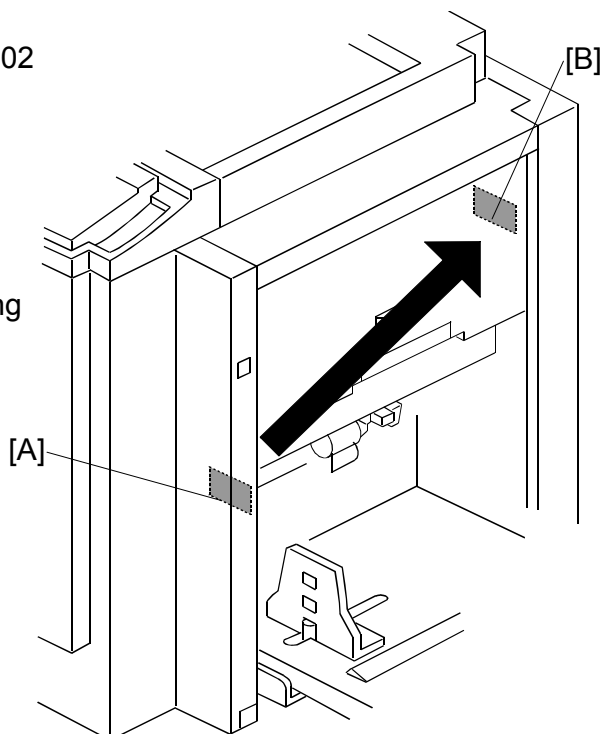
C249A045.WMF

The plate [B] is visible when the master making unit is pulled out.

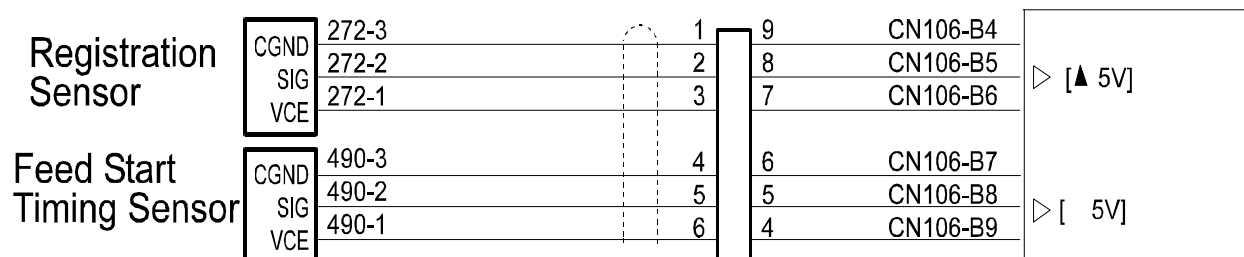
Registration and feed start timing sensors shown going to **CN 106** on the MPU.

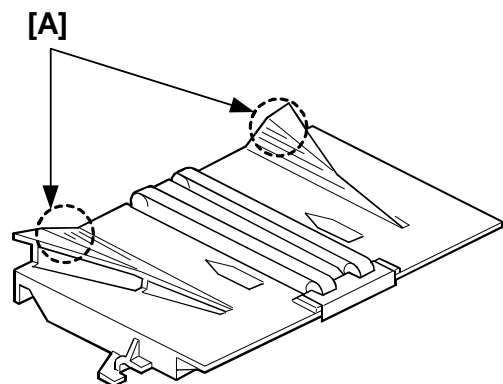
The paper delivery unit wing tips [A] are scratched by the paper, increasing the static electricity buildup in the area. The static buildup eventually overcomes the force of paper delivery, triggering the jam.

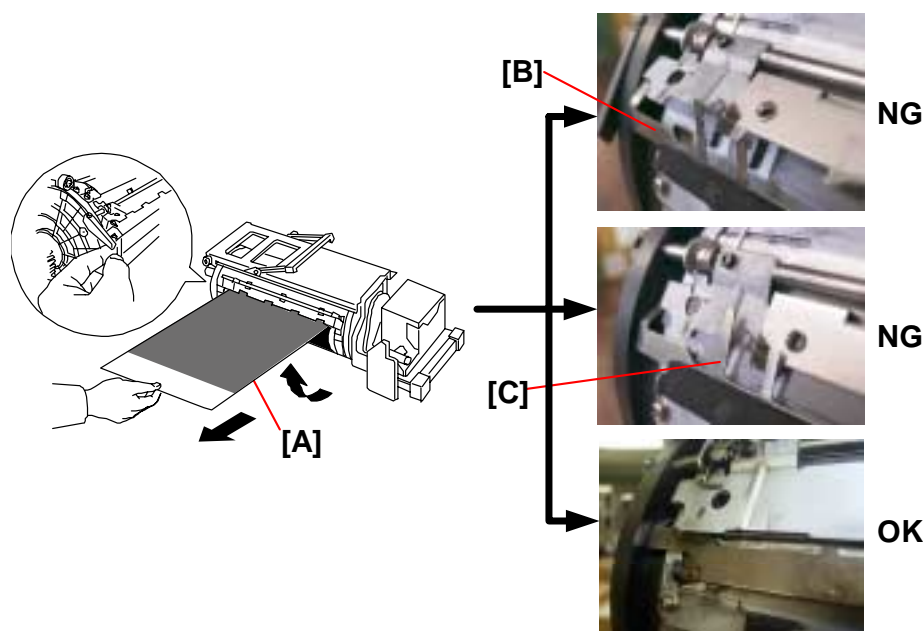
Note: Incorrect = The clamber's lower teeth are on the outside.

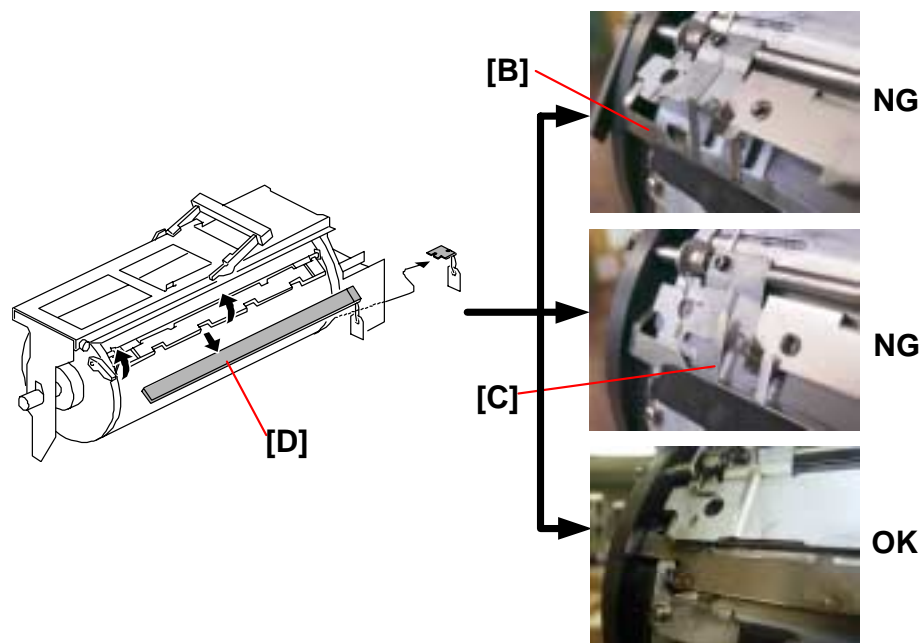
Note: Incorrect = The clasper's lower teeth are on the outside.

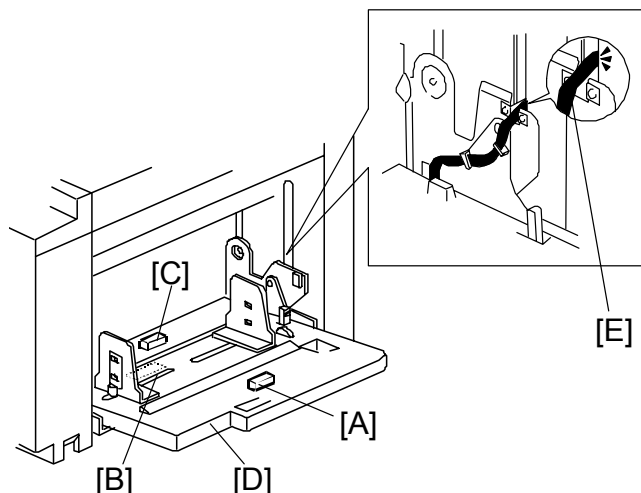
A sensor misdetection occurs (sensors [A], [B], [C]), which can sometimes damage the harness [E] for the paper feed tray.

The harness [E] rubs up against the paper size sensor stay when the paper table [D] is moved. As a result, the outer layer of the harness is damaged.

Important: When you install the new parts for the first time, install them **together as a set**.

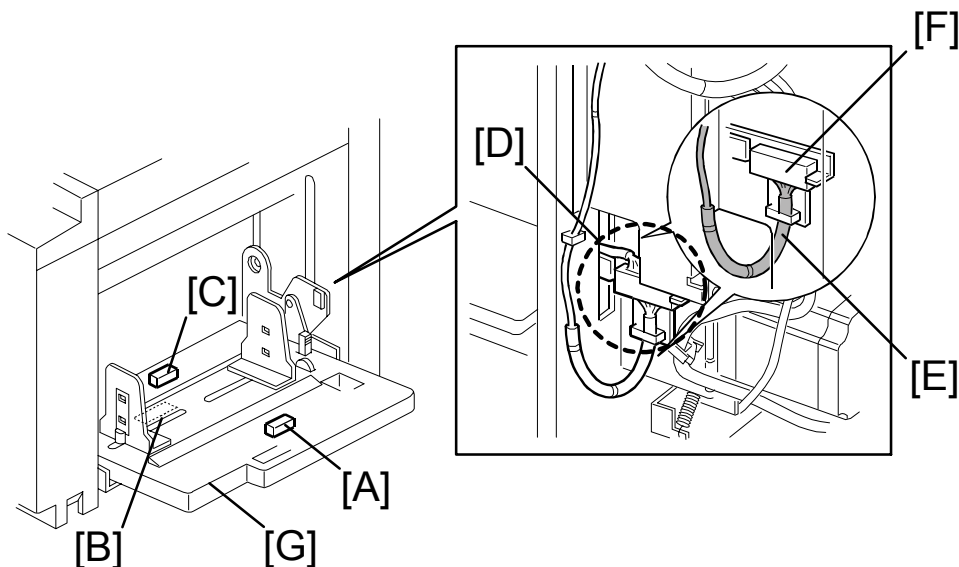
- 1) Poor connection [D] between the paper tray relay harness [E] and CN420 [F].
- 2) The paper tray relay harness [E] comes loose when the paper table [G] is lifted up or down.

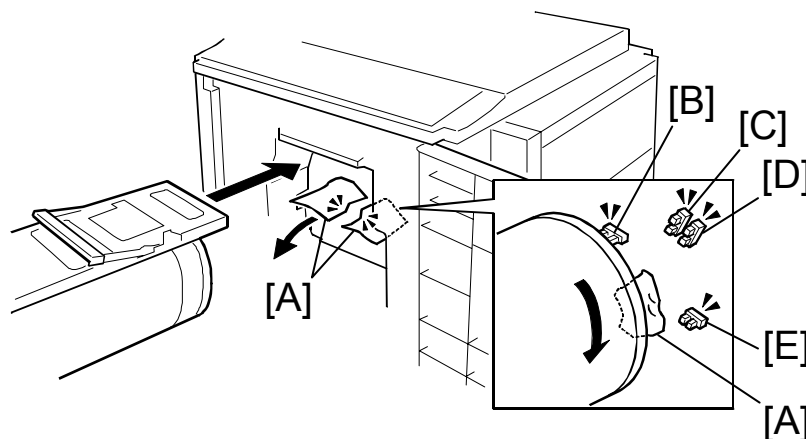
[B]: 2nd feed timing sensor, [C]: Paper exit timing sensor

Jammed paper [A] contacts one of the sensors below during a print job, and the sensor comes loose from the bracket.
