Model: PRIPORT SILVER	Date: 31-Dec-98	No: 01												
Subject: Firmware Modification History		Prepared by: H. Kokubo, Priport Service Planning Section

Model: PRIPORT SILVER	Date: 15-Apr-99	No: 02
Subject: Controller Connectivity Problem (Firmware Update Information)	Prepared by: H. Kokubo, Priport Service Planning Section

Model: PRIPORT SILVER	Date: 15-Jun-99	No: RC231003	
Subject: Paper jam at the paper delivery section	Prepared by: H. Kokubo, Priport Service Planning Section

Model: PRIPORT SILVER	Date: 15-Jun-99	No: RC231004
Subject: E-01 Cutter Failure, Master Misfeed	Prepared by: H. Kokubo, Priport Service Planning Section

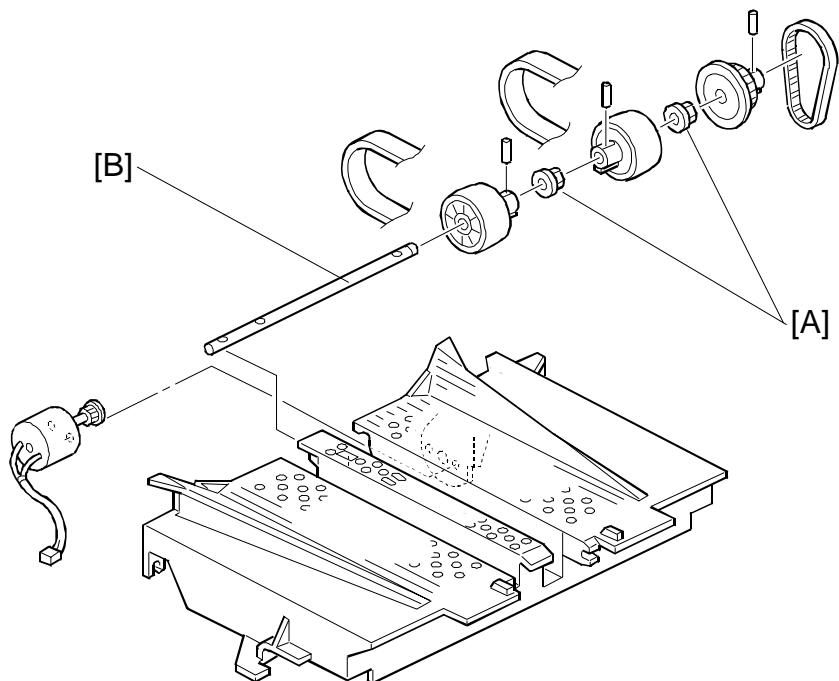
The paper jam indicator is displayed due to slow timing of paper delivery. The paper delivery motor, which is an independent motor for the delivery unit only, slows down and does not feed the paper at the proper speed. (When this occurs, the delivery motor has a high temperature.)

The bushings and the shaft have run out of oil, so there is friction between the shaft and the bushings.

When this problem occurs, lubricate the shaft [B] where the bushings [A] contact.

On the production line, lubrication has been added from October '98.

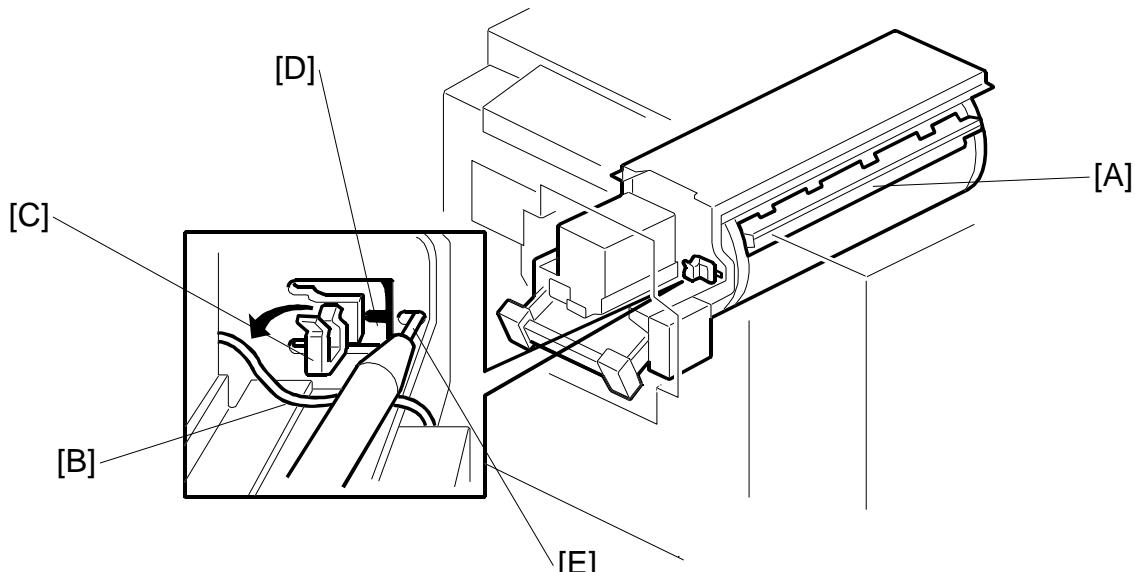
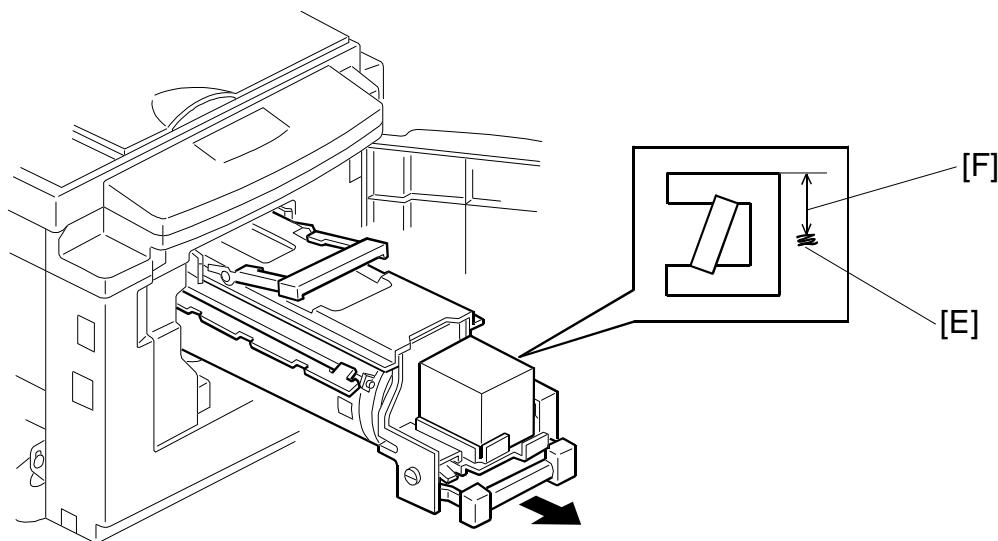
Moving the drum to an incorrect master clamping position causes a master clamping error. This is caused when the drum turns from the home position to the master clamping position to start the master wrapping process (around the drum). Then this incorrect positioning causes the clamp to miss the master's leading edge. The master continues feeding for master making, but is not pulled while the drum turns. Consequently, the master bunches up against the cutter unit, resulting in a master cutting error.

Use SP mode 23 to adjust the master clamping position of the drum. Usually, the position in SP mode is around "2." (If it is too large, a master clamping error will occur. And, if it is too small, the clamper will hit the base of the master unit when it opens.)

6. After the drum turns to the clamping position [A], look at the operation side of the drum.

7. Release the cable [B] from clamp [C].

8. Look at the drum flange spoke [D] inside the U-shaped cut out.

9. Mark a line [E] next to the spoke [D].

10. Pull out the drum and measure the distance [F] between the line marked in step 9 [E] and the top edge of the U-shaped cut out.

11. If the distance [F] is 9.5 ± 1.5 mm, the drum stopping position is correct. If it is not, reinstall the drum and change the drum stopping position for master making by using SP23 (Plot position adjustment). Then, repeat step 5 and continue until you obtain the correct drum stop position.

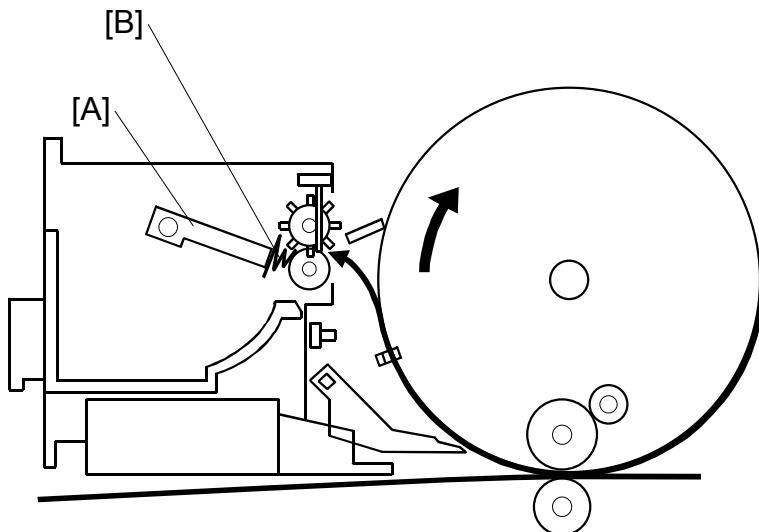
This is because the home position of the pressure plate [A] is wrong.

If the pressure plate position is slightly lower than normal, the pressure plate [A] will interfere with the ejected master [B] as shown above, causing a jam.

Make sure that the stop position for the pressure plate is correct.

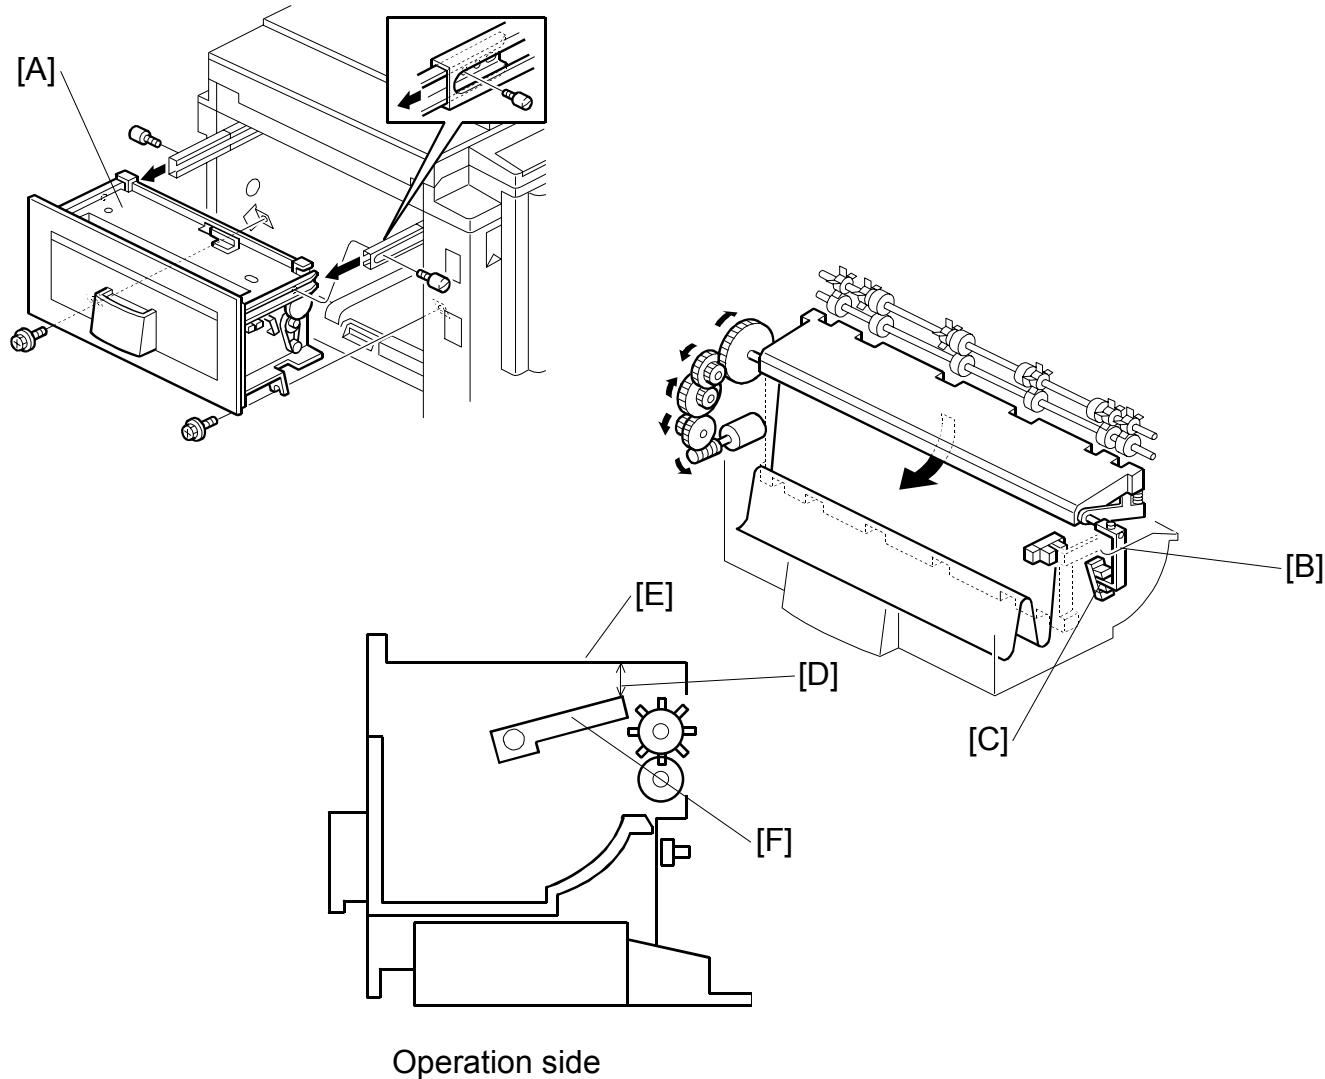
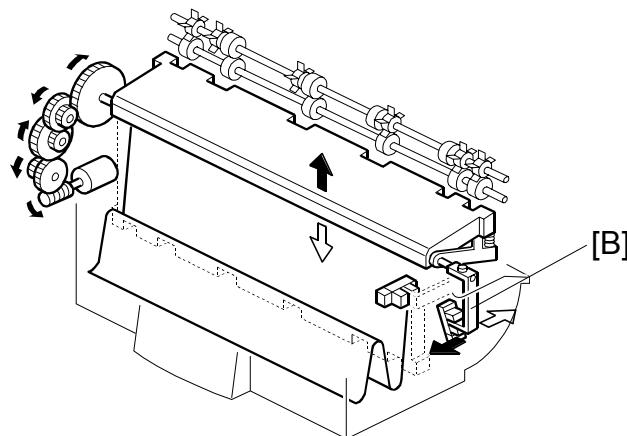
Standard: 11.0 ± 3.0 mm

1. Turn the main switch on. Then, turn it off after a few seconds.
2. Remove the master eject unit [A]. (2 screws)
3. When pulling the master eject unit out (2 screws), make sure the pressure plate position feeler [B] interrupts the home position sensor [C].
4. Measure the clearance [D] between the crossbeam [E] and the surface of the pressure plate edge [F]. It should be 11.0 ± 3.0 mm.

1. Twist the pressure plate position feeler [B] (C231 3505), so that the plate moves closer to the correct home position. For example, if you want to shift the plate upwards (as shown by the black arrow), twist the feeler [B] clockwise.
2. After adjusting it, repeat the confirmation procedure on the previous page.

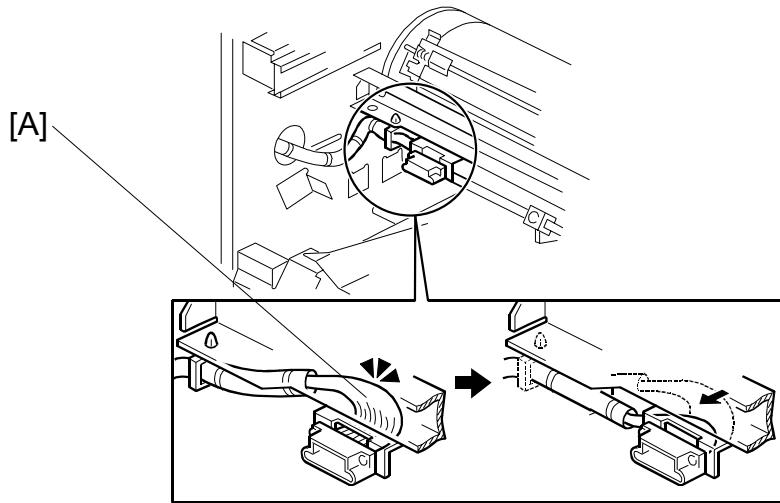
Damaged DC harness wires located inside the stay that hold the master eject unit can cause these problems.

The wires are damaged by the master clamper on the drum while the drum is turning. DC current (+ 5-volt going to the master eject sensor) grounded at a certain interval (synchronizing the drum rotation) during printing, causes these problems.

If the DC harness wires [A] are warped, adjust them as shown above.

Check if the harness (located as [A]) touches the master clamper when it comes close to the turning drum. If the harness touches the drum (and if it is already damaged), reroute the harness and firmly attach it with tape.

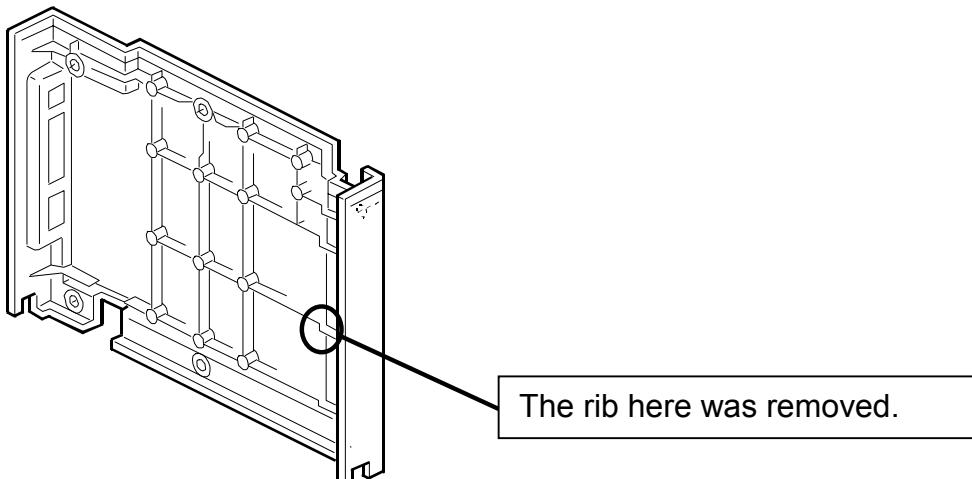
There is a short relay cable that goes to the paper end sensor (from the main dc harness). The relay cable tends to be caught by the rib on the reverse of the rear exterior cover (C2311362) when the cover is installed. This will damage the relay cable wires, causing the paper end sensor to malfunction.

Take caution when you install the rear cover, so as not to damage the wires.

To make the rear cover installation easier, the rear cover has been changed. The rib where the cable wires are caught was removed (see below). This modification was applied from January 1999 production.

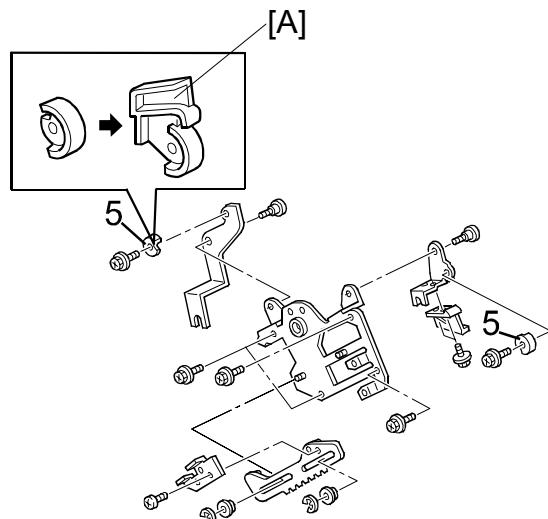
When a new drum guide (see MB #MC231007) was installed, it may be broken.

1. Grease is not applied to the drum guide service parts.
2. The drum position on the master making section is not correct.

Please lubricate area [A] of the drum guide as shown above.

NOTE: The part number of our recommend grease is 52039502.
