TELEVISION TECHNICAL BULLETIN

MODELS 66DW18H 76DW18H

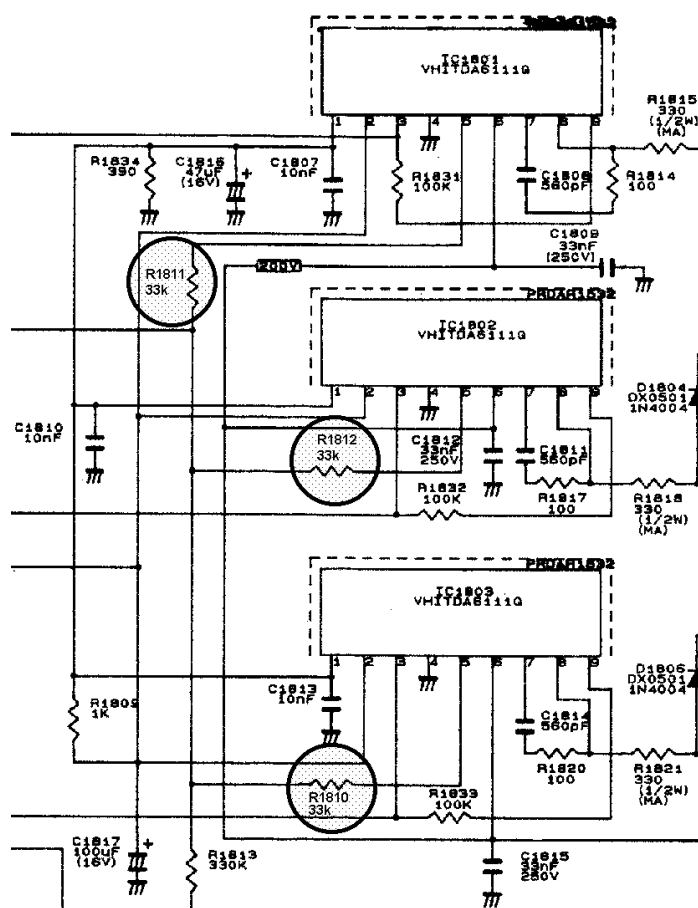
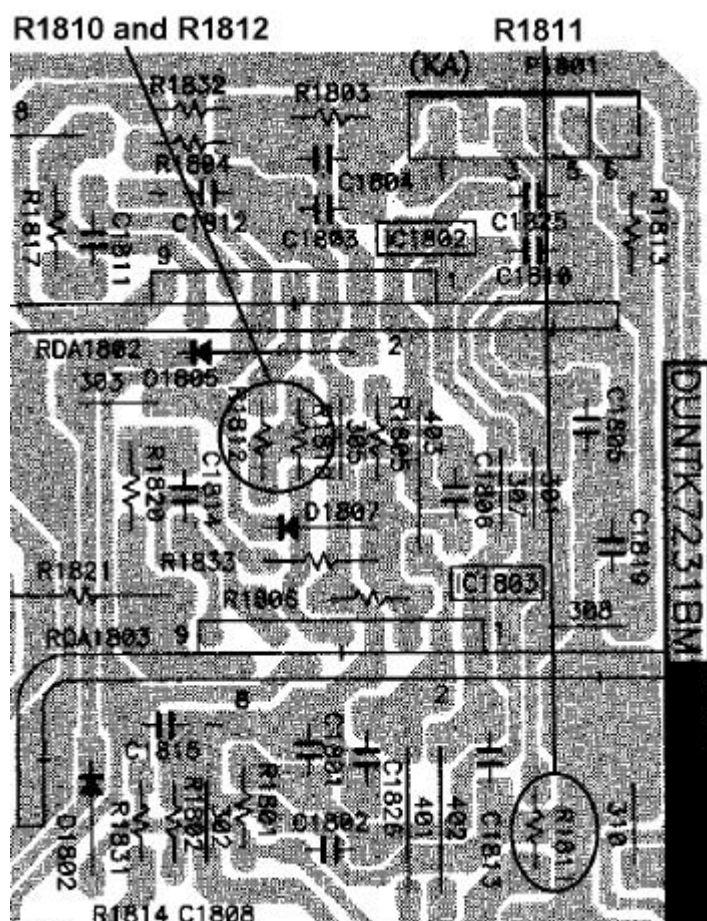
Location of R1810, R1811 and R1812 on the CRT PWB

SYMPTOM No picture - blank raster.

CAUSE R1810, R1811 and R1812 changing in value.

ACTION Replace R1810, R1811 and R1812.

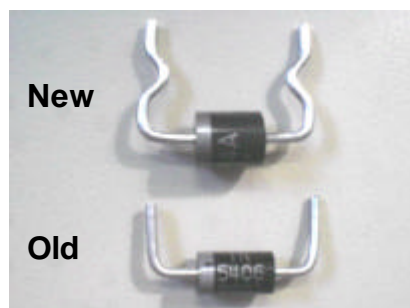
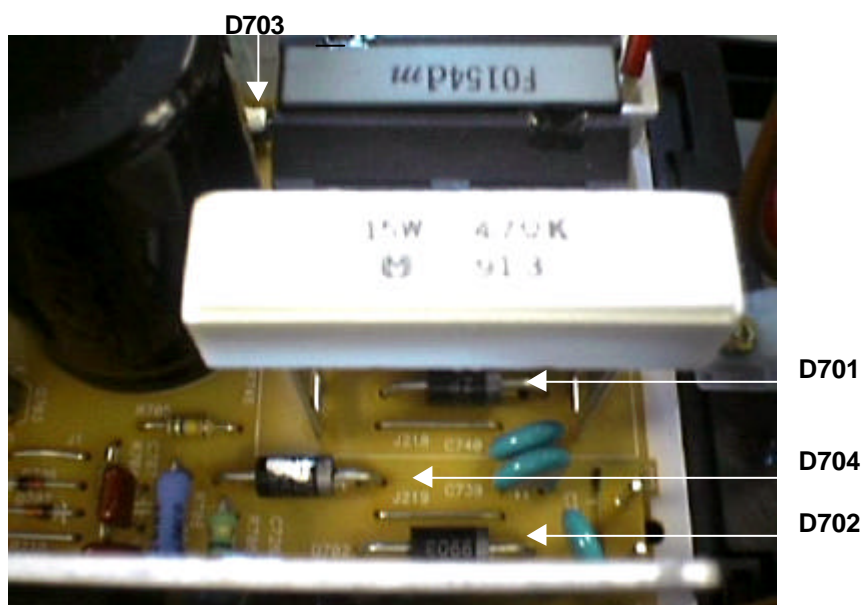
SYMPTOM The reciever does not turn on - mains fuse blown.

CAUSE Bridge rectifier diodes short circuit (D701, D702, D703 and D704).

ACTION Replace D701, D702, D703 and D704 with the part specified below.

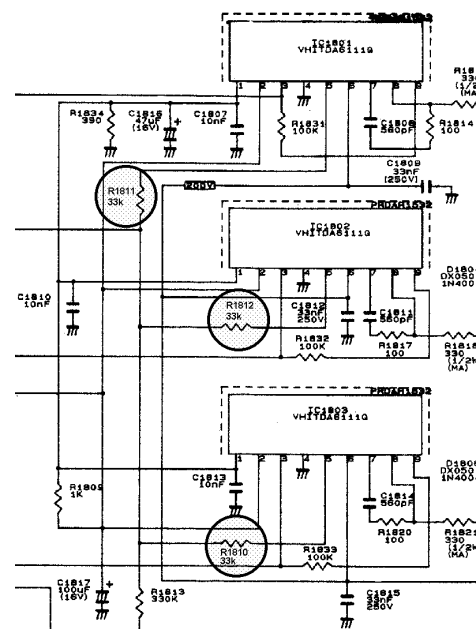
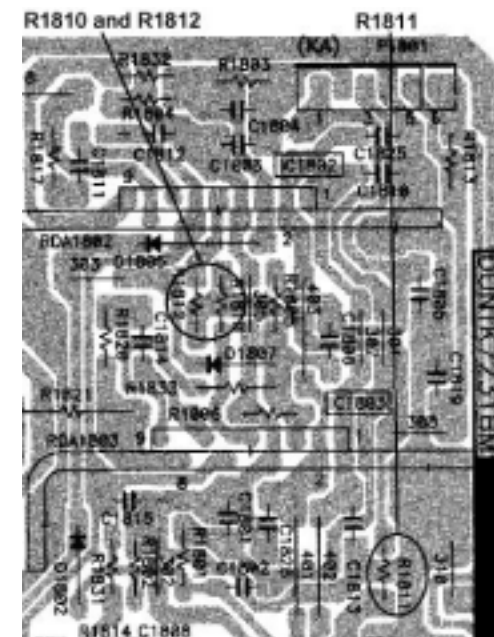
Location of R1810, R1811 and R1812 on the CRT PWB

SYMPTOM No picture - blank raster.

CAUSE R1810, R1811 and R1812 changing in value.

ACTION Replace R1810, R1811 and R1812.

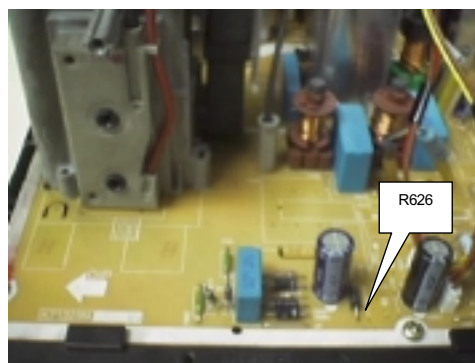
SYMPTOM Failure of Q509.

CAUSE Excessive excursions of the positive forty volt supply from the line stage.

ACTION Fit an extra zener diode, D632, in the position of R626 as shown in the diagram below.

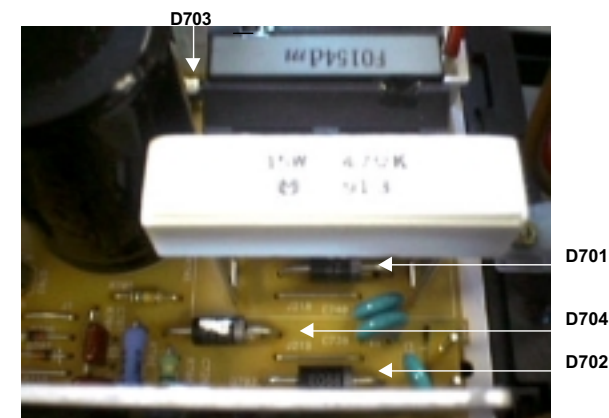
SYMPTOM The receiver does not turn on - mains fuse blown.

CAUSE Bridge rectifier diodes short circuit (D701, D702, D703 and D704).

ACTION Replace D701, D702, D703 and D704 with the part specified below.
