Analyses of Arrow Air DC-8-63 Accident of December 12, 1985: Gander, Newfoundland

James K. Luers* and Mark A. Dietenberger†
University of Dayton Research Institute, Dayton, Ohio

A performance analysis was conducted of the Arrow Air DC-8-63 takeoff accident at 10:15 GMT, December 12, 1985 at Gander, Newfoundland. A two-part study was conducted. A takeoff sensitivity analysis was performed using a digital, fixed stick simulation program to establish the relative performance degradation resulting from several factors that were candidate causes or contributing factors to the accident. The second approach was to reconstruct the accident trajectory by solving the airplane equations of motion using flight recorder data and known accident facts supplied by the Canadian Aviation Safety Board (CASB) as input. Consistent results were achieved from the two approaches.

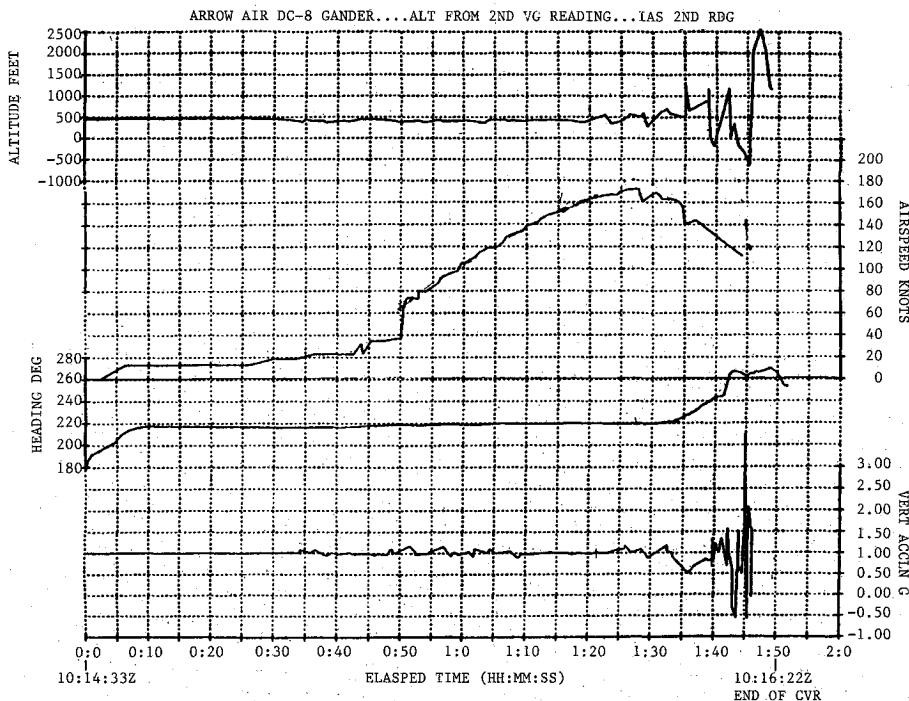
The aircraft was equipped with a Sundstrand cockpit voice recorder (CVR) and a United Control flight data recorder (FDR). The cockpit voice recorder was not functioning properly and did not provide the cockpit conversation that occurred during the takeoff. The four-channel FDR provided traces of airspeed, pressure altitude, heading, and vertical acceleration as shown in Fig. 1. Although the vertical acceleration recordings on the FDR foil were substandard, usable data were obtained from each channel. Visual inspection of Fig. 1 provides several likely conjectures about the takeoff event. From the load factor (vertical acceleration) and pressure altitude traces, liftoff probably occurred in the time range of 1:25–1:28 (min:s). Stall likely occurred near 1:33 where the load factor indicates a sharp downward acceleration and the heading begins deviating from 220 deg (indicative of a stalled wing). The airspeed at this time was approximately 165 kt, well above the 144-kt clean wing stall speed of the airplane.

Fig. 1 Flight data recorder information.

Other indications that the airplane actually stalled are the erratic pressure altitude and airspeed profiles after about 1:30. An analysis of the accident by the CASB uncovered the following irregularities that may have caused or been contributing factors to the accident.

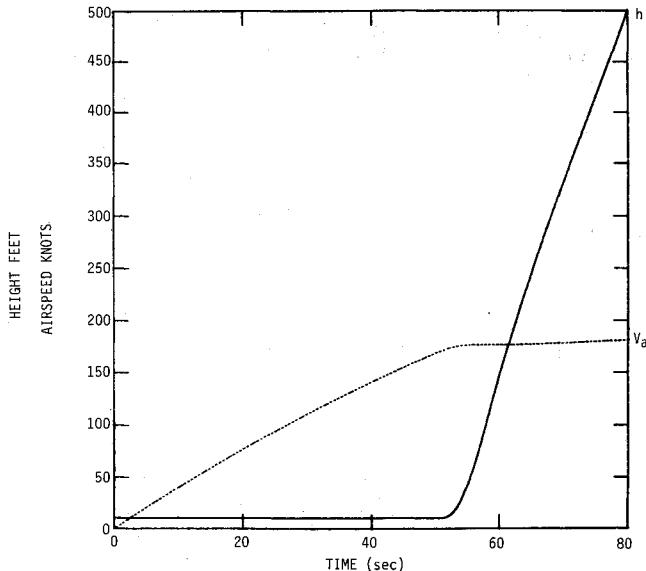
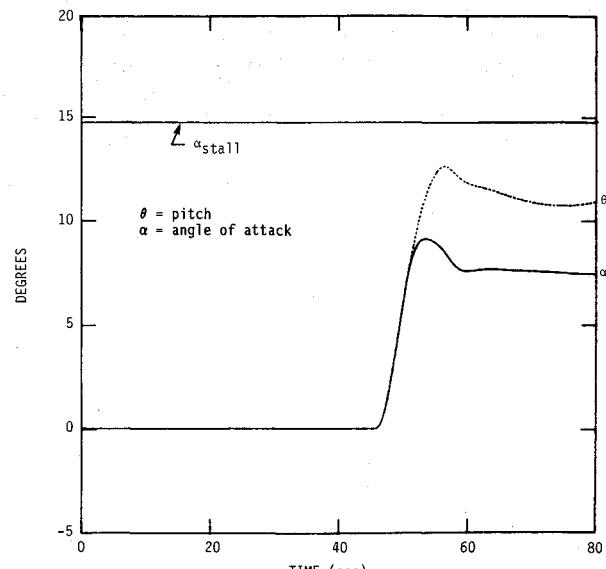
Fig. 2 Normal takeoff.

kt. For the sensitivity analysis, a normal takeoff consisted of initiating rotation 1 s after V_2 , rotating to a pitch of approximately 13 deg at a rate < two deg/s and climbing out at $V_2 + 10$ kt. This was achieved in the simulator program by deflecting the elevator linearly to -14 deg over a 6-s period beginning 1 s after V_R then backing the elevator to -13 deg over the next 2 s. This resulted in the aircraft rotating to a pitch of 12.6 deg at a rotation rate slightly less than 2 deg/s and reaching $V_2 + 10$ at 35 ft and climbing out at a stabilized speed of $V_2 = 10$ (see Figs. 2 and 3).

Fig. 3 Normal takeoff.

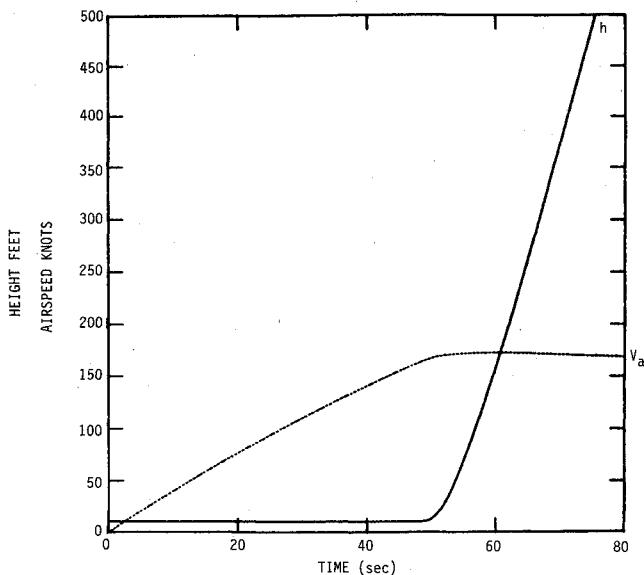
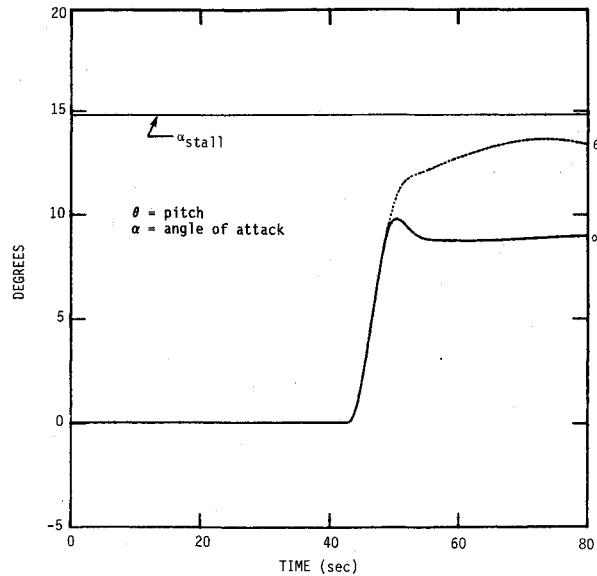
Since the V_R and V_2 speed bugs on the co-pilots instrument panel, as observed from the wreckage, corresponded to the aircraft being at a lighter weight than that deduced after the accident, the result of premature rotation at the corresponding V_R speed was simulated. The input conditions were 1) begin rotation at the instant $V_R = 146$ kt + 1 s, 2) deflect elevator to -14 deg over 6 s, and 3) backoff elevator to -13 deg over 2 s. The results are shown in Figs. 4 and 5. The climb rate changes very little from a normal takeoff. Airspeed can be maintained. The angle of attack is about one degree higher than for a normal takeoff. A very adequate stall margin still exists. This scenario does not produce serious performance degradation.

Fig. 4 Early rotation.

Fig. 5 Early rotation.

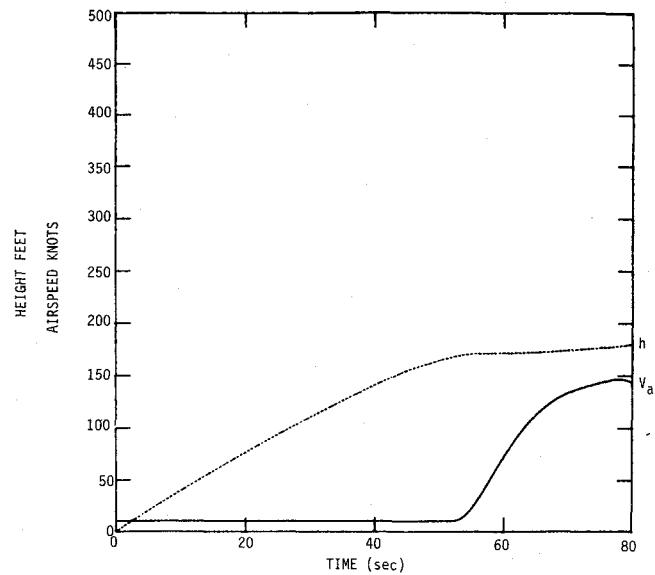
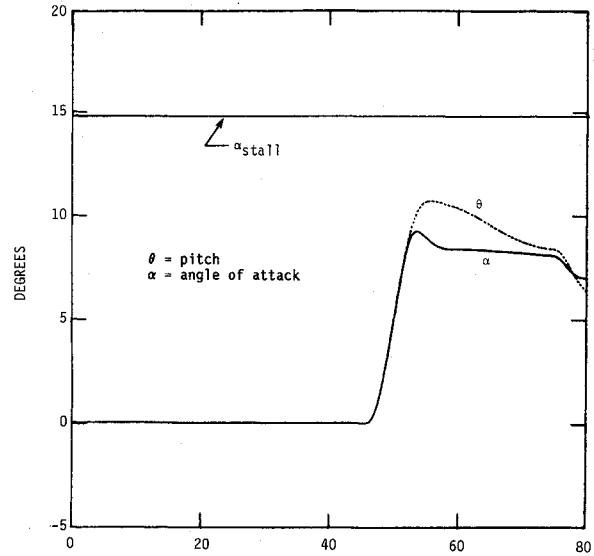
Fig. 6 Engine loss at V_R .

Fig. 7 Engine loss at V_R .

The results are shown in Figs. 6 and 7 for engine loss at V_R . The climb rate is near normal to 100–150 ft, at which time it drops sharply to near zero. However, the airspeed is maintained and even increases slightly. Altitude is also maintained. The angle of attack is about one degree higher than normal with no danger of stall. The results for engine loss at $V_R + 5$ s are similar to those for engine loss at V_R with slightly less performance degradation. These results confirm the expected normal performance deterioration resulting from the loss of an engine. This is not a likely cause of the DC-8 Gander accident in which an airplane stall is apparent.

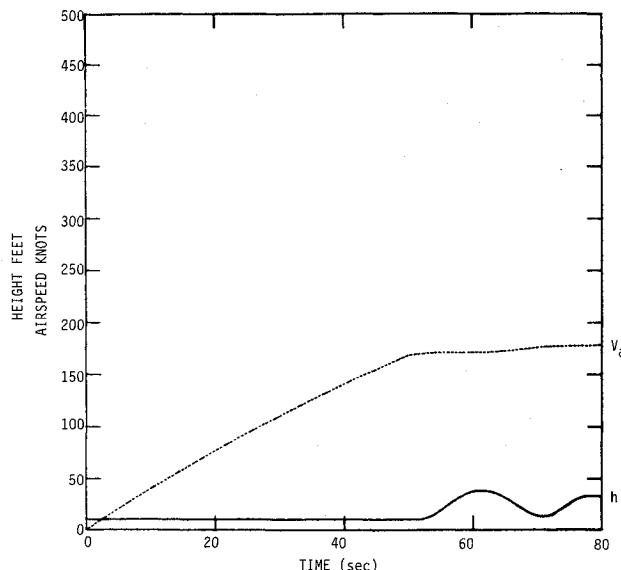
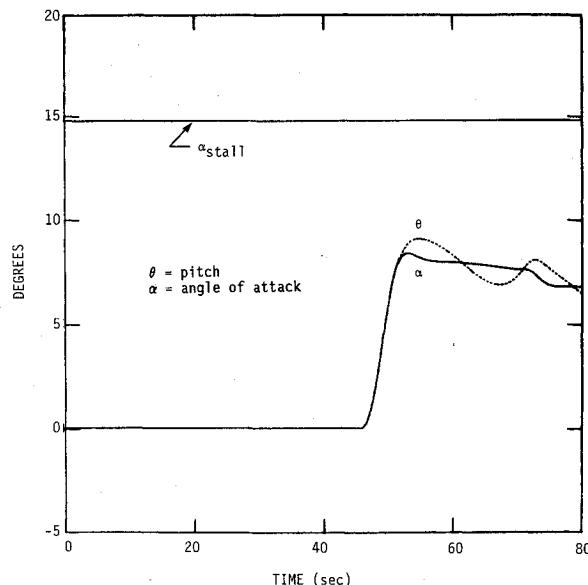
To assess worst case possibilities consisting of the use of one engine in a thrust reversal mode, a simulation was made by assuming a loss of thrust from two engines at $V_R + 5$ s. The results are shown in Figs. 8 and 9.

The airplane climbs initially then begins to lose altitude, then increases speed, and again starts to climb. It is able to maintain airspeed at a low altitude. The angle of attack is very

similar to that of a normal takeoff. This scenario will not result in a stall unless the airplane is allowed to climb rapidly at takeoff until sufficient airspeed is lost to stall the airplane at an altitude well above the ground level. Since, in the Gander accident, the aircraft barely climbed off the ground, the two-engine loss (one engine in thrust reversal) scenario is not a likely event that caused the accident.

Fig. 8 Loss of two engines.

Fig. 9 Loss of two engines.

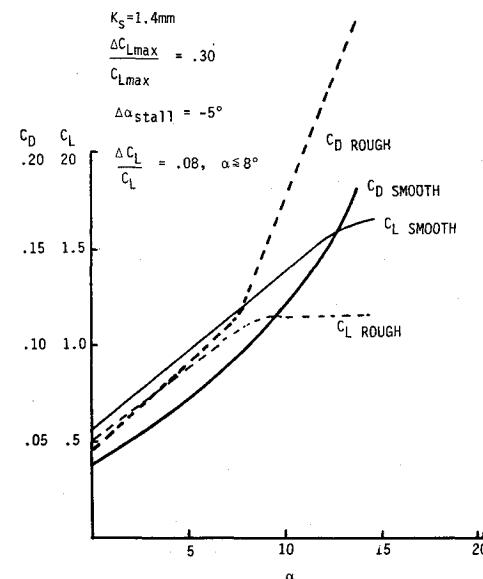
Weather conditions observed at Gander suggest the possibility that the aircraft penetrated supercooled water droplets or light freezing rain while landing at Gander approximately 1 hr and 10 min prior to takeoff. Ice on wings, due to roughness, is known to cause serious loss in lift near $C_{L_{max}}$ and a significant rise in drag. To simulate this effect, the DC-8-63 lift and drag curves were modified. The modified curves represent only the generic nature of what can be expected with an ice-roughened airfoil. The curves should not be considered to represent how the DC-8-63 actually performs when exposed to a specified amount of icing. Fig. 10 shows the basic C_D and C_L curves for the DC-8 aircraft and aerodynamically roughened curves derived from Haines and Luers⁷ based on an equivalent sand-

Fig. 10 Lift and drag curves for airplane with roughened wing surface.

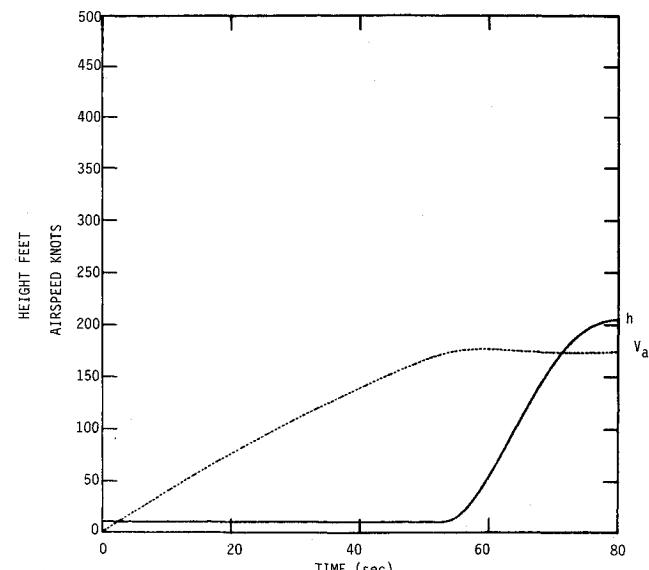
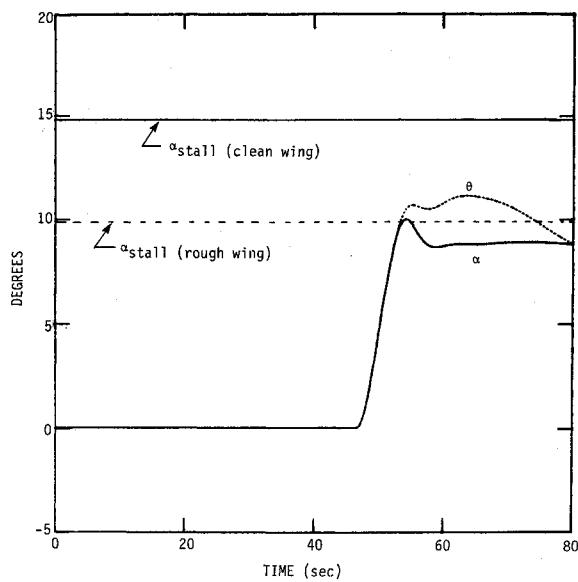
grain roughness of $K_s = 1.4$ mm. The results of simulations using the rough surface curves are shown in Figs. 11 and 12.

The airplane climbs with a pitch of about 11 deg while maintaining airspeed but is dangerously close to the rough wing stall angle of attack. In fact, during rotation, the stall angle is actually reached. If the airplane were rotated to a 12- or 13-deg pitch attitude (as would be expected), the airplane would stall at the end of the rotation at a very low altitude with recovery impossible. This scenario provides a reasonable explanation of the accident.

Fig. 11 Ice on wings.

Fig. 12 Ice on wings.

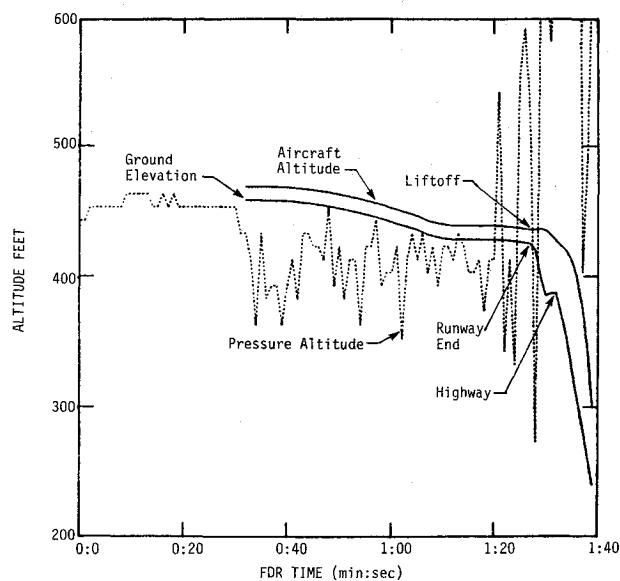
Figure 13 shows the FDR pressure altitude trace (too erratic to be of use in the analysis) and the derived aircraft trajectory

Fig. 13 Plot of pressure altitude, ground elevation, and aircraft center of gravity in ft above sea level (ASL) vs FDR time for scenario 1.

vs ground elevation. The airplane barely climbed near the end of the runway and then started to descend rapidly. Its center of gravity altitude was about 140 ft below the runway when the tail struck the tree.

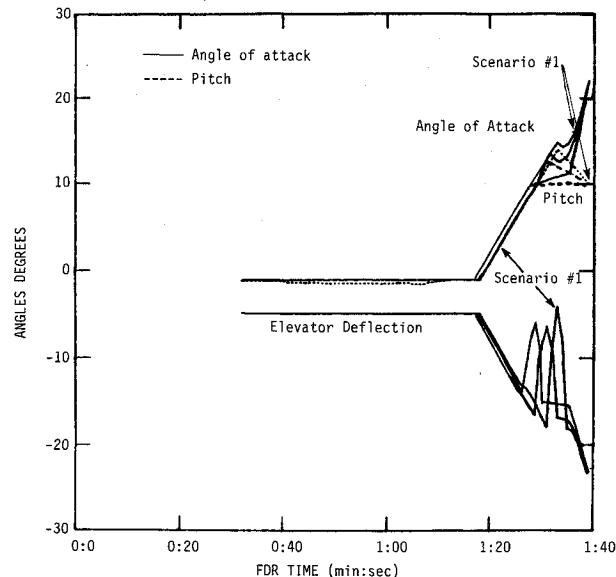
Fig. 14 Plots of assumed pitch history and the derived angle of attack and elevation deflection history for scenario 1; two other assumed pitch histories are included for comparison.

Figure 14 provides results about elevator deflection and angle of attack for three different assumed pitch time histories. Each pitch profile assumes the nose began to rise at about time 1:19, shortly after V_R at a rate of 1 deg/s. At 1:27 the airplane wheels lifted off the ground, which required a pitch angle of 8 deg. The pitch was assumed to continue to increase to 14, 12.5, and 10 deg, respectively, at a rate of 1 deg/s. Pitching to a limit of 14 deg gave the most consistency between lift and drag penalties that are representative of ice accretion on an airplane. Other pitch history assumptions, i.e., the 12.5- or 10-deg pitch limits had only a minor effect on changing the aircraft trajectory. The derived elevator deflection time history indicates that after the end of rotation, it decreased monotonically (more negative), even while the nose was lowering to a 10-deg pitch. The derived elevator deflection of -23.3 deg at time 1:39 and the derived angle of attack of 22 deg are consistent with known impact conditions. No scenario utilizing clean wing aerodynamics could be found that pro-

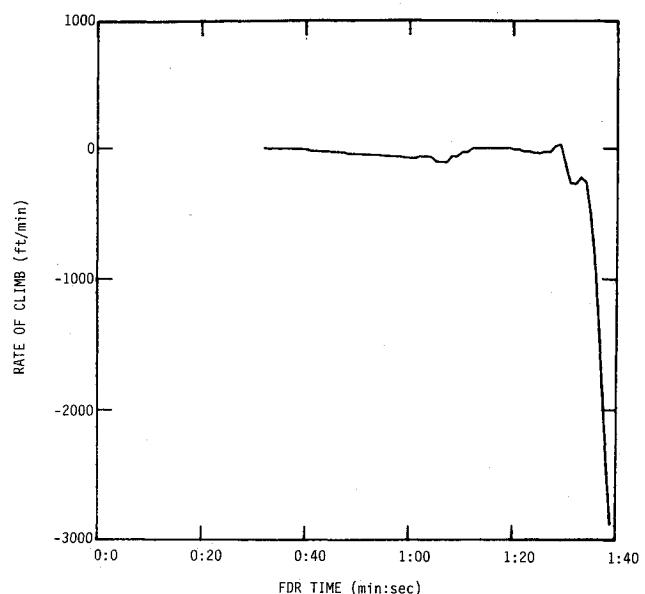
Fig. 15 Plot of rate of climb vs FDR time for scenario 1.

Figure 15 shows the climb rate throughout the trajectory. A positive climb only occurred for a few seconds after liftoff. At impact the descent rate approached 3000 ft/min.

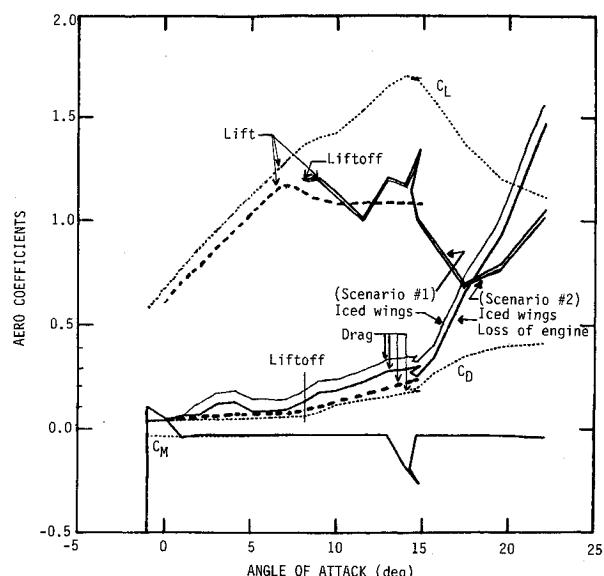
Fig. 16 Aerodynamic data relating to each scenario.

In Fig. 16 the dotted lines represent clean wing C_L , C_D , and C_M obtained from the aerodynamic data for the DC-8 aircraft. The solid lines represent C_L , C_D , and C_M derived from the method of solution discussed earlier for the case of pitching up to 14 deg. At angles of attack less than 15 deg (during the airborne segment of the flight) a 20-30% loss in the lift coefficient is noted, and at angles of attack greater than 15 deg the loss in the lift coefficient is 30-50%. At angles of attack less than 9 deg, the drag increment is about 200% of clean wing drag, and at angles of attack greater than 10 deg, the drag increment decreased to 100% of clean wing drag. At impact, the angle of attack was 22 deg, the drag increment was more than 200%, and $C_D = 1.5$. This value seems extremely high even for a deep stall. A re-examination of Fig. 1 shows a questionable steep drop in airspeed during the last 3 s before impact that gives rise to such an unreasonably high drag coefficient at initial impact.

In this solution, for the equations of motion, a loss of thrust from one engine is assumed to have occurred at time 1:20. This scenario also produced an acceptable solution to the equations of motion. The results shown in Figs. 13-16 from scenario 1 are practically identical to the results obtained for scenario 2 with the only difference being the derived values of drag coefficient. As shown in Fig. 16, instead of the 200% increment in C_D for angles of attack less than 9 deg found in scenario 1, we have about a 100% increment in drag for scenario 2. Thus, loss of an engine is equivalent to a drag coefficient increment of about 0.05. The lower increment in drag coefficient for the scenario 2 solution is more representative of that expected for a roughened airfoil.
