# Structural Response and Failure of a Full-Scale Stitched Graphite–Epoxy Wing

Analytical and experimental results of the test for an all-composite full-scale wing box are presented. The wing box is representative of a section of a 220-passenger commercial transport aircraft wing box and was designed and constructed by The Boeing Company as part of the NASA Advanced Subsonics Technology program. The semispan wing was fabricated from a graphite–epoxy material system with cover panels and spars held together using Kevlar® stitches through the thickness. No mechanical fasteners were used to hold the stiffeners to the skin of the cover panels. Tests were conducted with and without low-speed impact damage, discrete source damage, and repairs. Upbending, downbending, and brake roll loading conditions were applied. The structure with nonvisible impact damage carried 97% of design ultimate load before failure through a lower cover panel access hole. Finite element and experimental results agree for the global response of the structure.

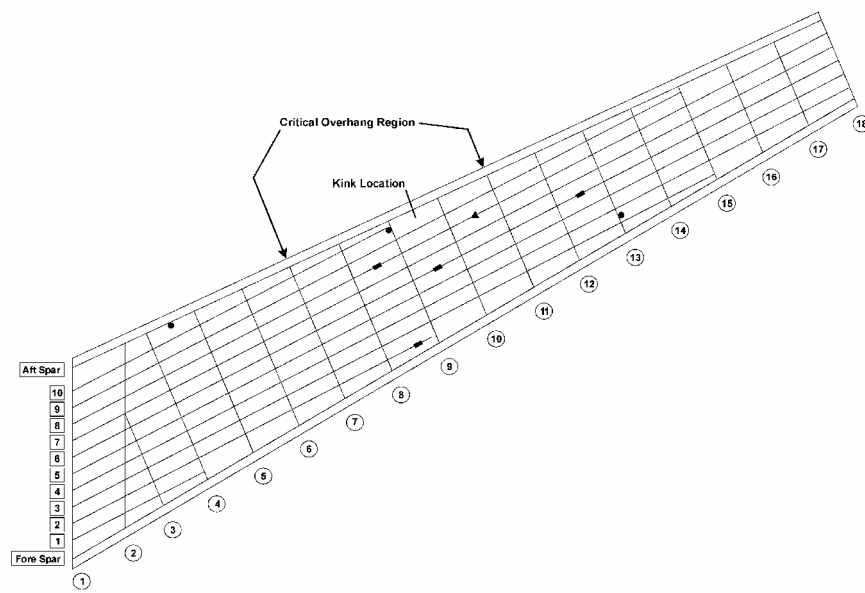
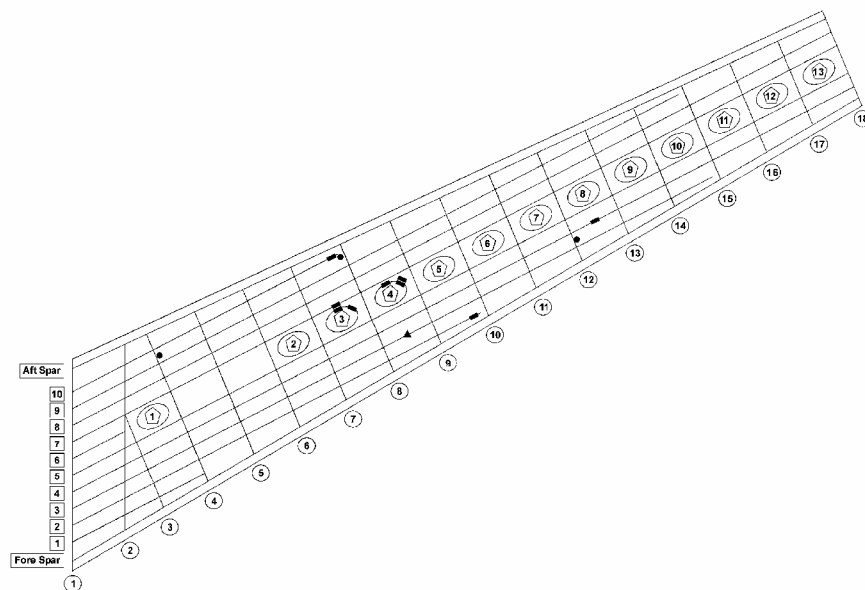
Fig. 2 Upper and lower panel configuration and strain gauge locations: ○ rib number; □, stringer number; △, hole number; ▲, sawcut/repair; ●, impact damage; and ■, strain gauge locations.

An air-propelled steel projectile was used to inflict three impacts with an energy level of 83–84 ft · lb to the lower cover panel. The locations of these damage sites are shown in Fig. 2b. A steel sphere with a 0.5 in. diameter was accelerated to a speed of approximately 545 ft/s, resulting in clearly visible damage with dent depths up to 0.135 in.

The wing was subjected to discrete source damage in the form of 7-in.-long sawcuts to the upper and lower cover panels, as shown in Fig. 2. Each sawcut ran through two stinger bays and cut through a stringer. Metal patch repairs were used to restore the wing to full load-carrying capability. The damaged region was removed before implementing the repair. The repairs consisted of a metal plate that conformed to the wing surface on the outer surface of the cover panels and internally spliced stringers. All parts of the repair were attached to the wing with mechanical fasteners.

An overhang of the cover panels with a width of approximately 4 in. behind the rear spar left an unsupported edge along the length of the test article. This region is shown in Fig. 2a as the critical overhang region. A small initial geometric imperfection in the form of a kink in the upper cover panel was present in the as-manufactured

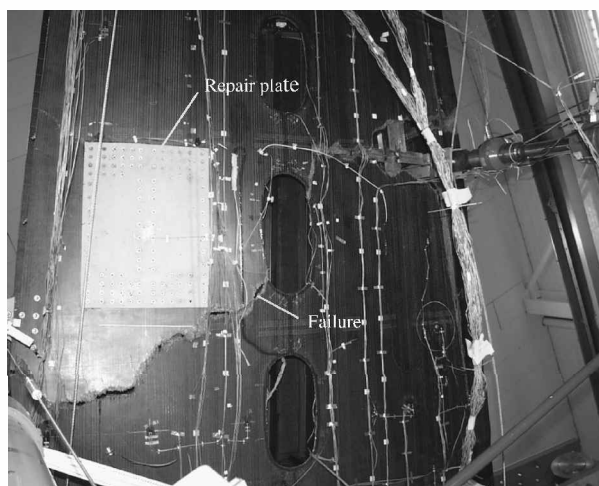
Fig. 8 Failure across lower cover panel.

The primary failure location is across the lower cover panel through access hole 4. This region of the lower cover panel after final failure is shown in Fig. 8. The failure goes through all stringers but primarily remains between ribs 8 and 9. Both spars were also damaged. Other minor damage was found but appears to be unrelated to the initial failure event. The discussion of the failure will be limited to the regions between ribs 6 and 10.

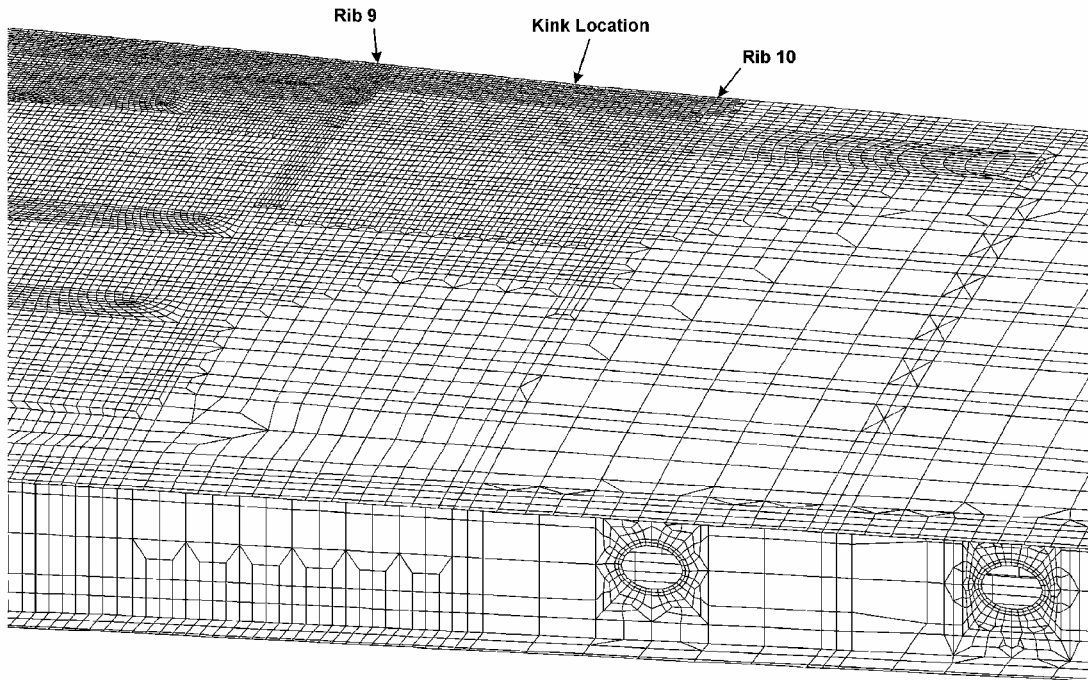
Fig. 16 Finite element model of kink region.

structure. This kink is centered half way between ribs 9 and 10 and has a maximum depth of 0.1 in. The kink was initially considered minor enough that it would not influence the cover panel structural behavior. However, because the kink is in close proximity to a stringer runout and is in the region of the upper cover panel that displays nonlinear behavior, the kink influenced the behavior of the overhang region. Therefore, the kink was included in the posttest finite element model. This local refinement is shown in Fig. 16. The kink is a geometric imperfection in the skin.

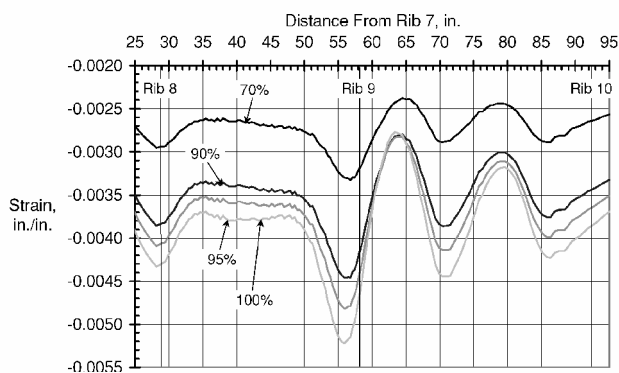
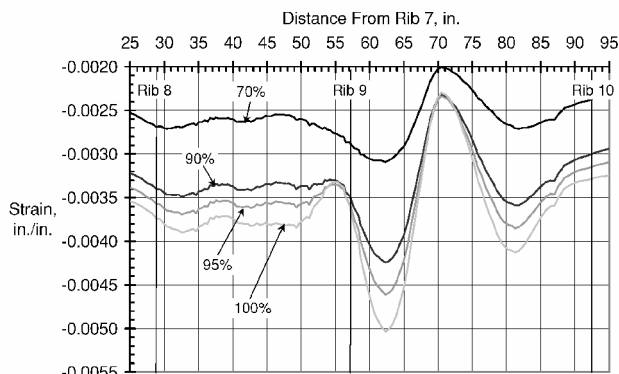
Fig. 17 Strains in the upper cover overhang region aft edge at several values of percent DUL.

Calculated strains along the rear overhang of the upper cover for the outer and inner skin surfaces for load levels of 70, 90, 95, and 100% DUL are shown in Fig. 17. Reversal of strain occurs in several places along the exterior cover surface. Strain reversal for the outer skin surface occurs 6–8 in. outboard of rib 9. Strain reversal for the inner skin surface occurs from 1 to 4 in. inboard of rib 9 and from 13 to 15 in. outboard of rib 9. There were very few strain gauges in this region, and hence, experimental results are not presented.

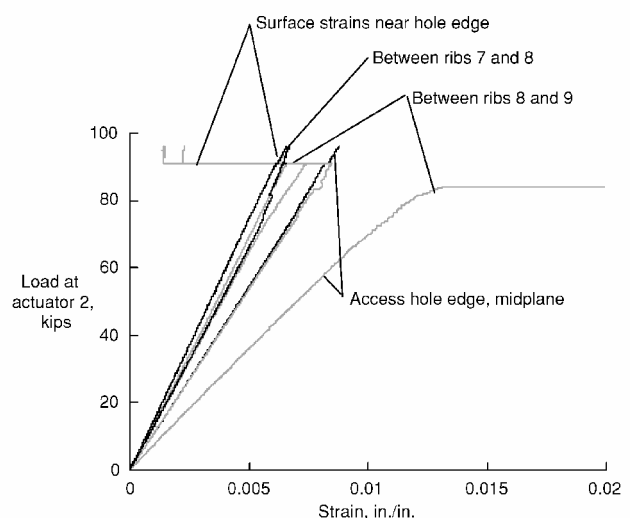
Fig. 18 Measured strain results at the edge of critical access holes.

Strain gauges at the edges of the lower cover panel access holes indicate high strains at these locations. Measured strains at the outboard, rear corner of access holes 3 and 4, between ribs 7 and 8 and ribs 8 and 9, respectively, are presented in Fig. 18. The strain gauge locations are shown in Fig. 2b. Nonlinearity in the load-strain behavior can be seen at these access holes. The most significant nonlinearity is at the outboard corner of access hole 4. The largest measured strain is at this location and is approximately 0.0096 in./in. at DLL. Final failure of the cover panel ran through this location. Because analytical results to date do not adequately capture the failure, comparisons of these strains for the access hole edges are not done with experimental results.
