# Fatigue Testing of a Stiffened Lap Joint Curved Fuselage Structure

Abubaker Ahmed\* and John G. Bakuckas Jr.<sup>†</sup>

*Federal Aviation Administration William J. Hughes Technical Center,  
Atlantic City International Airport, New Jersey 08405*

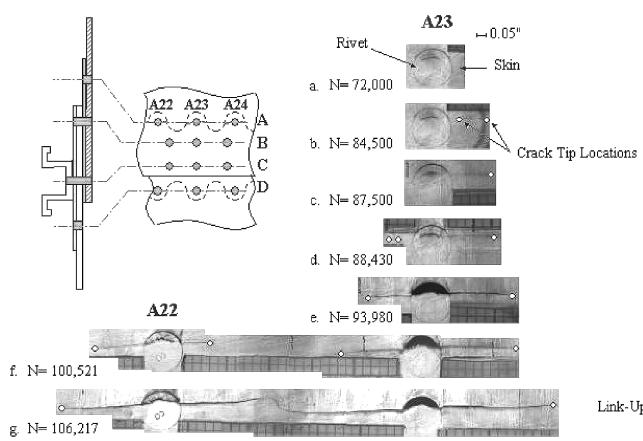
Damage was first visually detected via the RCCM system after 51,500 fatigue cycles. A crack was detected on the rivet head of rivet A23, located in the upper rivet row between frames F2 and F3 (Fig. 6a). Similar rivet head cracks were detected at seven other rivets in row A. Fractographic examinations of the rivet head crack showed marker bands and striations indicating fatigue failure due to cyclic pressure applied by the skin on the countersunk rivets in row A, where high local bending was measured [8].

After 80,550 cycles, a skin crack (designated A23-R) was visually detected on the right-hand side of the rivet hole A23 at a distance from the edge of the rivet hole (for clarity, open circles were inserted to indicate crack tips in the photographs of Fig. 6). Crack A23-R grew in both directions (Fig. 6b) and eventually linked up with the rivet hole (Fig. 6c). At a later stage, a second skin crack (designated A23-L) was visually detected on the left-hand side of rivet hole A23

Fig. 6 Crack growth process in outer critical rivet row.

(Fig. 6d), also at a distance from the rivet hole. Crack A23-L also grew in both directions and linked up with the rivet hole (Fig. 6e). Cracks developed in a very similar way at the neighboring rivet, A22 (Fig. 6f). At 106,217 fatigue cycles, cracks from rivet holes A22 and A23 linked up and formed a 2.87 in. crack (Fig. 6g).

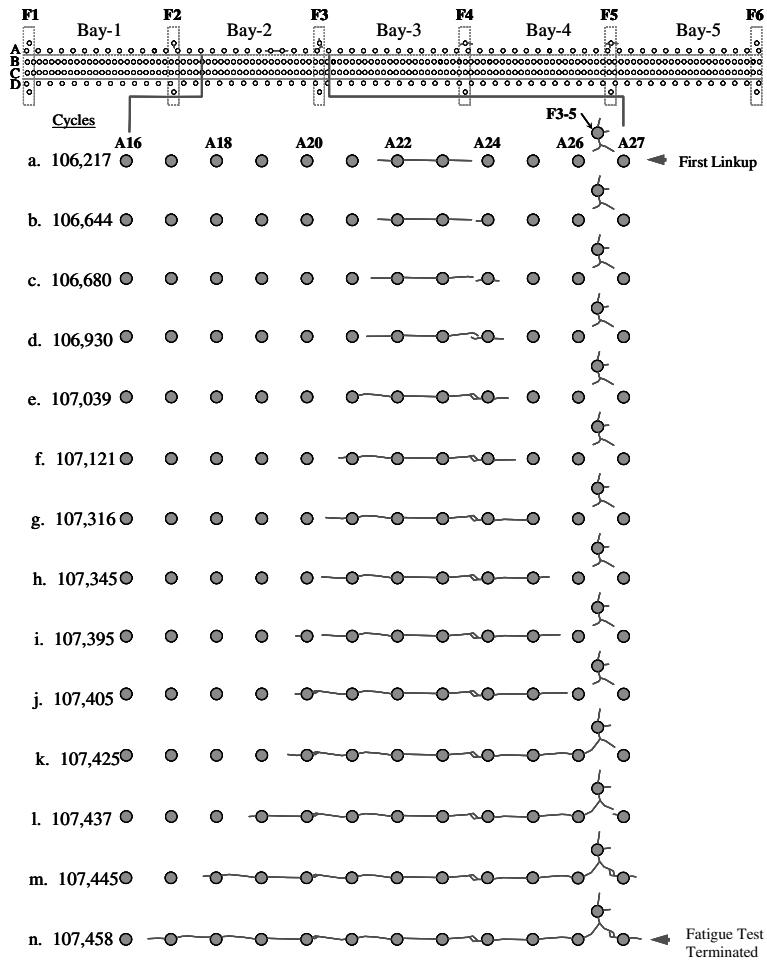
Crack growth after the first linkup of MSD between rivets A22 and A23 at 106,217 cycles (crack length = 2.87 in.) is shown schematically in Fig. 8. Shortly after the first linkup, cracks were detected emanating from rivet hole A24. Cracks A24-L and A24-R were detected at 106,644 and 106,680 cycles, respectively (Figs. 8b and 8c). Unlike the cracks at A22 and A23, the two cracks at rivet hole A24 were completely linked to the rivet hole when first observed. Additionally, due to crack interaction and stress redistribution, cracks A24-L and A24-R grew relatively faster than the cracks detected earlier at rivet holes A22 and A23. The second crack linkup occurred at 106,930 cycles when the lead crack (formed between A23 and A22) and crack A24-L grew past each other and formed a football-shaped ligament before linkup (Fig. 8d). After 109 additional fatigue cycles (at 107,039 cycles), the lead crack grew into rivet hole A21 to the left (Fig. 8e). No cracks were visually observed at rivet hole A21 before the linkup. Subsequently, there was a notable increase in the crack growth rate of the lead crack at both ends (Figs. 8f–8j). At 107,425 fatigue cycles, the lead crack extended to the right through rivet hole A26 and linked up to one of the existing cracks at shear-clip rivet hole F3-5 (observed earlier at 79,915 cycles) (Fig. 8k). As a result of linkup to the cracks at F3-5, the lead crack crossed over into the third skin bay and became a two-bay crack. Soon thereafter, a short crack (crack A27-L) was observed on the left-hand side of rivet hole A27 (Fig. 8l). At that time, the lead crack also grew into rivet hole A19 to the left. It took only eight additional fatigue cycles (at 107,445 cycles) for the lead crack to link up with crack A27-L and reappear on the right side of rivet hole A27. Simultaneously, the left crack tip propagated through rivet hole A18 (Fig. 8m). At 107,458 fatigue cycles, the lead crack was spanning across rivet holes A17 to A27 with a total length of 16.04 in. (Fig. 8n). Considerable crack growth was observed during each of the final few fatigue cycles. Therefore, the fatigue test was terminated at 107,458 cycles for postfatigue residual strength test [8].

Fig. 8 Crack progression along rivet row A following the first linkup.

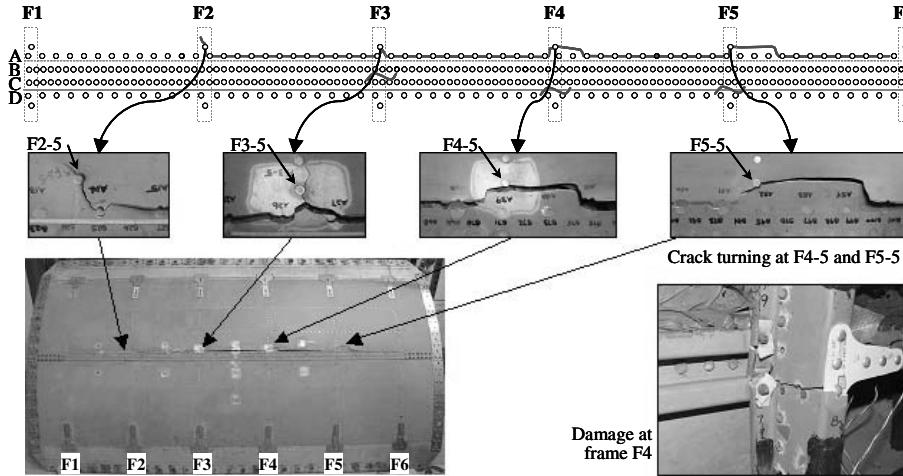
After terminating the fatigue test, the panel was subjected to quasi-static pressurization up to failure to determine its residual strength. Loads were applied quasi-statically with a pressure increment of 2 psi up to 14 psi and an increment of 1 psi thereafter. Further crack extension was observed at 16 psi pressure, which was the maximum applied pressure during the fatigue test. Catastrophic failure of the joint occurred at a pressure of 17.8 psi. The lead crack abruptly extended to a five-bay, 75 in. long crack. Figure 10 shows the final state of damage after the residual strength test. To the left, the lead crack extended to frame F2, linked up with the crack at shear-clip rivet hole F2-5, and stopped about 0.5 in. past that shear-clip rivet hole. To the right, the crack extended much further and was arrested between rivets A62 and A63 close to frame F6.

As the crack propagated primarily along rivet row A, the panel exhibited very limited crack-turning or flapping capabilities. At the locations of frames F4 and F5, the crack turned upward and linked up with the cracks emanating from shear-clip rivet holes F4-5 and F5-5 before turning downward to continue extending along rivet row A. A posttest inspection on the inner surface of the panel showed that frames F3, F4, and F5 were completely fractured under the lap joint. The damage at frame F4 is shown in Fig. 10. Further examinations of frame failures are currently underway.

Fig. 10 Final state of damage at the end of the residual strength test.

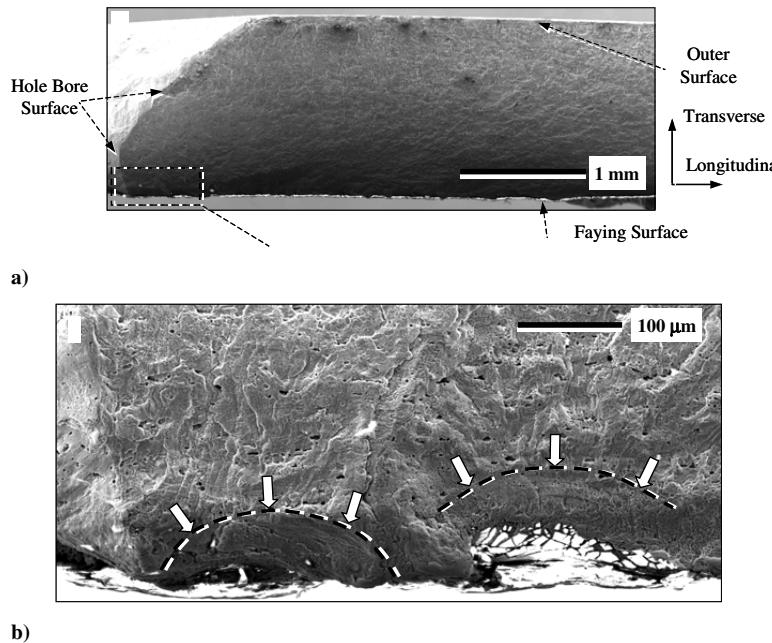
Fig. 11 SEM images of crack A23-R showing a) a wide view of the fracture surface, and b) a closeup of crack origin locations along the faying surface.

the faying surface (the inner surface of the outer skin mating with the finger doubler). Multiple crack origins were identified in the vicinity of the rivet hole indicating that the crack resulted from the coalescence of multiple small cracks. The locations of crack origins on the faying surface were characterized by the presence of surface damage that, apparently, occurred either during joint installation or as a result of fretting with the doubler during fatigue loading. Surface damage and the high tensile hoop strains resulting from secondary bending along rivet row A (Fig. 4) would contribute to crack initiation along the faying surface.

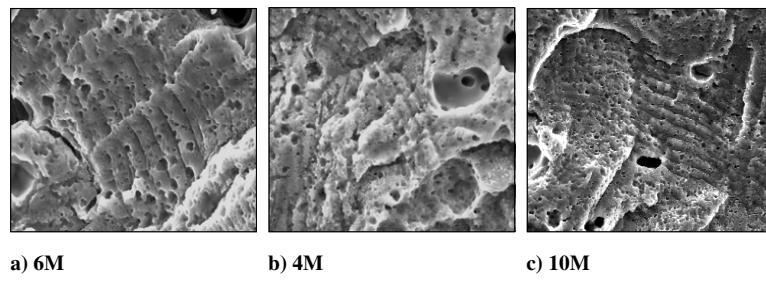
Fig. 12 SEM images of showing the appearance of marker band groups.

Marker bands, generated by applying the load spectrum shown in Fig. 3, were readily detectable under the SEM at magnification levels ranging from 350X to over 3500X, depending on the crack size. In general, the groups of 10-marker bands (10M) were easier to follow, whereas the groups of four-marker bands (4M) were somewhat more challenging. Examples of SEM images of all three marker band groups are shown in Fig. 12. Near the locations of crack origins, where multiple cracks grew independently, marker bands were more difficult to interpret. Further down the fracture surface, marker bands became easier to identify and trace nearly across the entire thickness

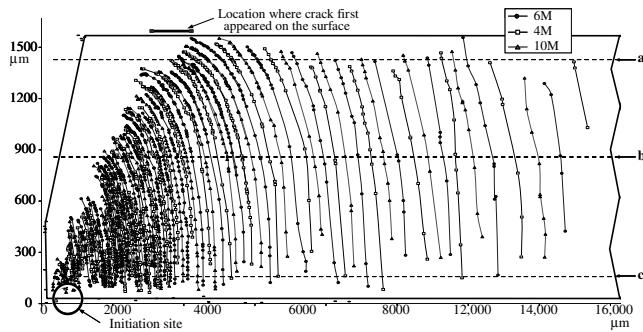
Fig. 13 Marker band locations for crack A23-R.

To reconstruct subsurface crack growth history, the locations of marker bands for crack A23-R were plotted (Fig. 13). For clarity, a thickness-to-length ratio of about 2:1 has been used in the plot. The location where the crack was first visually detected on the outer surface of the skin is indicated in the figure. Crack front shapes were, in general, part-elliptical with the major axis lying along the faying surface and the minor axis in the thickness direction. Marker bands were tracked back to the location of crack origins at the faying surface near the corner of the rivet hole. In the region surrounding the countersink of the hole, where residual compressive stresses from the rivet clamp were dominant, no marker bands or fatigue striations were detected. The absence of marker bands and striations indicates that the area around the countersink of the rivet hole remained uncracked as the subsurface crack propagated to the outer surface of the skin. Eventually, when the tensile stress at the crack tip became sufficient to overcome the residual compressive stresses, the countersink area ruptured.

Subsurface crack lengths and crack growth rates were measured directly from the plot of marker bands. Measurements were made in the longitudinal direction at three different depths across the skin thickness, as indicated by the three horizontal dashed lines in Fig. 13: near the free surface (line a), along the geometric centerline of the skin (line b), and near the faying surface (line c). The number of load cycles associated with each marker band was determined by correlation with visual measurements recorded during the fatigue test [8].
