Surveyor Spacecraft Vernier Propulsion System Survival in Lunar Environment

GILBERT F. PASLEY*

Hughes Aircraft Company, El Segundo, Calif.

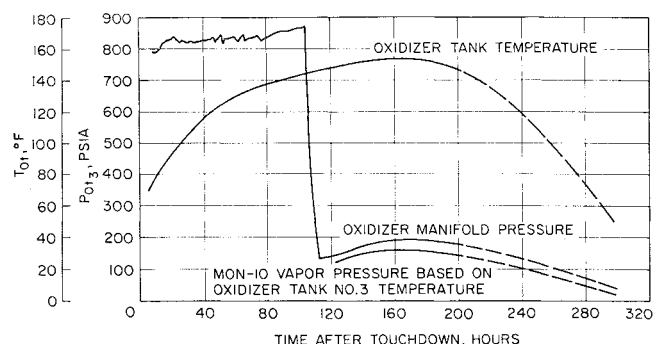
Approximately 9 min after the lunar touchdown of Surveyor I, the remaining He was vented to reduce the probability of propellant expulsion onto the lunar surface.⁵ The sun's position was such that the leg 1 propellant tanks and thrust chamber assembly (TCA) were shadowed, and the leg 2 and 3 propellant tanks, lines, TCAs, and the helium tank illuminated. (As the sun rose and set, this situation was reversed.) Radiant heating caused the oxidizer pressure (P_{ot3}) to increase (Fig. 3); 22 hr after touchdown, the oxidizer relief valve automatically relieved for the first time. Over

Fig. 3 Oxidizer pressure and tank temperature history—Surveyor I.

the next 78 hr, the valve cycled 9 times as the propellant continued to vaporize. After the ninth cycle, P_{ot3} began to drop and continued to fall for 8 hr, and the temperatures of all 3 oxidizer tanks dropped due to propellant cooling by vaporization.

During lunar operation, the oxidizer relief valve had opened at pressures between 825 and 865 psia and reseated between 817 and 825 psia. The acceptance test records indicated that the valve opened at 827 psig and reseated at 810 psig. Since the relief valves were attached to the top of the He tank in the full sun and were isolated from the mass of the tank shell through a threaded connection, they were significantly hotter than the 140°F indicated by the nearest temperature sensor (on the shaded part of the tank); therefore, the relief valve malfunction was attributed to degradation of the seat material caused by the combined effects of high temperature and oxidizer vapor exposure. Temperatures seen by the various components are given in Table 2.

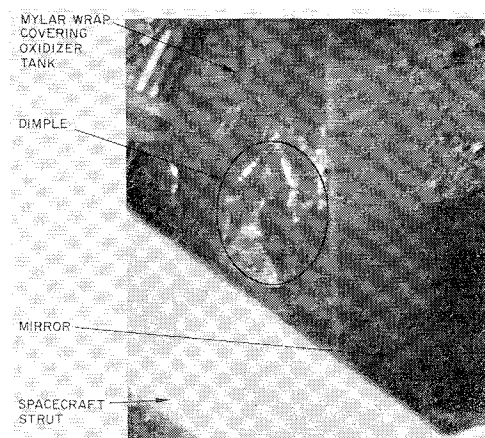
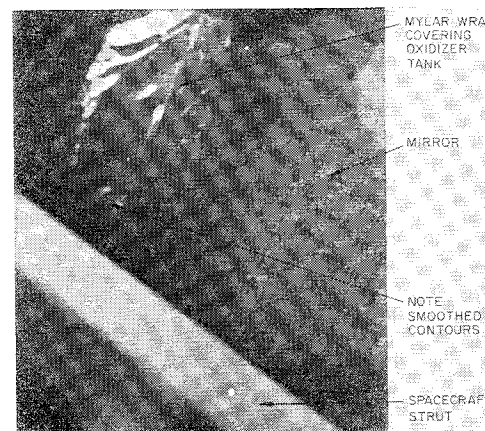
over a period of about 55 hr. P_{ot3} had stabilized 57 hr later and thereafter corresponded to the vapor pressure in the leg 3 tank. Concurrent with the pressure decrease, a 100°F drop in T_{ot1} and a 30°F drop in T_{ot1} occurred. These data are consistent with a liquid propellant leak through the leg 1 oxidizer tank O-ring seal. In addition, TV photographs† (Fig. 4) illustrate that portions of the mylar insulation on oxidizer tank 1 were inflated at approximately the time of pressure loss. Of the seals near the base of this tank, only the O-ring was enclosed within the mylar wrap, and only leakage at that location could have caused the mylar insulation to inflate. (The mirror shown in Fig. 4 was attached to the spacecraft structure to allow TV pictures of the lunar terrain beyond the field of view of the camera. The two photographs of the mirror reflect the moving spacecraft shadow and the changing appearance of the lunar surface as the lunar day proceeds from morning to afternoon.) Special tests simulating the lunar day profile for T_{ot1} showed that at $T_{ot1} \geq 160^\circ\text{F}$, the O-ring material (Viton A) is severely attacked by the oxidizer, whereas very little degradation occurred over the temperature range seen during the earth-lunar transit.

Fig. 4 Changes in surface of oxidizer tank insulation between lunar morning and afternoon—Surveyor V.

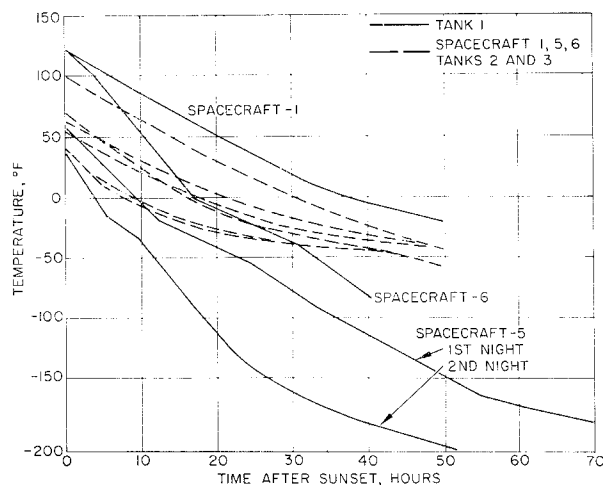
Fig. 5 Oxidizer tank temperatures after lunar sunset—Surveyors I, V, and VI.

to -50°F resulted from binary freezing of the oxidizer. Each of the 9 tanks had approximately 5 lb of oxidizer remaining at touchdown and would, therefore, be expected to have similar cooling profiles at sunset if there were no propellant usage or leakage. However, oxidizer tank 1 on Surveyor VI cooled very much like the nearly empty tank on Surveyor V, and in a significantly different manner from that of the other tanks. The amount of oxidizer remaining was calculated from both cooling and freezing data. The calculations correlated and indicated that approximately 4 lb of oxidizer had been lost. Oxidizer tank 1 on Surveyor V subsequently showed an increased rate of cooling at the second lunar sunset, indicating further propellant loss during the second lunar day.

In summary, all available data confirm that a liquid leak occurred on the Surveyor VI oxidizer tank 1 prior to the rapid gas leak. Such liquid losses could produce engine starvation during a lunar translation maneuver, and the resulting uneven torques could cause catastrophic loss of attitude control.
