AIAA 81-0716R

# Results of the Mission Profile Life Test— First Test Segment: Thruster J1

E.L. James\*

R.T. Bechtel†

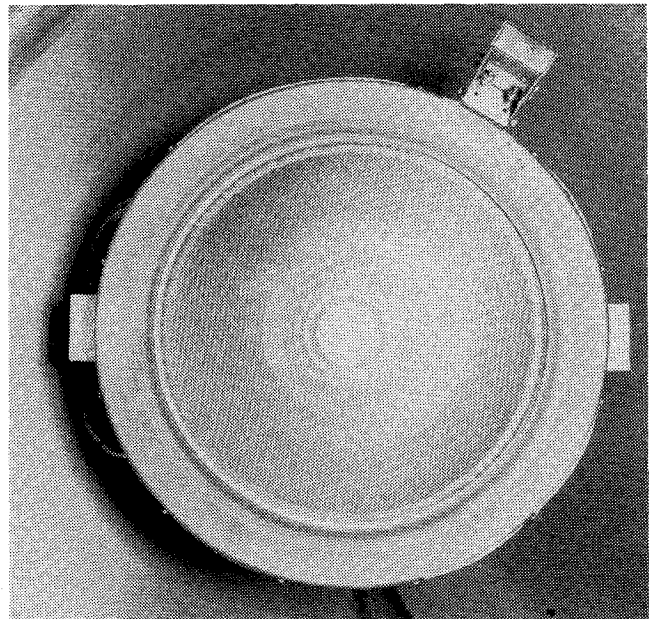
The condition of thruster S/N J1 on removal from the mission profile life test facility after 3940 h of testing was generally very clean (Fig. 3). A chip of material on the grids observed telescopically during the test was seen to be inside the grids rather than between the grids. The general shape and size was consistent with those suggested by the telescope. However, the chip was lost on trying to remove the grids, indicating that there was no firm attachment of the chip to the screen grid. The thruster then underwent post-test evaluation prior to complete disassembly. The problem of wrinkling of the wire-mesh anode covering noted on S/N 901 did not occur on S/N J1 where the mesh was diffusion bonded to the anode.<sup>3</sup> The three upstream anode screw heads and the area immediately around them, had a bluish discoloration.

Fig. 3 General view of thruster S/N J1 after 3940 test hours.

However, no operational difficulties were noted during or after the test and the cause of the discoloration is not known.

The change in coloration of the neutralizer housing graphite cover reflects the primary ion beam boundary. However, there was no detectable change in thickness at this point. There was also a large margin to accommodate any increase in the beam spread which might occur for any reason. Lack of this margin on the test of S/N 901 prompted an increase in length of the graphite cover.

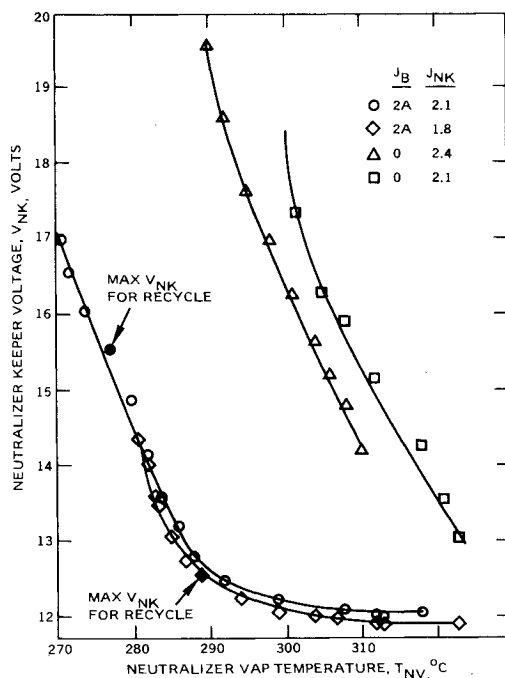
Since the high voltage recycle sequence occurs in 300 ms, the changes in neutralizer operation occur at constant flow rate. Figure 2 shows the  $V_{NK}$  vs  $T_{NV}$  characteristic for selected conditions. At 1.8-A keeper current the maximum  $V_{NK}$  for successful recycle every time is very close to the minimum  $V_{NK}$  that maintains control stability. This requires operation of neutralizer at or very near the maximum  $V_{NK}$ . Small perturbations can thus cause outages during recycle. By increasing the neutralizer keeper current from 1.8 to 2.1 A during beam-on operation; the maximum  $V_{NK}$  for successful recycle can be increased from 12.5 to 15.5 V. The neutralizer can then be operated sufficiently far from the limit to preclude outages.

Fig. 2 Typical neutralizer control characteristics.

An assessment of performance penalties was made over the range of operating beam current. Flow rates were measured at values of  $V_{NK}$  near the midpoint of the ranges for 1.8- and 2.1-A keeper currents. For small variations about the steady-state operating point, the tradeoff between power and flow rate was approximately 0.8 mA = 1 W at high beam and 1.4 mA = 1 W at low beam. The summary for operating points is given in Table 4. Note that the flow rate reduction per watt of power increase is greater than required to maintain constant total efficiency. Based on these test results, the steady-state value of  $J_{NK}$  has been increased from 1.8 to 2.1 A. This value is currently being used in ongoing life test segments.

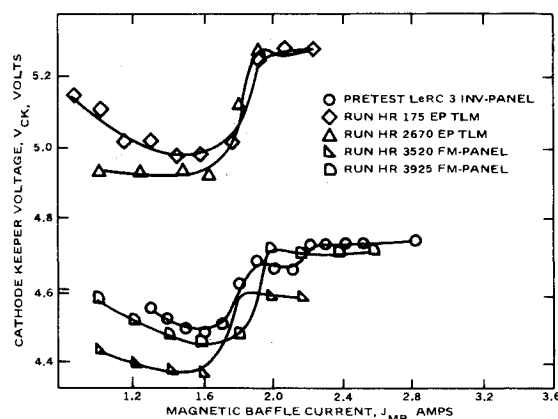
Fig. 4 Discharge characteristics of thruster J1 during extended testing in MPLT facility.

Periodic  $J_{MB}$  characterization throughout the test did not show any indication of a shift. Figure 4 shows the  $J_{MB}$  vs  $V_{CK}$  curves taken at various run hours. The values of  $J_{MB}$  at which the various identifiable critical points occur are much more constant in these comparisons than in the before-after comparison only (Fig. 5). In addition, the absolute level of  $V_{CK}$  is reasonably constant for curves generated by the same type of measurement technique (PPU telemetry or digital meter panel). The constancy of the dependent operating parameters suggests no discharge variation. From run hour 1013, when the change to the FM/PPU and the improved software program resulted in longer, less anomalous test segments, through the end of the test at run hour 3940, the cathode keeper voltage was quite constant.

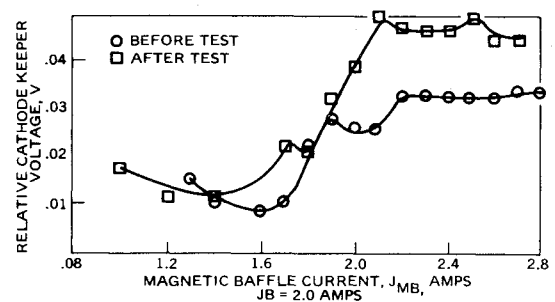
Fig. 5 Discharge characteristics of thruster J1 measured during performance mapping before and after extended test.

There are several possible reasons for the before-after differences of Table 5 and Fig. 5. Although care was taken to duplicate and calibrate the electrical and flow measurement systems, it is possible that systematic measurement errors may be responsible for these differences. The flow measurement system had been modified between tests to reduce the possibility of trapped air. If air is trapped in the measurement system, it can expand giving an optimistic flow reading. The higher main propellant flow rate after the test could be due to a small vapor leak in the new feed systems, an optimistic "before" reading, or a combination of the two. It is also possible that the measurements are accurate but that the cause of the differences in performance is associated with the exposure to atmosphere after continued operation rather than the long-term operation itself. This possibility is supported by the simultaneous change in magnetic baffle characteristics. Also, an undetected shorting of turns in the magnetic baffle coil could cause an increase in the required value of  $J_{MB}$  for specific operation. Finally, the possibility that thruster performance was degrading continually through the test (although believed unlikely) cannot be absolutely ruled out.
