Surface Analyses of Composites Exposed to the Space Environment on the Long Duration Exposure Facility Satellite

Joseph J. Mallon,* Joseph C. Uht,† and Carol S. Hemminger‡
The Aerospace Corporation, El Segundo, California 90245

We have conducted a series of surface analyses on carbon fiber/poly(arylacetylene) (PAA) matrix composites that were exposed to the space environment on the Long Duration Exposure Facility (LDEF) satellite. These composite panels were arranged in pairs on both the leading edge and trailing edge of the LDEF satellite. None of the composites were catastrophically damaged by nearly six years of exposure to the space environment. Composites on the leading edge exhibited from 25 to 125 μm of surface erosion, but trailing-edge panels exhibited no physical appearance changes due to exposure. Scanning electron microscopy (SEM) was used to show that the erosion morphology on the leading edge samples was dominated by crevasses parallel to the fibers with triangular cross sections 10–100 μm in depth. The edges of the crevasses were well defined and penetrated through both matrix and fiber. The data suggest that the carbon fibers are playing an important role in creva

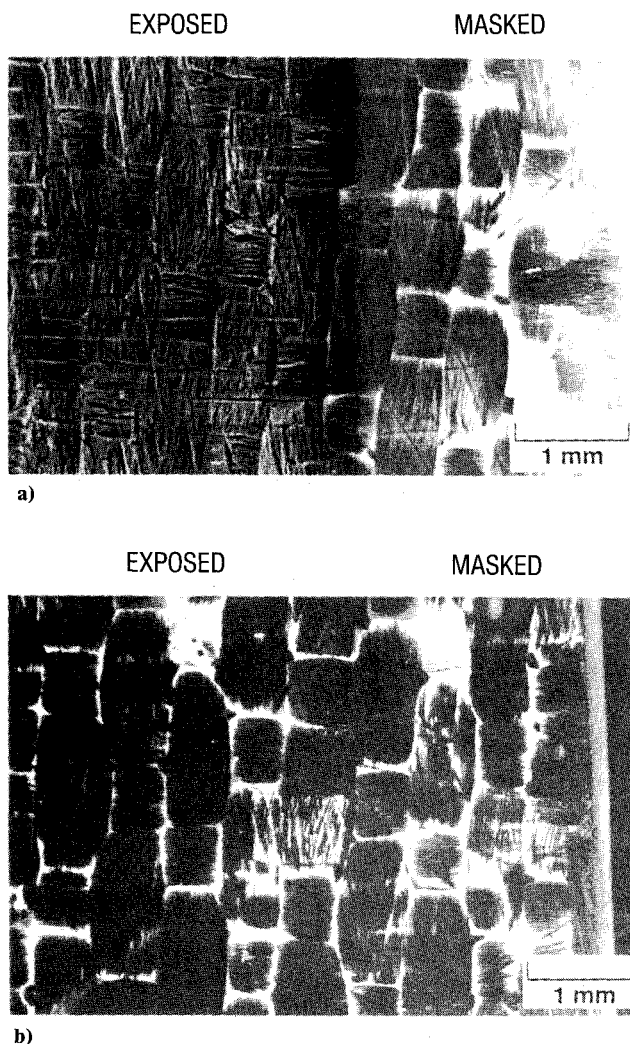
Fig. 3 Difference in surface erosion of samples after leading- and trailing-edge exposure: a) SEM of sample L-A surface, and b) SEM of sample T-A surface.

right-hand side of the sample was masked from the effects of the space environment by the mounting hardware. In Fig. 3, the lack of surface charging on the exposed area of L-A relative to the masked area and relative to T-A in the SEM chamber demonstrates that the nonconductive matrix at the surface of the leading-edge samples was removed by atomic oxygen erosion. In each sample pair, we found that the exposed area of the leading-edge sample had little or no surface charging, indicating that the conductive carbon fibers were exposed. The trailing-edge samples had extensive surface charging and were difficult to image because the nonconductive matrix had not been removed by erosion.

The erosion process resulted in a morphology on all of the leading-edge samples that is best visualized by examining the micrographs of the surface and of the cross-sectioned samples. Figure 3 shows that a leading-edge exposed surface is characterized by large crevasses that have developed predominantly parallel to the long axis of the fibers. This emphasizes the weave pattern of the carbon fiber tows in the fabric. However, the surface SEM micrographs do not clearly elucidate the condition of the remaining exposed fibers, even at higher magnification, as seen in Fig. 4. The optical micrograph cross section of the L-A surface shown in Fig. 5a highlights the "peak and valley" morphology associated with crevasse development on the exposed surface. Note that crevasses parallel to the cut of the cross section may not be seen. The area on the left side of the optical micrograph, where the sample was masked, shows the relatively smooth preflight condition of the surface. Higher magnification SEM micrographs of the L-C cross section are shown in Figs. 6 and 7. They show that the crevasses tra-

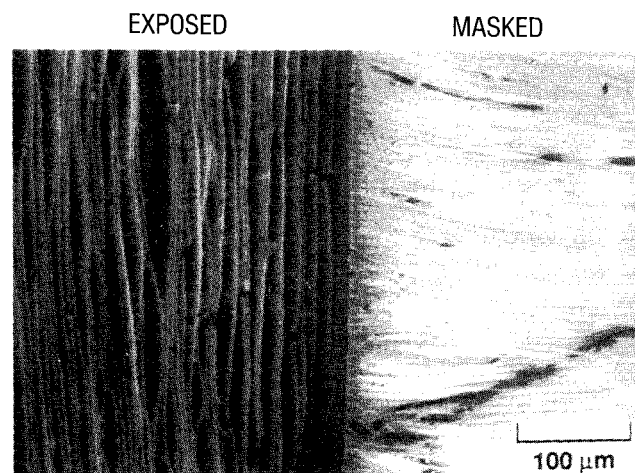
Fig. 4 SEM micrograph of L-C surface showing details of exposed and masked areas.

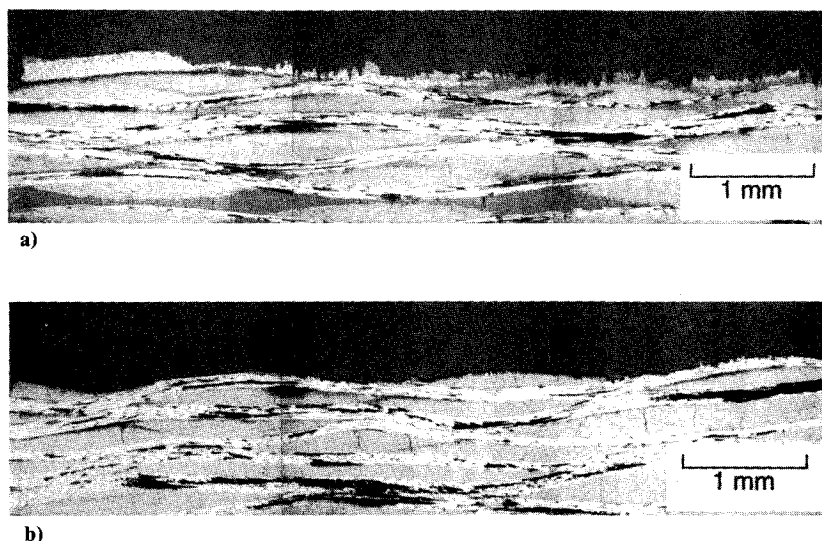
It was estimated from the cross-sectional optical micrographs that the erosion depths on L-A and on L-C were about 125 μm . The measurements were taken at the left side of the micrographs (see Fig. 5), where there is an edge between the masked and exposed areas of the surface. Individual crevasses reflect erosion depths less than or greater than the value at the edge. The optical micrograph of L-B, shown in Fig. 5b, showed features similar to those in the micrographs of L-A and L-C. However, the average depth of erosion from Fig. 5b appeared to be 25–50 μm and was difficult to measure because of the curvature of the surface. For comparison, reactive polymers, such as Kapton and Mylar, were eroded to a relatively uniform depth of about 220 μm by the atomic oxygen fluence received on row 9.¹⁶ We hypothesize that the decreased erosion of the composites relative to polymers is probably best understood in terms of a two-step erosion process. In the first step, the outer layer of organic matrix was removed at roughly the same rate as other reactive polymers. In the second step, when the carbon fibers became exposed, a lower reaction efficiency for the fibers led to a lower overall (bulk) erosion rate and contributed to the development of the highly irregular surface morphology. Carbon fabric/organic matrix composites with epoxy, polyimide, and polysulfone matrices were reported to have leading-edge erosion values near the masked edge of 50, 75, and 50 μm , respectively,¹⁷ measured from cross-sectional optical micrographs. Maximum crevasse depths of 80 μm were reported for the epoxy and polysulfone matrices and 120 μm for polyimide matrices.

The addition of PPQ to the HA-43 matrix did not have an obvious effect on the erosion rate or pattern of erosion for L-C relative to L-A. L-B, however, was eroded only 20–40% as deeply as the

Fig. 5 Optical micrographs of a) L-A cross section and b) L-B cross section.

other two composites, as seen by comparing Fig. 5b with Fig. 5a. Examination of L-B at high magnification, as seen in Fig. 8, revealed well-defined crevasses comparable to those on L-A and L-C in appearance but on average less enlarged. The panel for samples L-B and T-B, fabricated using PAA prepared in our laboratory, had the lowest resin content (about 40% lower than the other two panels). In this case, the lower reaction efficiency of the fibers relative to the organic matrix would contribute to the lower erosion rate observed for L-B. With so few samples, it can only be noted at this point that resin content and/or the details of resin composition/fabrication may play an important role in the overall composite erosion rate.

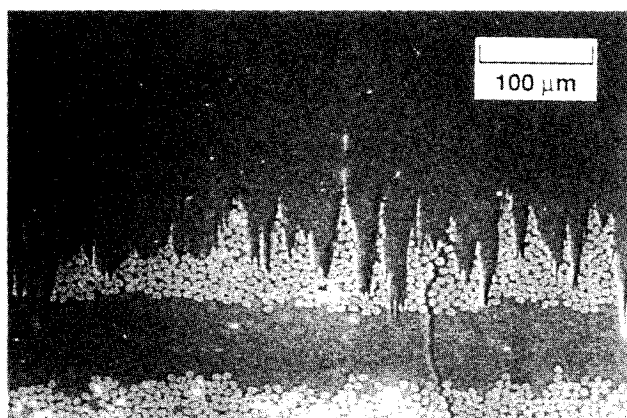
versed both fibers and matrix, and most appeared to have steep sides and a well-defined tip. The crevasses ranged from 10 to 100 μm in depth, and no undercutting of the matrix relative to the fibers was apparent along the sides of the crevasses.

At this point, it may be useful to distinguish between "cracks" and "crevasses." Cracks form when two previously united sections of the composite become separated. There is no net loss of material during crack formation. The cracks observed in the samples were probably caused by thermal stresses during molding or during flight. In contrast, crevasses resulted from removal of fiber and matrix material and were characterized by sharp triangular cross sections. Crevasses were completely absent on trailing-edge sample surfaces, suggesting that they developed on leading-edge surfaces as a result of atomic oxygen erosion. Figure 6 shows a section of L-C that contains both a surface crack and surface crevasses. The crack is narrow, uniform in width, and extends farther into the sample interior than the wider, triangular crevasses. Note that the intersection of the crack with the surface did not cause a crevasse to form. In general, we found no correlation between the location of cracks and crevasses, and as seen in Fig. 6, crevasses were more numerous than cracks.

Fig. 6 SEM micrograph of L-C cross section contrasting surface crack with surface crevasses.

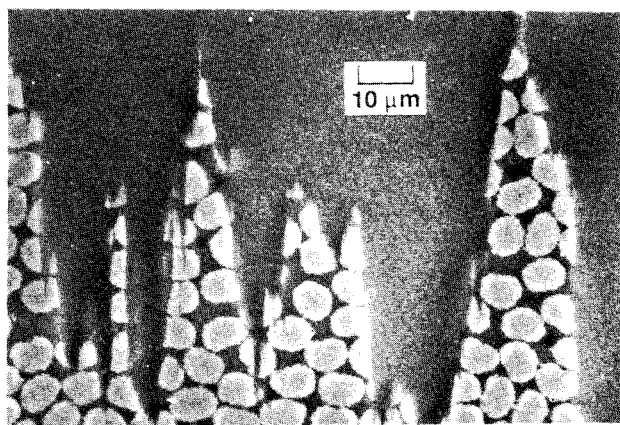
Fig. 7 SEM micrograph of detail of L-C cross section.

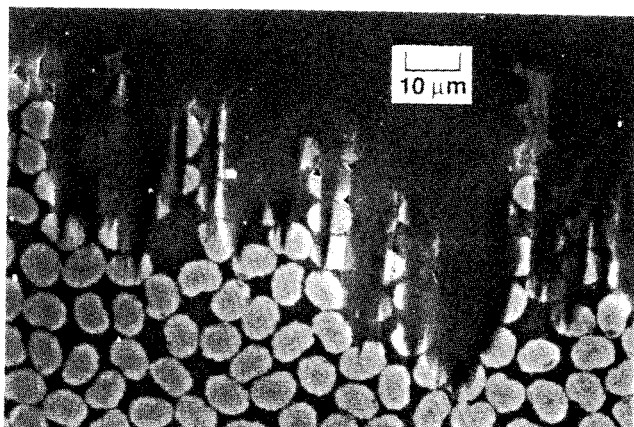
Fig. 8 SEM micrograph of detail of L-B cross section.

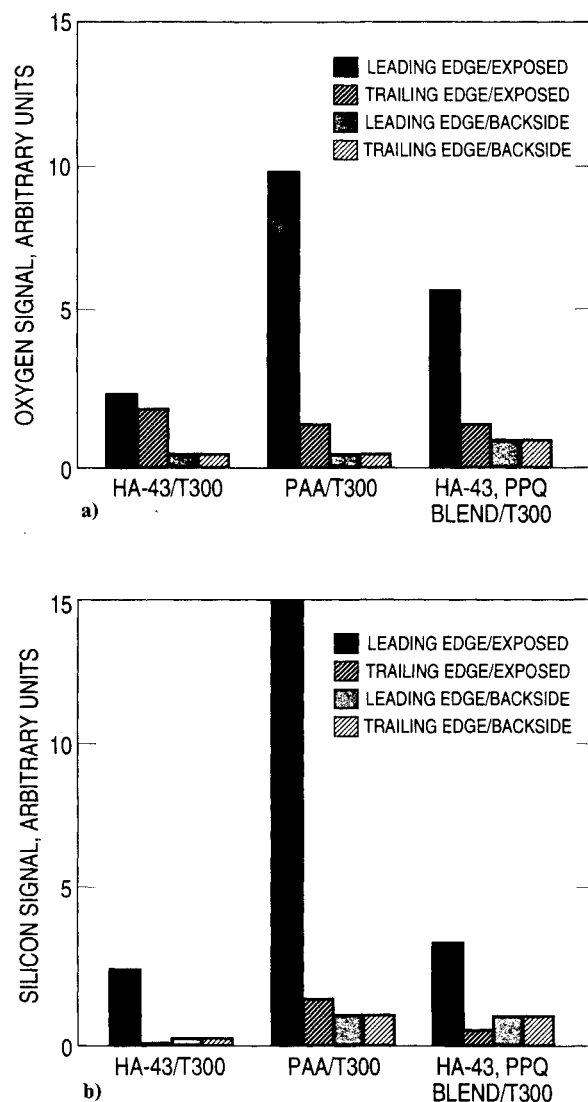
At 15 kV, x-ray information for EDS surface composition determination comes from a depth of $\leq 1 \mu\text{m}$. The EDS data showed that all of the composites flown on LDEF were contaminated with Si and O. Low levels of Cl and Cu were also present on most of the analyzed samples. Other minor contaminants detected on one or more surfaces included Ca, Al, S, P, Mg, Ni, Fe, and Ti. In each case, the O concentration was higher on the exposed face than on the backside face and higher on the leading-edge exposed surface than on the trailing-edge exposed surface, as seen in Fig. 9a. EDS data are not readily quantified for the low atomic number elements, such as C and O. Therefore, comparison of relative surface concentrations has been approximated for these composite samples by using elemental peak heights (arbitrary units) after setting all of the carbon peaks to the same height. This should be a valid approximation since carbon from the fabric and organic matrix is the dominant component in the volume analyzed (SEM analysis of the sample cross sections and XPS analyses do not show thick contaminant overlayers on the exposed surfaces). It is seen in Fig. 9b that the silicon concentration was higher on the leading-edge exposed surfaces than on the trailing-edge exposed surfaces or any of the backside surfaces. The exposed surface of L-B had higher silicon and oxygen concentrations than the exposed surfaces of L-A and L-C, which is consistent with the lower extent of erosion on L-B observed in the micrographs.

Fig. 9 EDS surface composition of samples compared as a function of exposure: a) EDS relative oxygen signals, and b) EDS relative silicon signals.
