Contamination and Damage to Filmed Microchannel Plates on the International Space Station

J. D. Carpenter,* T. J. Stevenson,[†] and G. W. Fraser[‡]
University of Leicester, Leicester, England LE1 7RH, United Kingdom

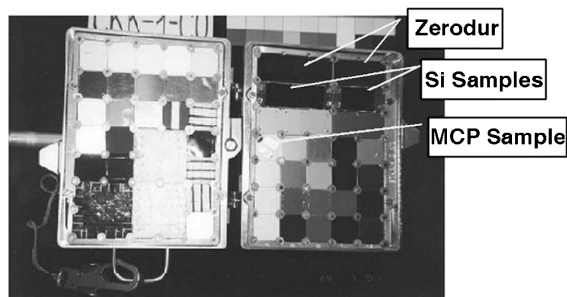
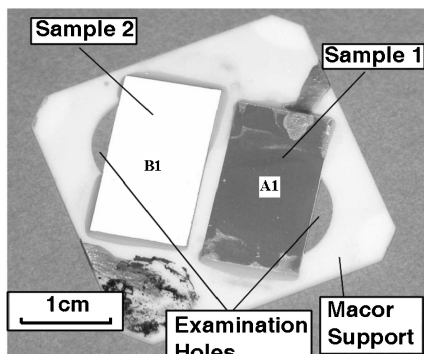
Fig. 1 MCP samples a) in situ on ISS [image courtesy of Kayser-Threde and S. P. Korolev Rocket and Space Corporation (RKK) Energia] and b) returned filmed samples and their Macor sample support.

Figure 1 shows the returned samples and sample support. Analysis of these samples revealed a number of features that had appeared during exposure. These features are described next.

corners where the material appears paler in color. These corners, shown in Fig. 1a, have been covered during exposure. In addition, a thick brown substance surrounded the MCP samples. This may be the adhesive used to bond the samples to the support structure altered by exposure to solar UV (Fig. 1b).

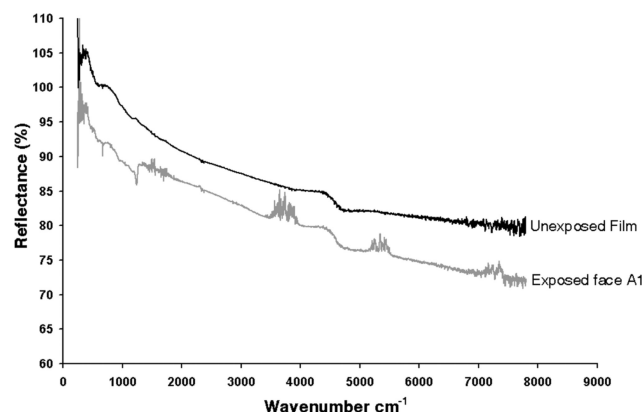
Fig. 3 FTIR spectra of faces A1 and B2.

FTIR reflection spectra of face A1 postexposure and that of a nonexposed filmed MCP of identical format are shown in Fig. 3. The bulk reflectivity of face A1 is reduced from that of nonexposed films. This may be due to the damaged film not over the examination hole reducing the reflecting area. This damage is described in the following subsections and is probably related to the process of attachment to the support structure; as such, it is unrelated to the ISS environment directly. No evidence of significant contamination was observed, although the minima at 1229 cm^{-1} indicates the presence of a carbon layer. The noise observed in the spectrum of the exposed MCP indicates the presence of a contaminating film,

though any such film will be very thin and its composition cannot be quantified on the basis of such features.

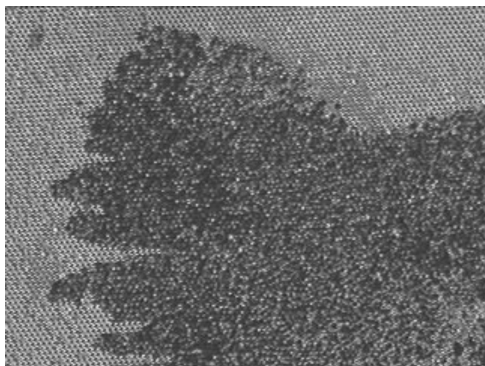
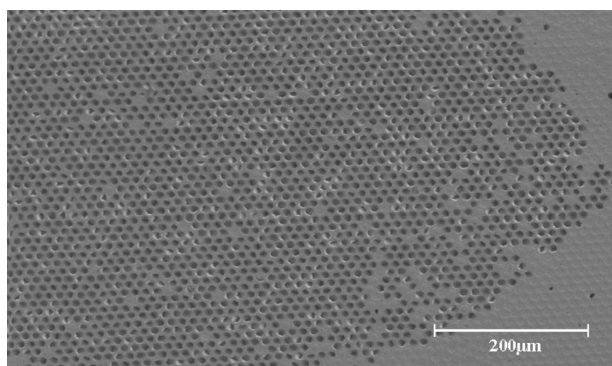
1. Feature 1: Dark Patches; Holes in Al Film

Under an optical microscope, extended dark patches with clearly defined boundaries (Fig. 4a) were observed. The features appeared black to the naked eye but were seen to have an irregular and textured surface under the microscope with metallic and black patches. In places, the region around the rim appeared pale in comparison with the surrounding film. With the higher magnification of the SEM, the feature appeared to be made up entirely of holes in the Al film (Fig. 4b).

EDX spectra of the feature showed x-ray lines consistent with MCP glass and the Al film. No other elements were detected.

Fig. 4a Optical microscope image of face A1 feature 1.

Fig. 4b SEM image of face A1 feature 1.

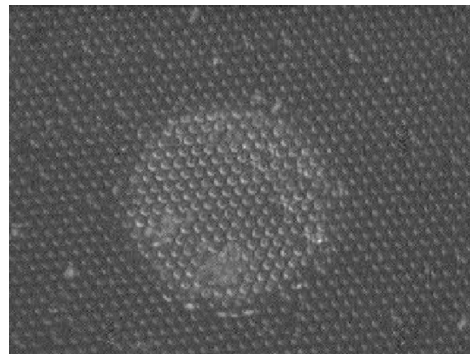
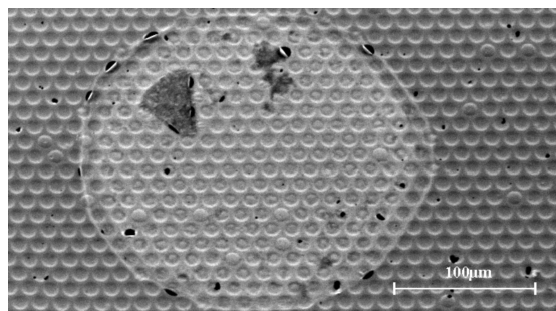
3. Feature 3: Regularly Shaped Patches

Two regular shaped, approximately circular to hexagonal patches, $\sim 12\text{--}16$ microchannels across ($180\text{--}240\text{ }\mu\text{m}$), were observed under an optical microscope (Fig. 6a). In these features, the metallic

Fig. 6a Optical microscope image of one example of face A1 feature 3.

Fig. 6b SEM image of one example of face A1 feature 3.

appearance of the film was diminished. There was a clearly defined rim, which appeared brighter than the central region. This was observed in more detail with the SEM (Fig. 6b).

The shapes and structures of these features were consistent with contamination spots observed on returned samples from the Mir space station and may result from the impact of droplets during a water dump. (Mir Solar Array Returned Experiment Archive System, data available online at <http://setas-www.larc.nasa.gov/sare/sare.html>.) Phosphor was detected in the EDX spectra from these features, as well as traces of iron. Phosphor is an element very abundant in biological cells, suggesting that these features may contain biological waste. Other elements consistent with this were observed but are components of MCP glass and cannot, therefore, be taken into account.

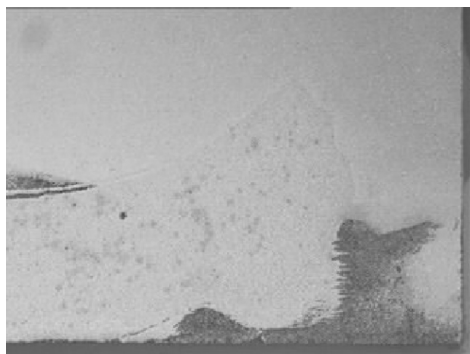
2. Feature 2: Light and Dark Patches

Two extended patches were observed optically, where the MCP film appeared slightly different in coloration to the majority of the surface (Fig. 5). Clearly defined edges were visible. Optical interference was observed with the naked eye in an oil-film effect. This implies the presence of a thin molecular film. Under the optical microscope, the areas were seen to contain light and dark patches. The shape and position of this feature corresponded with A2 feature 1 on the reverse side of the MCP.

Feature 2 was not visible with SEM imaging. EDX spectra did not indicate the presence of any elements inconsistent with MCP glass or the Al film.

Fig. 5 Optical microscope image of one of two examples of face A1 feature 2, located at center and bottom of face A1 in Fig. 1: dark area surrounding it is face A1 feature 1.

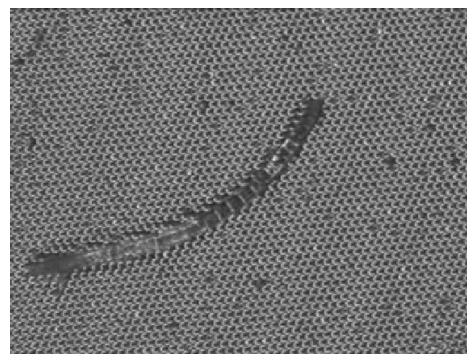
4. Feature 4: Scrape

A long, thin scrape along the Al film (Fig. 7) was observed. This feature was approximately 30 microchannels diameters in length ($\sim 450 \mu\text{m}$).

Fig. 7 Optical microscope image of face A1 feature 4, located just above bottom example of face A1 feature 1.

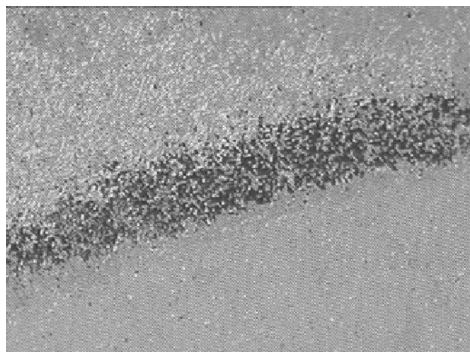
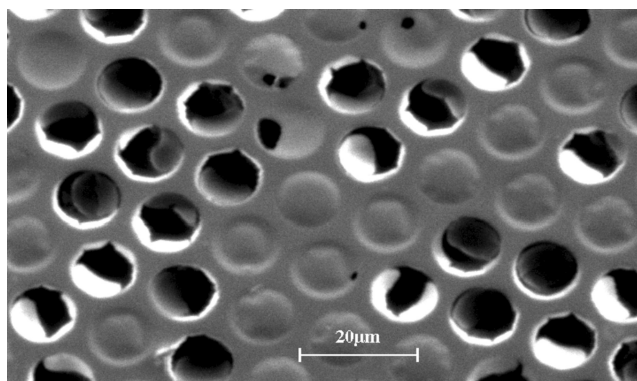
5. Feature 5: Close-Packed Holes

A region was observed that appeared entirely made up of closely packed (almost all microchannels) holes in the film (Fig. 8a). This region extended along the face of the MCP, arcing slightly, above the edge of the inspection hole (Fig. 1). There were visible differences in the material above and below this feature. A high-magnification SEM image of the area is also shown in Fig. 8b. These holes are likely related to the adhesion of the MCPs to the sample support, given that such features do not occur over the examination holes where the MCPs are not in contact with the sample support. Gas trapped in the microchannels during adhesion may burst the film in vacuum due to the large pressure differential across the film.

Fig. 8a Optical microscope image of face A1 feature 5.

Fig. 8b SEM image of face A1 feature 5.

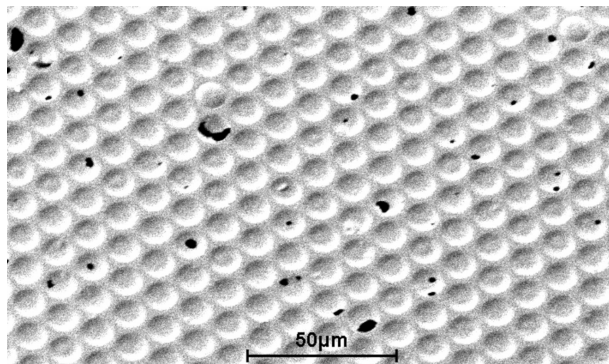
7. Feature 7: Holes from Potential Small Particle Impacts

Fig. 10 SEM image of holes in A1 nanofilm.

Over the support structure inspection hole there was a seemingly uniform distribution of small holes with less than one microchannel diameter. These may arise from a high flux of small hypervelocity dust¹⁰ impacts and vary in size. Figure 10 shows a SEM image of these holes in the Al film. Size distribution and impactor flux have been determined through analysis of SEM images and are presented in Ref. 10. The fractional loss of Al film over the MCP open area in the region covering the inspection hole is 0.0027.

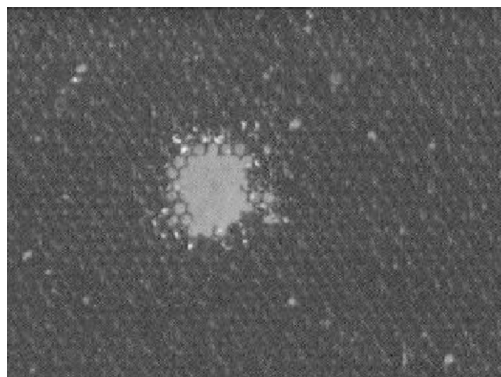
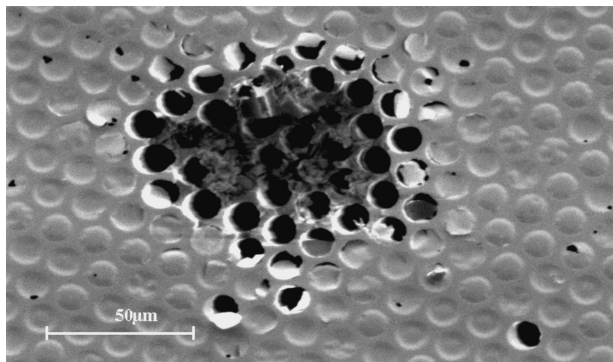
6. Feature 6: Holes from Potential Particle Impact

Two holes were seen on the in the Al film, which were resolvable with the naked eye, and $\sim 100 \mu\text{m}$ in diameter, enveloping several microchannels (Fig. 9a). Damage to the film around the microchannels was resolved with the optical microscope. These features are most likely the result of particle impacts.

With the SEM, further detail was resolved. A SEM image of one of these holes is presented in Fig. 9b. EDX spectra did not show

Fig. 9a Optical microscope image of one of two holes in A1 film, resolvable with naked eye.

Fig. 9b SEM image of other of two holes resolvable with naked eye.

the presence of any elements incompatible with MCP and Al film composition. As such, the impactor's origin (natural dust or man-made debris) cannot be determined.

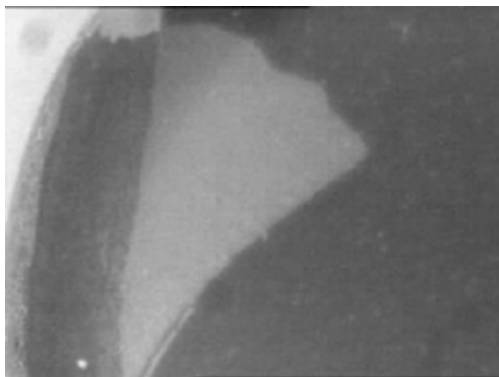
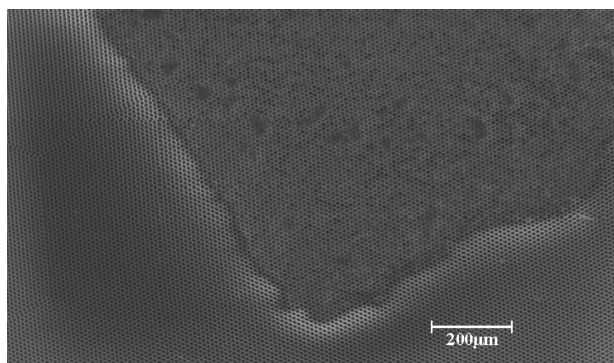
1. Feature 1: Undefined Structure

A structure extending on to face A2 from its edge was observed with optical microscopy (Fig. 11a). This was probably derived from adhesive. The shape and position of this feature correspond with face A1 feature 2 on the reverse side. SEM imaging (Fig. 11b) and EDX spectra offer no further insight into the structure or composition of the feature.

Fig. 11a Optical microscope image of face A2 feature 1.

Fig. 11b SEM image of face A2 feature 1.

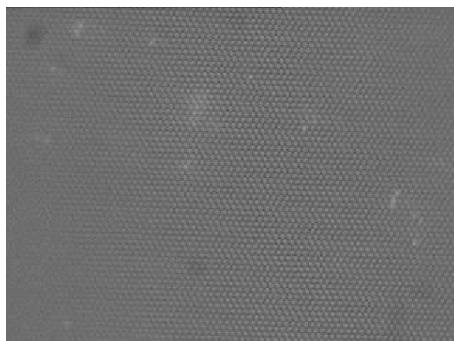
2. Feature 2: Pale Spots

Pale spots are observed in the MCP lattice across face A2. These are most likely a result of light transmission through holes in the Al film on the opposing side (Fig. 12).

Fig. 12 Optical microscope image of face A2 feature 2.

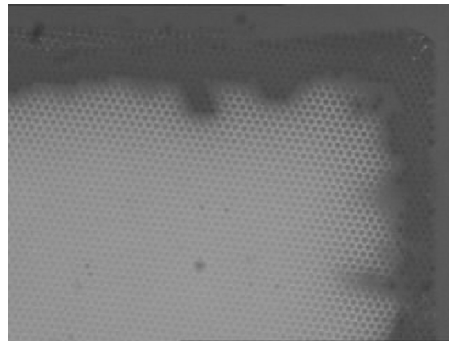
1. Feature 1: Stain

A brown stain was seen to extend around the perimeter of the MCP, where it was in contact with the support structure (Fig. 13). The stain extended in from the edge by around 5 microchannel diameters ($\sim 75 \mu\text{m}$). The origin of this stain seems most likely to be outgassing from the underlying adhesive and subsequent exposure to solar UV radiation.⁹

EDX spectra confirmed the presence of elements expected in MCP glass with the addition of Fe and Mg.

Fig. 13 Optical microscope image of face B1 feature 1 at top right corner of face B1, Fig. 1.

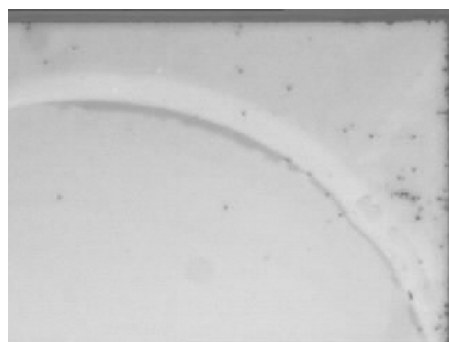
2. Feature 2: Colored Areas

A pale feature followed the majority of the circumference of the underlying inspection hole. Within this pale region, patches of

brown staining were clearly visible, particularly in the lower edges of the feature. Along stretches of the inner edge of this region, a gray feature is visible. This corresponded with the presence of what may be adhesive on the opposing face shown in Fig. 14. The white discoloration may have been the result of a darkening of the rest of the MCP.

This feature was not observable with SEM.

Fig. 14 Optical microscope image of face B1 feature 2 and examples of features 3 and 1.

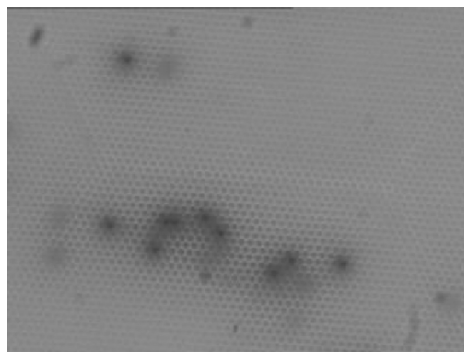
3. Feature 3: Discolorations

Numerous single microchannels, or groups of a few isolated microchannels, were found to have dark brown discolorations or blockages (Fig. 15). These occurred with far lower frequency over the inspection hole.

EDX spectra showed the presence of Mg in addition to elements present in MCP glass.

Fig. 15 Optical microscope image of examples of face B1 feature 3 located toward bottom and center of face B1.

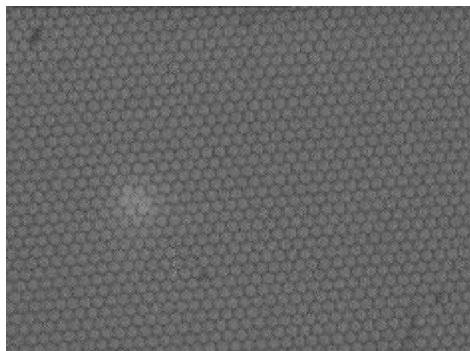
4. Feature 4: Discoloration

A pale white discoloration was observed around a few isolated microchannels over the inspection hole (Fig. 16). These may have resulted from transmission through holes in Al film at the opposing face or imperfections in the MCP lattice.

Fig. 16 Optical microscope image of face B1 feature 4.

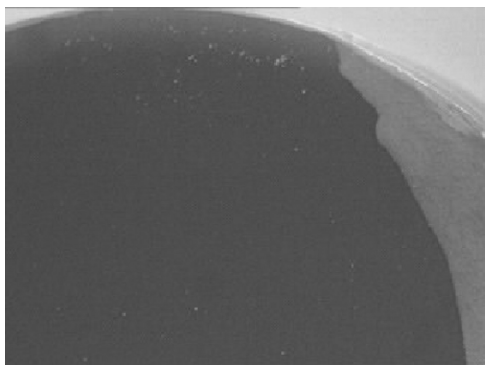
1. Feature 1: Contaminant Material

A spread of material from the inspection hole perimeter and onto the face was observed (Fig. 17). This is likely to be related to the presence of adhesive and corresponds with face B1 feature 2.

Fig. 17 Optical microscope image of face B2 feature 1.

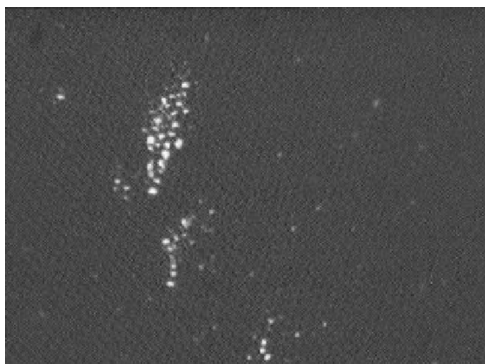
2. Feature 2: Holes

A diffuse distribution of holes was seen in the Al film (Fig. 18). However, it is less prominent than that of A1. In addition, clumps of several of these bright channels are observed together. These may result from impactors that have passed through the Al film on the front face with an angle of incidence less than the acceptance angle of the microchannels.

Fig. 18 Optical microscope image of clump of holes in A1 film described in face B2 feature 2.
