Report on the damage to FRP water tanks by the Great Hanshin Earthquake

NAOMI TADA

Abstract—The Great Hanshin Earthquake that took place in the dawn of January 17, 1995 brought about unprecedented disasters to the Hanshin area. The size of the earthquake was recorded as a magnitude of 7.2. The acceleration observed near the epicenter was the largest in the history of earthquake observation in Japan. In this earthquake, damage that could not be explained by conventional engineering theory was observed, such as the destruction of buildings, highways and underground structures. Much damage to water tanks made of FRP were reported. However, damage to those water tanks manufactured after the revision of the earthquake resistant standards based on the revised construction standard act (1981) was much smaller than that on tanks made before the act. Damage to ceilings of many water tanks was also reported in this earthquake which were not observed previously and which therefore also characterizes this particular earthquake.

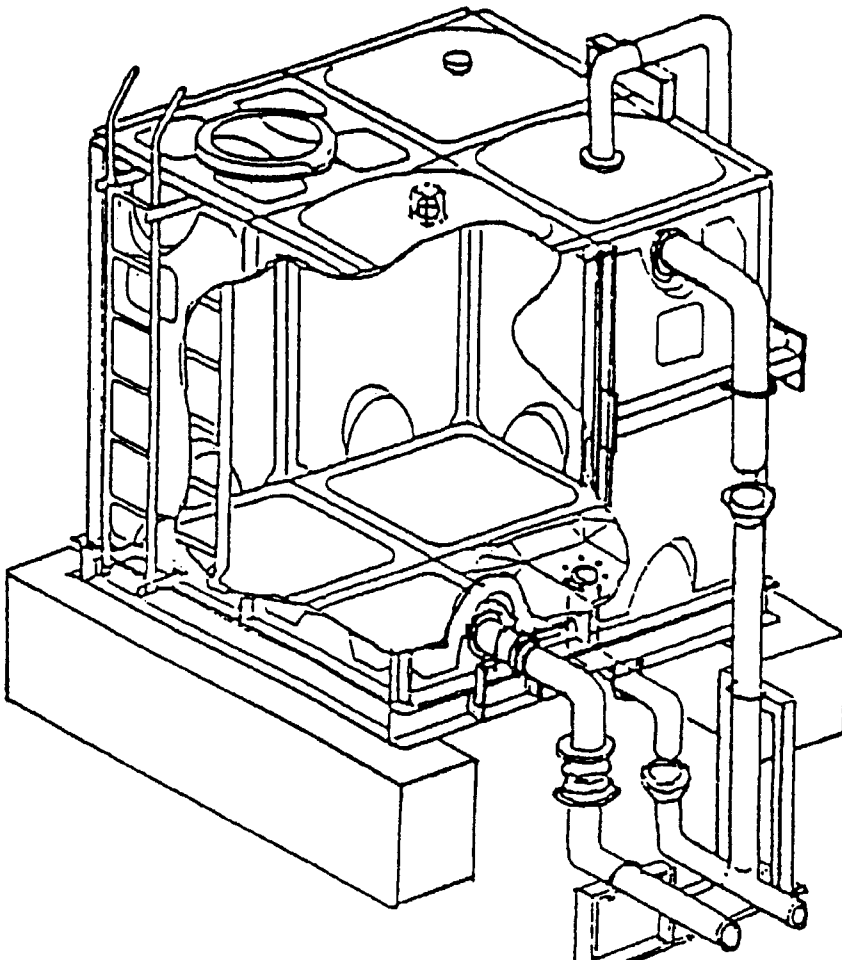
Many cracks and damage at water tank side walls and bottom boards initiating at the pipe mounting parts were reported. These are the results of excessive forces applied at the mount part of tanks due to vibration of pipes. The causes of these cases are thought to be related to the presence and proper selection of flexible joints, the location, pipe support location and its mounting methods.

Figure 3. Example of the water tank pipe connecting parts.

It is necessary to devise a piping system so that forces due to self-weight and vibration of the piping system are not applied directly to the pipe connection parts of water tanks. It is also necessary to have flexible joints made of synthetic rubber with a berose shape and design the pipe support system so that the flexible joints are effective in three-dimensional directions. Figure 3 shows such examples.
