## Effect of Li/MgO methane coupling catalyst on Alonized steel reactors

M. Dean Phillips and Alan D. Eastman

*Research and Development, Phillips Petroleum Company, Bartlesville, OK 74004, U.S.A.*

Alonized 316 stainless steel reactors were used in life tests of a Li/MgO methane coupling catalyst. Severe corrosion of the portion of the reactor in contact with the catalyst bed was observed. Loss of physical integrity and chemical passivity resulted from layer formations of differing elemental compositions from the bulk metal. Chromium was leached from the stainless steel alloy and deposited on the catalyst. There were no adverse changes in those portions of the reactor not in direct contact with the catalyst. These results demonstrate that Alonized 316 stainless steel is unsuitable for use in methane coupling service with this lithium-containing catalyst.

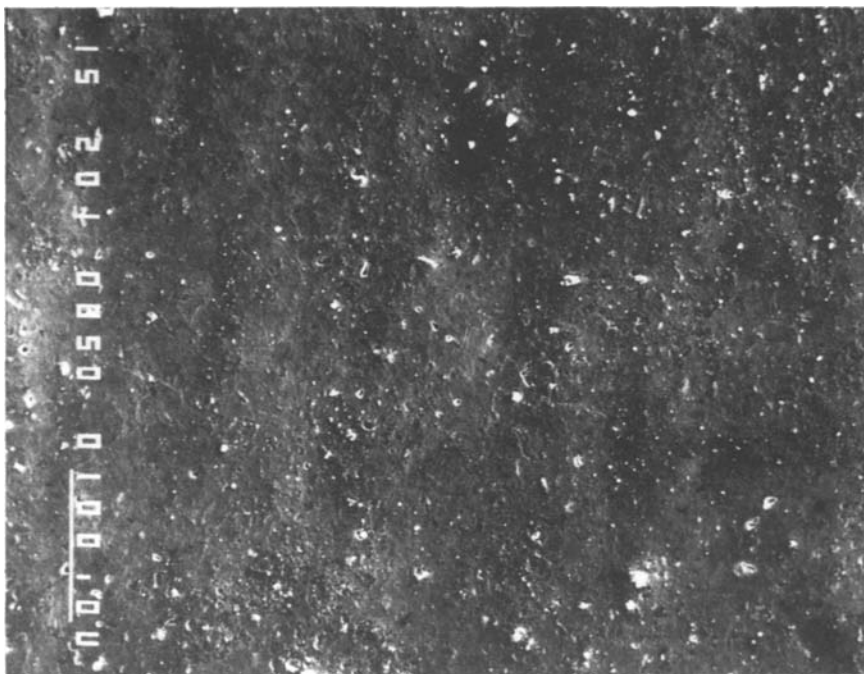
Fig. 1. Interior surface of the SI reactor in an area above the catalyst bed (200 $\times$ ).

A portion of the reactor sent to SI was returned after they had run a life test with Li/MgO catalyst; reaction conditions were the same as at Phillips. A micrograph of the interior surface of the reactor above the catalyst bed is shown in fig. 1. Physically, the area is rather smooth with small pits or pores, but no signs of extensive corrosion. Analytical data from a quantitative cross-sectional traverse of the tube wall is given in fig. 2. The aluminum is concentrated at the

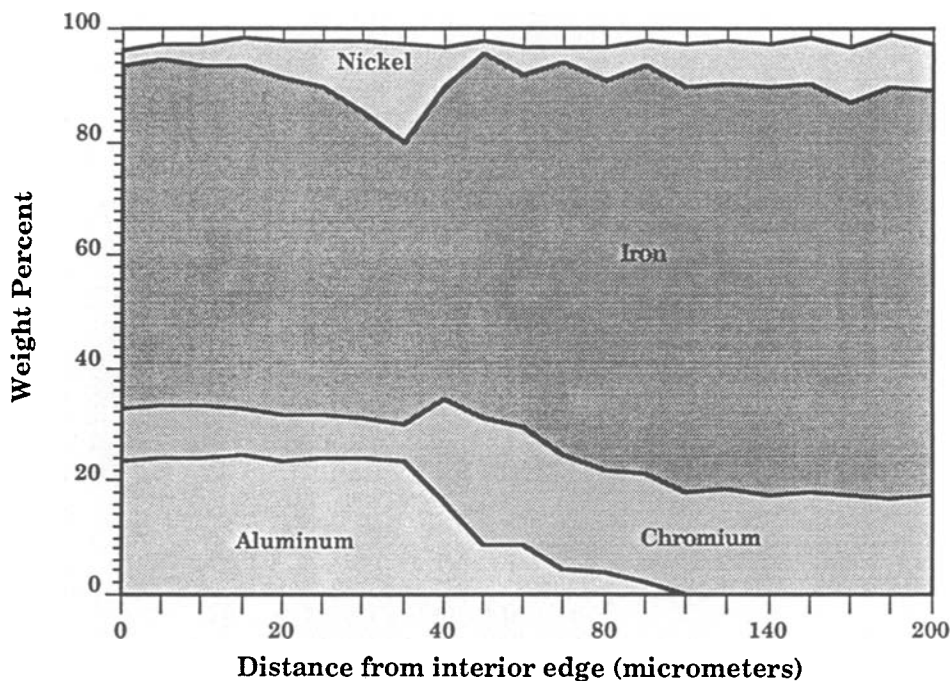
Fig. 2. Cross-sectional traverse of SI tube wall in area above catalyst bed.

surface and remains fairly constant, then decreases rapidly until it disappears at a depth of approximately 100 micrometers. Chromium and nickel are depleted in the aluminum-rich layer, relative to the bulk composition of the metal.

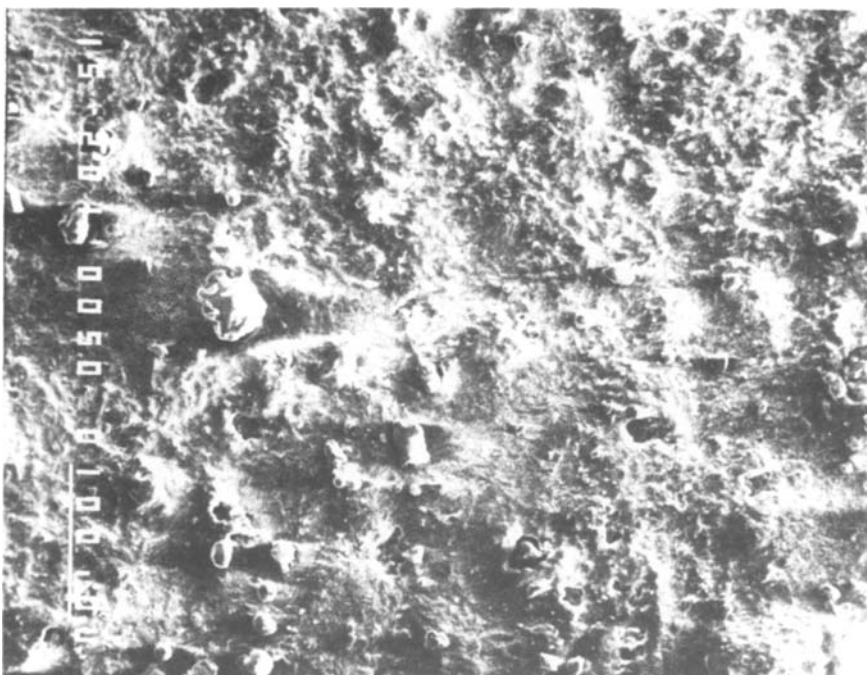
The interior surface of the metal in the area of the catalyst bed (fig. 3) is drastically changed from that seen above the bed. Severe surface corrosion and pitting is apparent, with what appear to be small particles either adhering to the surface or buried in pits. Fig. 4 shows analytical data from a cross-sectional traverse of the reactor tube bulk in the area of the catalyst bed. Compared with the area above the catalyst bed, that in the bed is greatly depleted in chromium, iron, and nickel. There are signs of the segregation of the aluminum and iron into layers.

Fig. 3. Interior surface of the SI reactor in the area of the catalyst bed (200 $\times$ ).

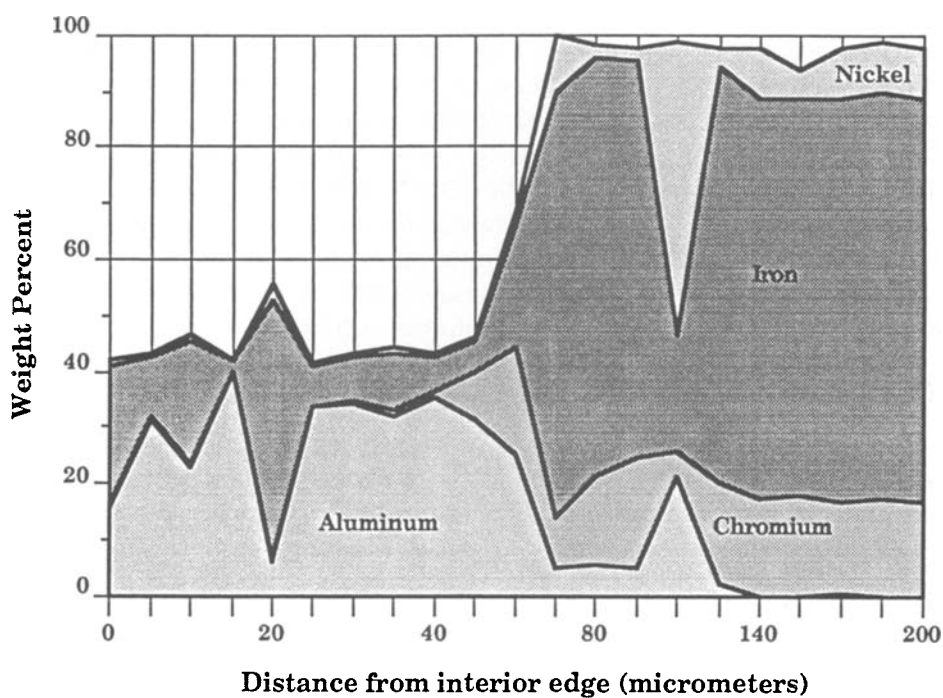
Fig. 4. Cross-sectional traverse of SI tube wall in the catalyst bed area.

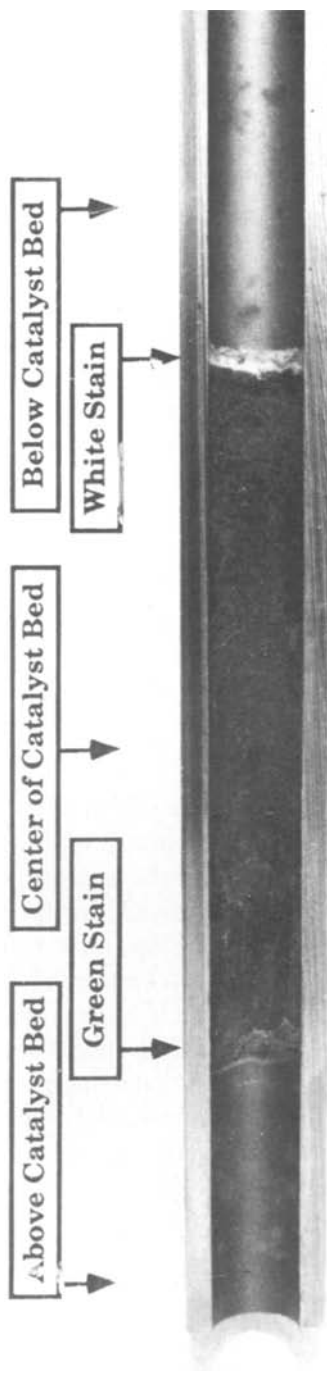
Fig. 6 shows the interior of the Alonized reactor which was used in the life test whose results are given in fig. 5. There is obvious damage to the reactor walls; that corrosion corresponds exactly to the area covered by the catalyst bed. Above and below the bed, the reactor was filled with quartz chips. Close inspection of the reactor revealed five distinct areas of the reactor, each of which was examined under the microprobe. The area above the catalyst bed looked much like a fresh reactor. At the top of the bed area, a greenish stain could be seen on the reactor wall. The center of the bed area was uniformly rust-colored, while the bottom of the bed was marked by a whitish stain. Below the bed itself was a region about an inch long which, though not particularly discolored, did not look like the “virgin” area above the bed either. In this region, the quartz chips removed from the reactor were discolored, presumably by deposited lithium leached from the catalyst.

Fig. 6. Photograph of the interior of a used Alonized stainless steel reactor.

When looking with the naked eye at the interior surface of the used reactor (fig. 6), the portion of the reactor in contact with the catalyst bed appears to be raised above the level of the undamaged reactor surface. The microprobe analysis of the cross-section confirms and amplifies that observation. Fig. 13, the photomicrograph, and fig. 15, the dot map of a region in the center of the catalyst bed, clearly show the layering of the reactor surface, together with some segregation of iron and aluminum. Those changes are also evident in the analysis given in fig. 14.

Whatever the mechanism of the corrosion, this study clearly demonstrates that Alonized 316 stainless steel is unsuitable for use in methane coupling service.

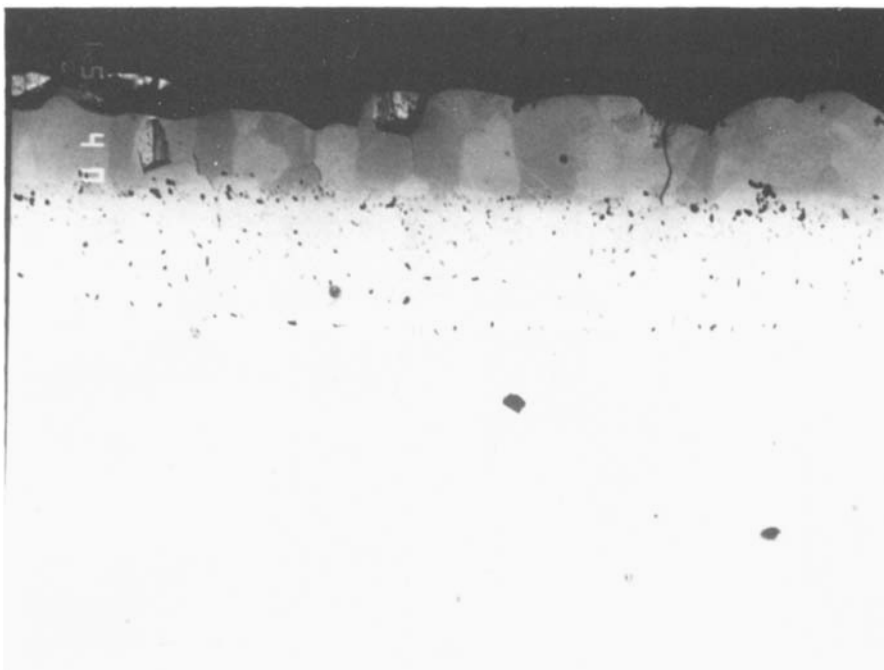
Fig. 7 is a backscatter electron image (BEI) of a cross-section of the tube wall in the region of the reactor above the catalyst bed. The brightness of an area in a backscatter image is proportional to the average atomic number of that area. Three distinct levels of brightness are visible in the photograph. The microprobe results graphed in fig. 8 reveal the differences in elemental distributions that cause the variation in the backscatter image. The darkest layer is the region approximately 30–40 micrometers thick where the aluminum concentration is highest and fairly constant. The medium-bright area just below this region is where the aluminum concentration starts decreasing to zero. This shifts the average atomic number of this region to a higher value and results in a brighter backscatter image. The brightest region of the image corresponds to the bulk stainless steel (non-Alonized) metal. Distribution profiles of the elements present are consistent with what is seen with a new reactor. An elemental X-ray dot map from this area is shown as fig. 9.

Fig. 7. Cross-section of PRC tube wall above the catalyst bed (backscatter image at  $400\times$ ).

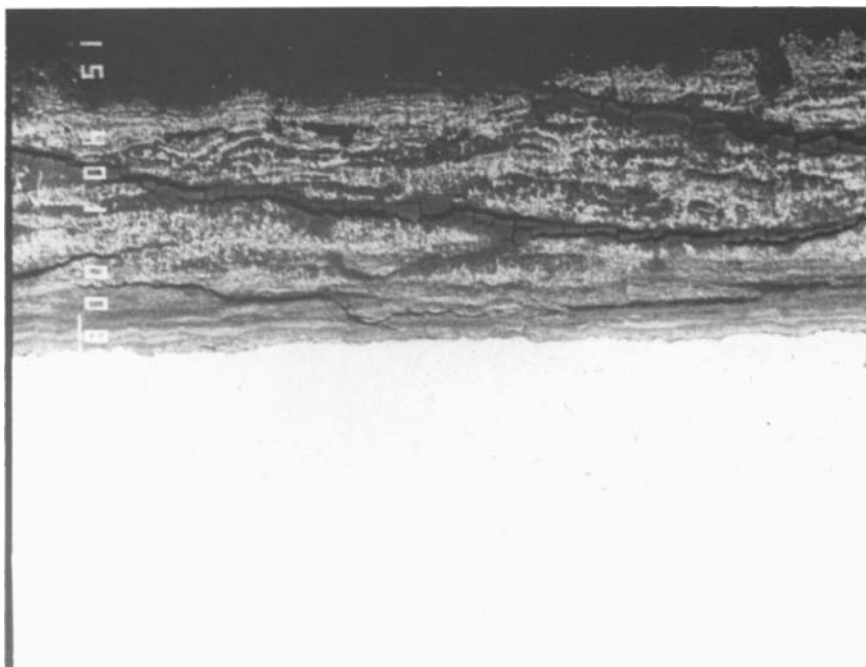
Fig. 10, taken in the region of green stain at the top of the catalyst bed, clearly shows development of layering. These layers are apparently composed of

Fig. 10. Cross-section of PRC tube wall in the region of the green stain (backscatter image at 400 $\times$ ).

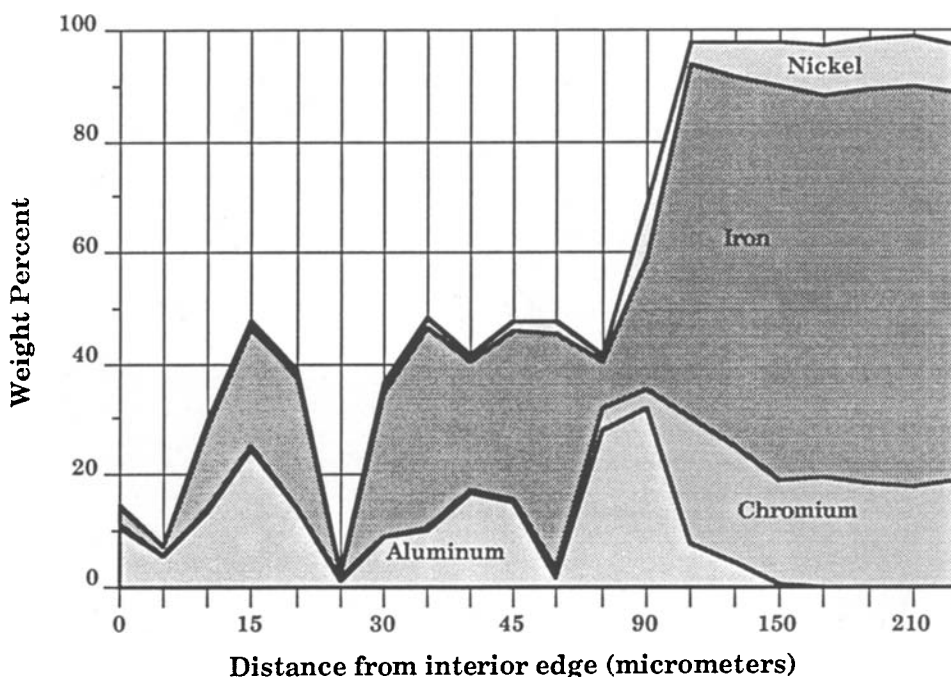
Fig. 11. Cross-sectional traverse of PRC tube wall in green stain area at the top of the catalyst bed.

the aluminum/iron alloy formed from the Alonizing process, as suggested in the dotmap (fig. 12) and in the analytical data of fig. 11. Although aluminum is still present at the surface, the surface is beginning to be significantly modified. Moreover, the level of chromium near the surface has decreased significantly. No one factor can be said to be responsible for the green stain.

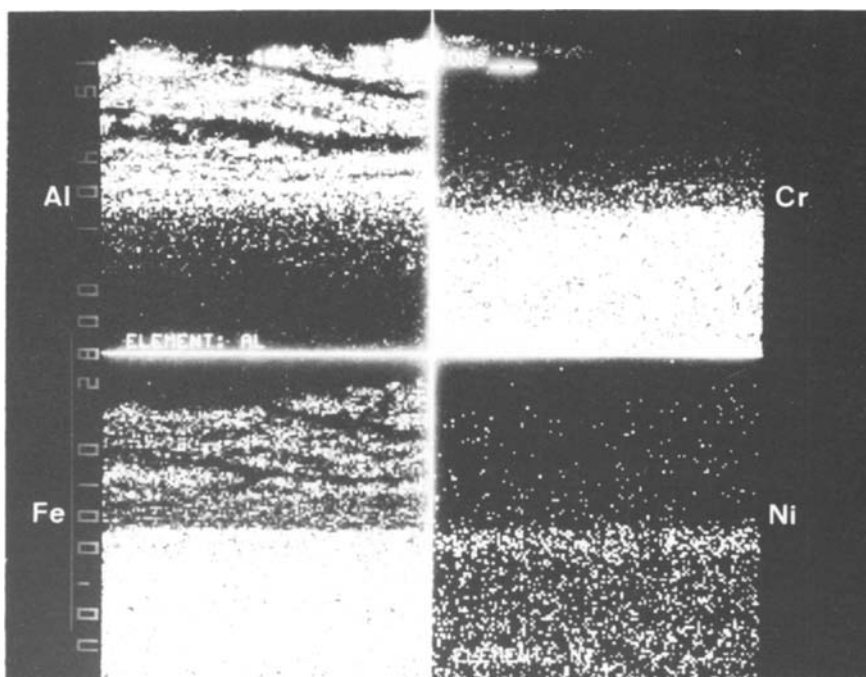
Fig. 12. Elemental dot maps of cross-section of PRC tube wall in the region of the green stain (400 $\times$ ).

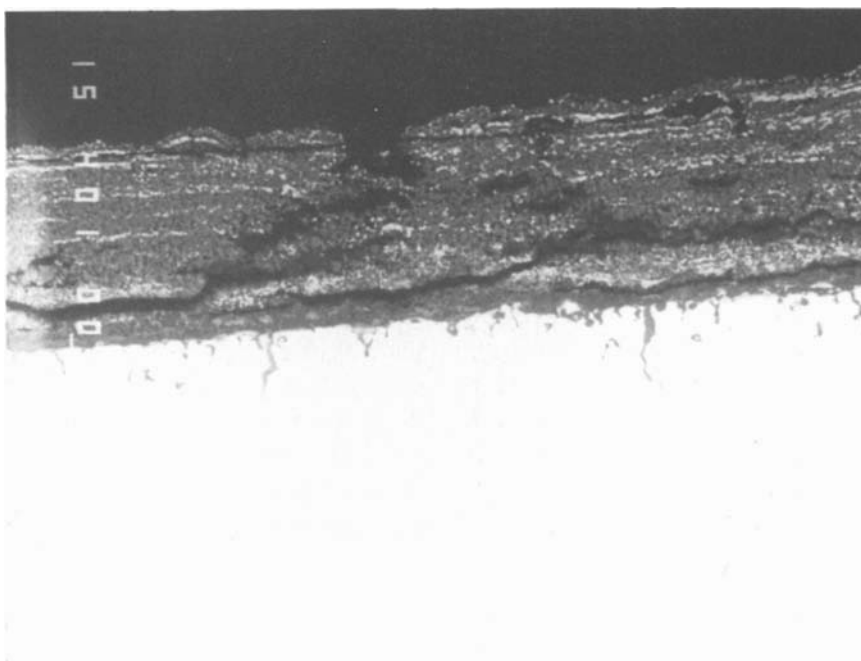
Fig. 13. Cross-section of PRC tube wall in the region of the catalyst bed (backscatter image at 400 $\times$ ).

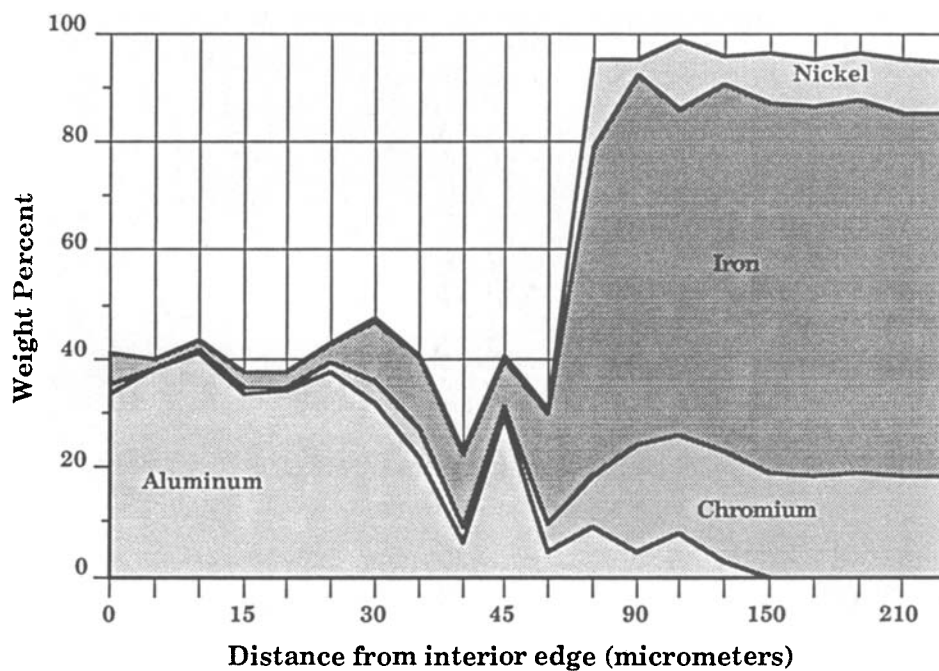
Fig. 14. Cross-sectional traverse of PRC tube wall in the middle of the catalyst bed.

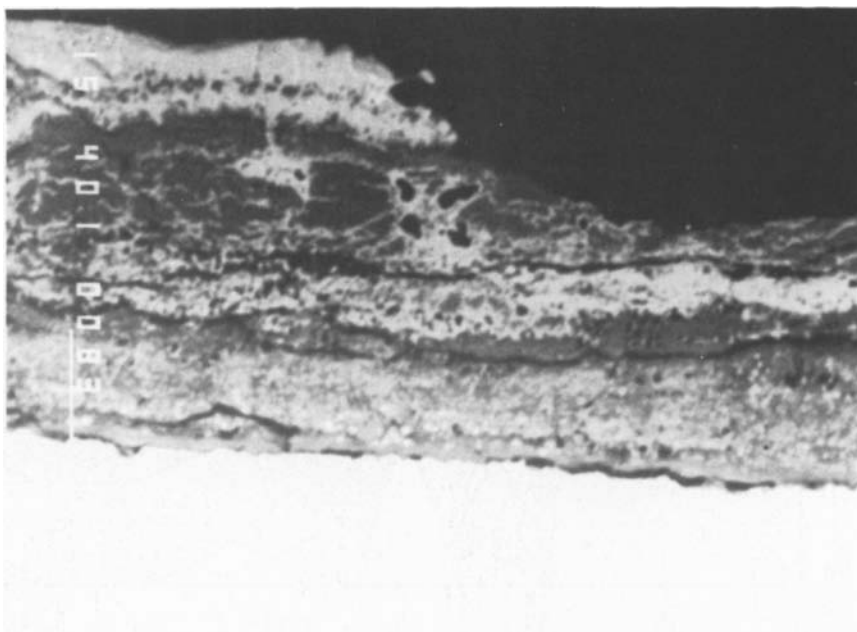
Fig. 16. Cross-section of PRC tube wall in the region of the white stain (backscatter image at  $400\times$ ).

data for the cross-sectional traverse of the tube in this area. The layering of iron is evident in the image, with the apparent loss of some of these layers. The data in fig. 17 collaborate the layering. No particular composition, however, can be assigned to the stain itself. The stain could be too thin to be analyzed by the electron beam, which has an analytical diameter of approximately one micrometer.

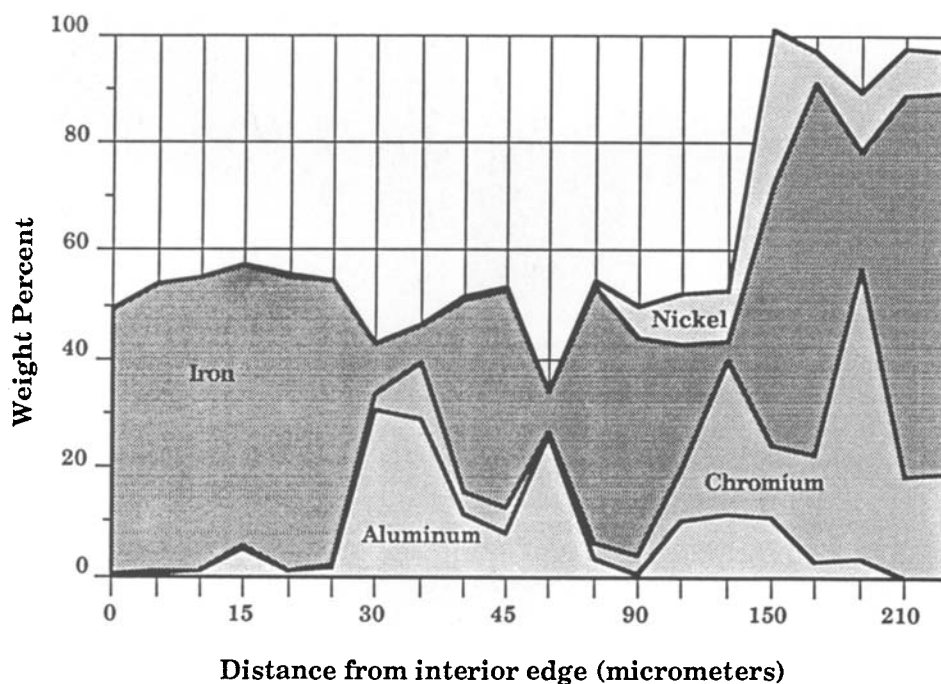
Fig. 17. Cross-sectional traverse of PRC tube wall in the white stain area at the bottom of the catalyst bed.

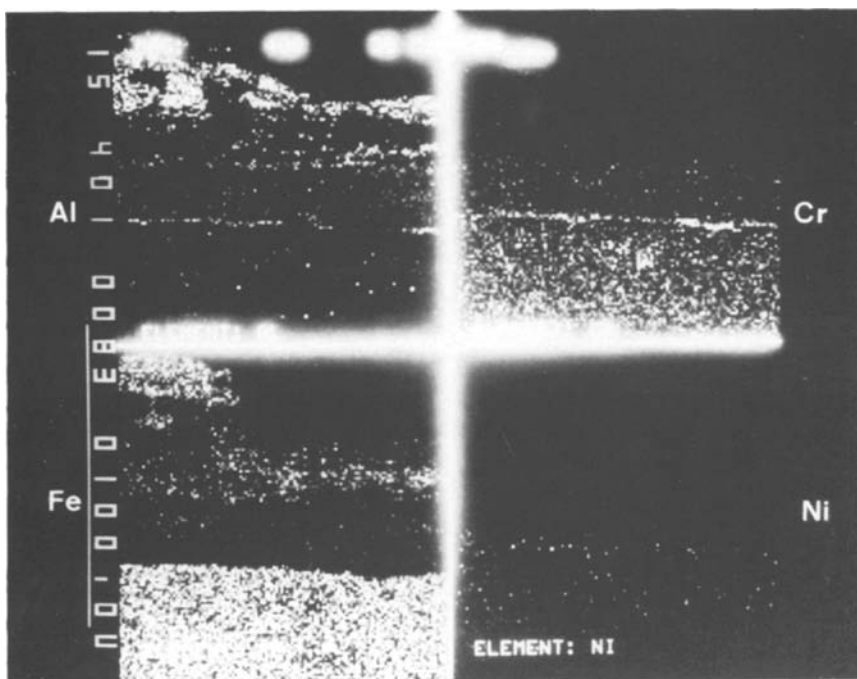
Figs. 16 and 18 are the backscatter image and dot map, respectively, of the white stained area at the bottom of the catalyst bed. Fig. 17 gives the analytical

Fig. 18. Elemental dot maps of cross-section of PRC tube wall in the region of the white stain (400 $\times$ ).

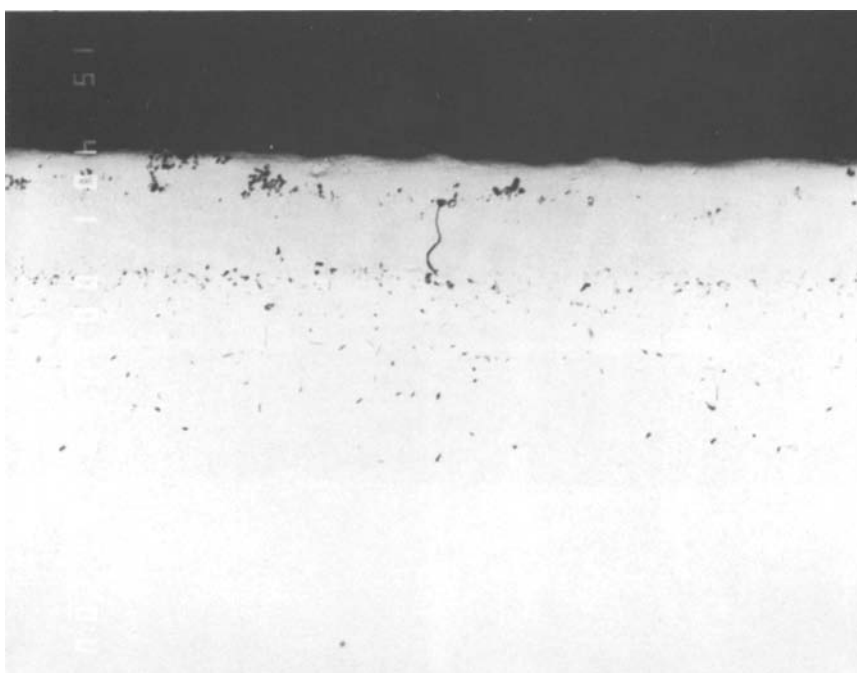
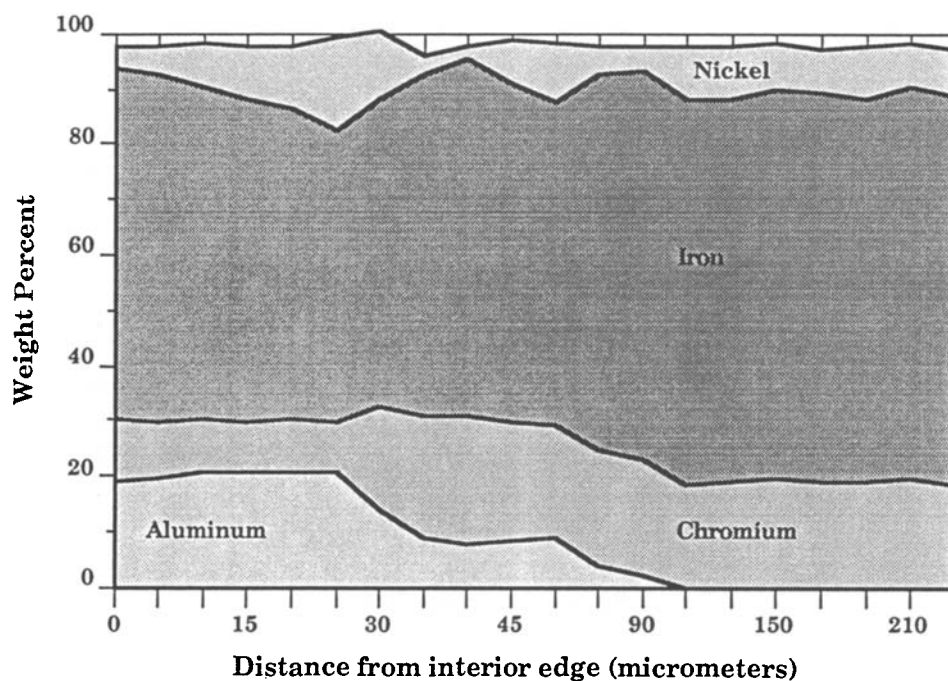
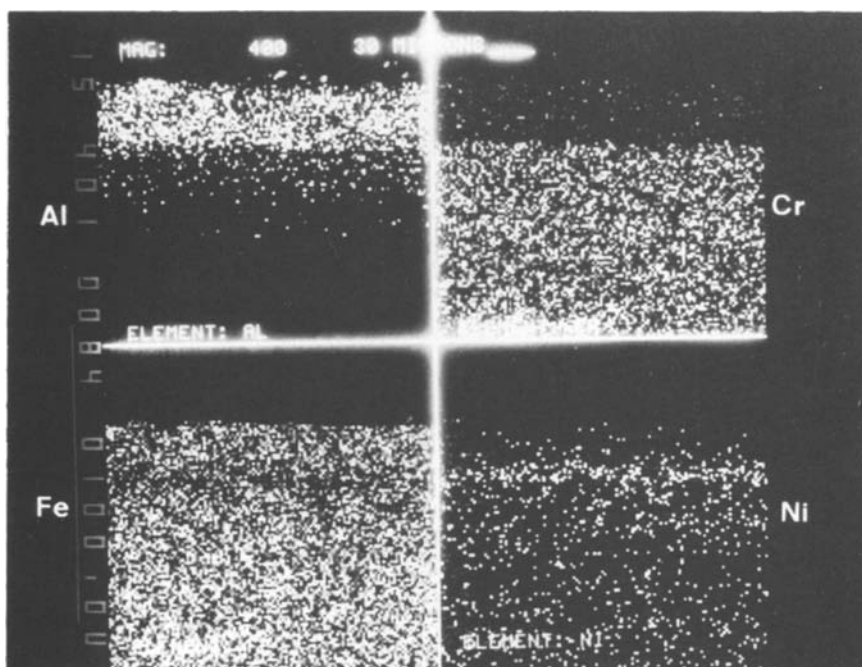
Figs. 19 and 21 are the photomicrograph and dot map of the slightly stained area below the bottom of the catalyst bed. Fig. 20 graphs the analytical data. The cross-section traverse looks identical to the traverse of the reactor wall above the catalyst bed. The difference seen by the naked eye must be due to lithium leached from the catalyst; lithium is too light to be observed by the electron microprobe.
