Interference at work: a case report of a malfunctioning insulin pump

Alexandra E. Reiher · Thomas A. Gallagher ·
Mary Ann Emanuele

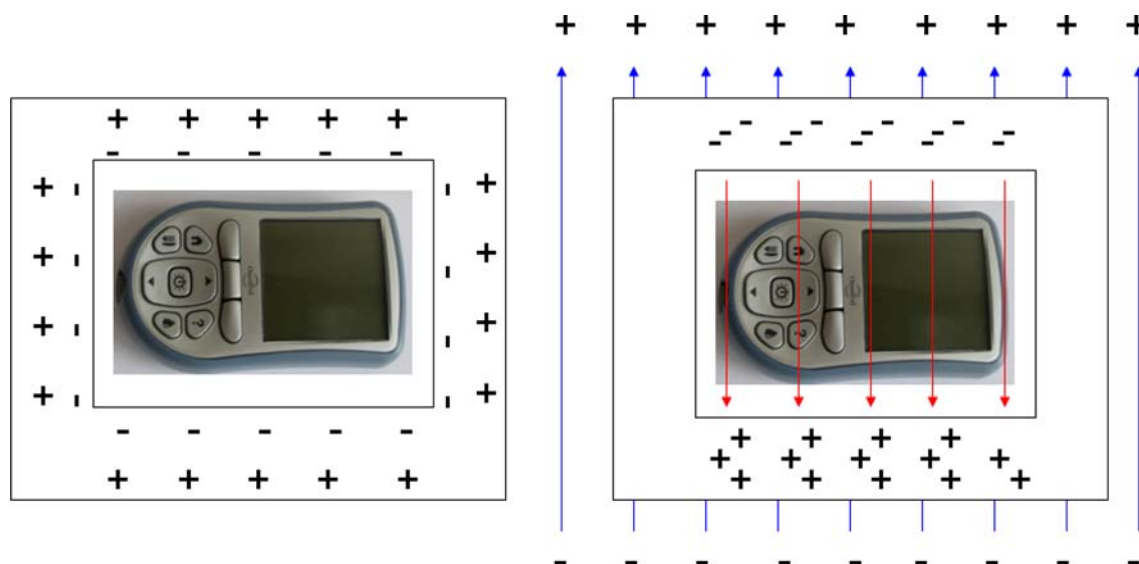
Fig. 1 Schematic representation of the Faraday cage for the PDM. In the absence of an external electric field (figure on left), a Faraday cage (depicted as rectangular boxes surrounding the PDM) has its charges arranged symmetrically and no current flows within the aluminum. In the presence of an external electric field (or electromagnetic interference) (right, depicted by blue arrows), electrons within the

aluminum Faraday cage flow toward the positive end of the field leaving positive charges at the negative end of the field. In doing so, the new configuration of charges within the aluminum have set up their own electric field (red arrows) that precisely opposes the external field. The net electric field experienced by the PDM inside the Faraday cage is zero

The homemade Faraday cage instantly resolved her problems. However, the patient needed to keep her PDM wrapped in aluminum foil while at work, and *unwrap* the PDM for a bolus or when using the PDM as a glucometer. It was important to do this in an area “safe” from presumed external interference. Although a culprit source of potential EMI was not identified, it may have been related to the recent construction project at her hospital, or other devices brought into or around the hospital (radio transmitters, etc). *The following 4 month period has been uneventful with no*
