CASE REPORT

An Explosion of a CNG Fuel Vessel in an Urban Bus

ABSTRACT: An investigation is presented of the explosion of a CNG (compressed natural gas) fuel vessel, called a liner, in an urban bus. The explosion happened at a gas station 10 min after filling was completed. There were no traces of soot and flames at the failed liner, which would be indicative of explosion by ignition of the gas. The filling process of the station was automatically monitored and recorded in a computer. There was no unusual record of the filling system that indicated excess pressure at the time of the accident. There were cracks on the liner that were initiated at the outer surface of the cylindrical shell located at a point 4 cm above the lower dome where cracks did not originate easily as a result of overload. Chemical analysis was performed on a specimen that was cut from the liner, and there was no peculiarity in the mix. Mechanical analysis was performed on the specimens and showed that the hardness was not in the specified range because of inadequate heat treatment of the metal. The hardness of the liner was strictly controlled in the manufacturing process. All the liners that were manufactur

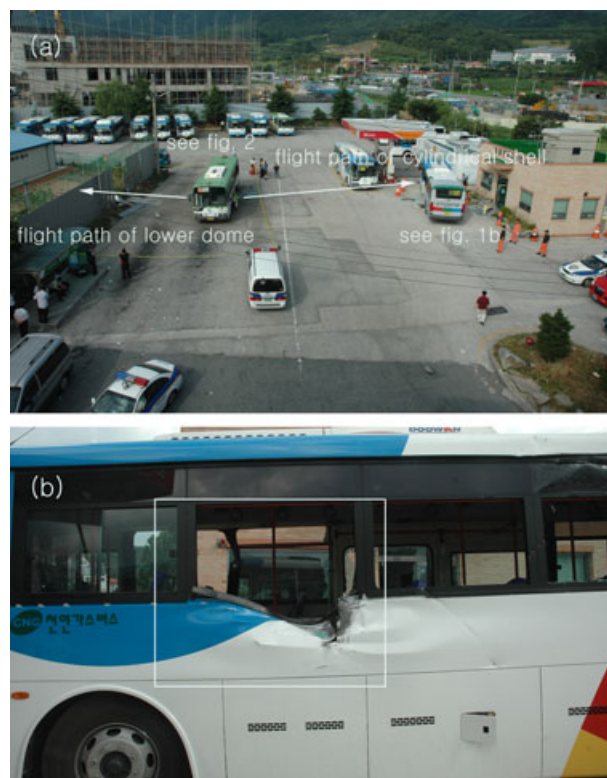
FIG. 1—(a) The gas station where the accident took place. Arrows indicate the flight path of a cylindrical shell and a lower dome. (b) The damage to the bus that was parked beside the bus that featured the explosion. The quadrangle indicates the trace where the cylindrical shell went through this adjacent bus.

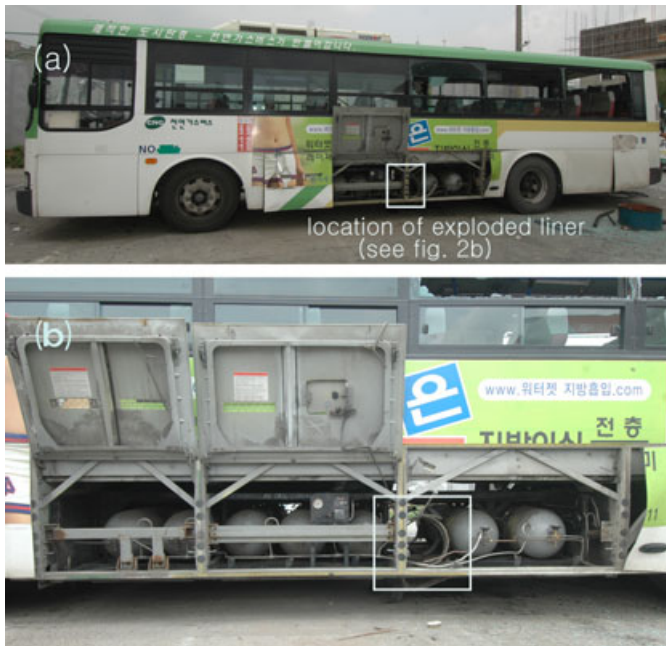
FIG. 2—The location of liners. The bus had a total of eight liners that were tied with parallel pipe lines. The liner that was the sixth from the front side of the bus had exploded.

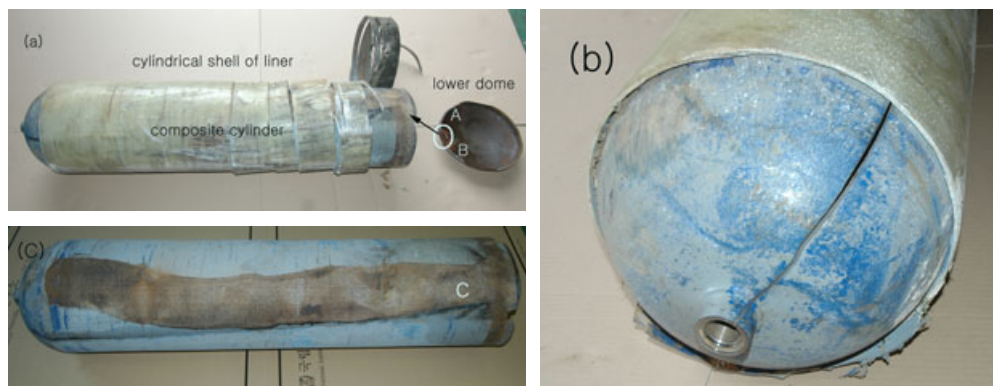
FIG. 3—(a) The exploded liner. The lower dome was completely blown off from the cylindrical shell along the circumference. The circle indicates the location where chevron patterns converge (refer to Fig. 5a). The fractured surfaces of A and B are shown in Fig. 4a,b. (b) The inlet nozzle of the exploded liner. A longitudinal crack was developed. (c) The cylindrical shell of the liner. Severe corrosion developed along the longitudinal direction and the circumference. The fractured surface of point C is shown in Fig. 4a.

composite cylinder was removed from the cylindrical shell, a longitudinal crack was seen that developed in the inlet nozzle. Severe corrosion also developed along the longitudinal direction and the circumference near the lower dome.

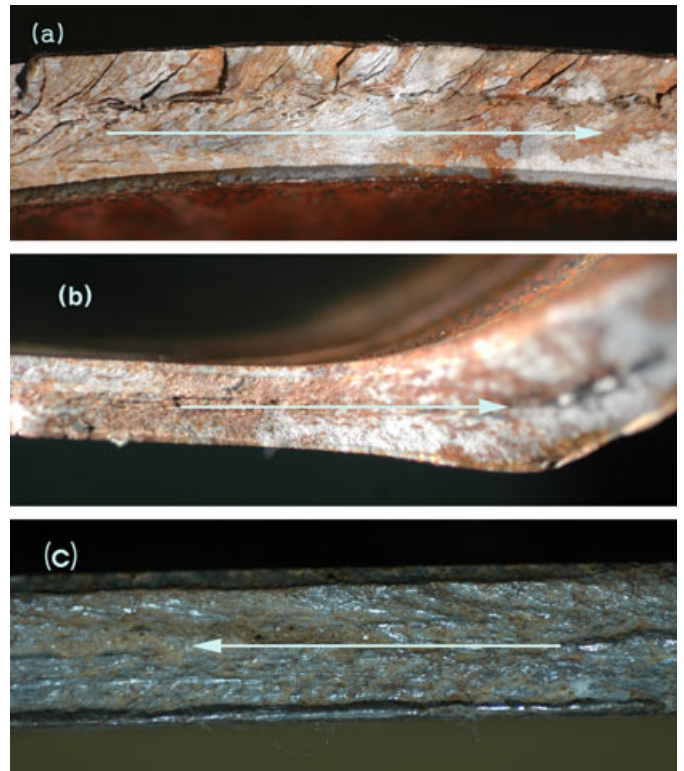
FIG. 4—(a) The fractured surfaces of the lower dome (refer to point A in Fig. 3a). Chevron patterns are clearly visible. The arrow indicates the direction of crack propagation. (b) The fractured surfaces of the lower dome (refer to point B in Fig. 3a). Chevron patterns are clearly visible. The arrow indicates the direction of crack propagation. (c) The fractured surfaces of the cylindrical shell (refer to point C in Fig. 3c). Chevron patterns are clearly visible. The arrow indicates the direction of crack propagation.

of the gas. The fractured surfaces of the lower dome and cylindrical shell are shown in Fig. 4. Chevron patterns, which indicate the direction of the crack propagation, were clearly visible in the fractured surface (2,3). There was no beach mark that would have indicated fatigue fracture (2,3). From the chevron patterns, it can be concluded that the crack in the cylindrical shell initiated at a

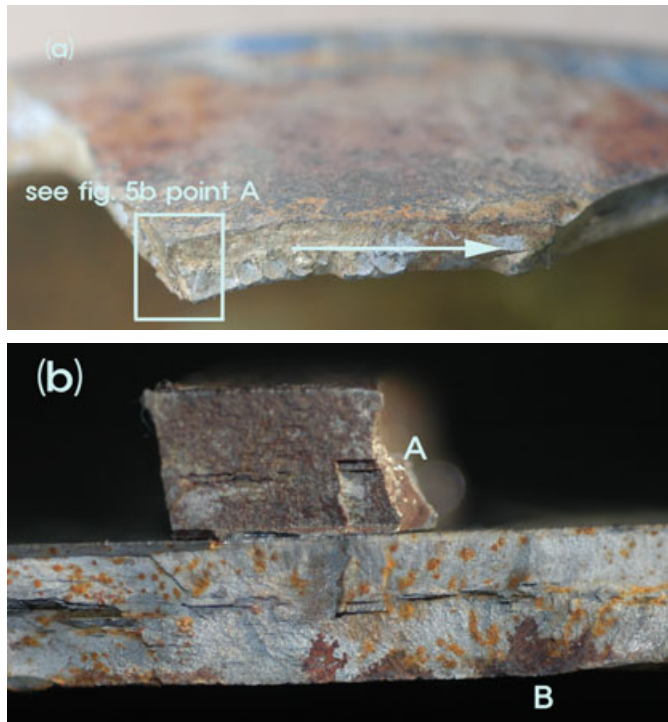
FIG. 5—(a) Magnification of the location where the chevron patterns converge (refer to the circle in Fig. 3a). The arrow indicates the direction of crack propagation and the counterparts of the fractured surfaces are shown in Fig. 5b. (b) The counterparts of the fractured surface shown in Fig. 5a. Point A indicates the location, which is shown as a quadrangle in Fig. 5a. Point B indicates the crack origin. The crack is initiated not at the inner surface but at the outer surface, which is severely corroded.

point 4 cm above the lower dome. From a microscopic examination, we concluded that the crack was initiated not at the inner surface but at the outer surface that was severely corroded. Figure 5 shows the location of the crack initiation (point B). Figure 6 shows the scanning electron microscope (SEM) fractograph of the crack-initiation point (arrow). Unfortunately, the crack-initiation point was severely damaged by erosion, etc. Hence, a detailed examination was not possible. In general, when the liner is over-filled, that is, over-pressured, it commonly fails at the boundary between the cylindrical shell and the lower dome. The investigated crack-initiation point was not the place where a crack originates easily as a result of overload. The manufacturing specification of the liner showed that the liner was made of 34CrMo4 with a DDI process that was followed by several steps of heat treatment. Chemical analysis was performed through an emission spectrometer on a specimen that was cut from the liner. Table 1 shows the specified chemical composition of 34CrMo4 with the results of the chemical analysis. There was no peculiarity in the mix. Analysis of the mechanical properties, including hardness measurements, was carried out on the four specimens that were cut by a water jet from the cylindrical shell. Table 2 shows the specified yield strength and the hardness with the results of the analysis of the mechanical properties. The measured hardness showed that the hardness of the liner was not in the specified range, which indicated that the liner was poorly heat-treated. The hardness of the liner was strictly controlled in the manufacturing process to prevent the possibility of brittle fracture, etc. All the liners that were manufactured at the same period as the failed liner were recalled for examination.

From these results, we reached the conclusion that poor heat treatment during the manufacturing process was a major cause of the failed liner. Considering that the crack started at the severely corroded outer surface, which was not permitted in the specification, severe surface corrosion also acted as an additional cause of the failed liner.

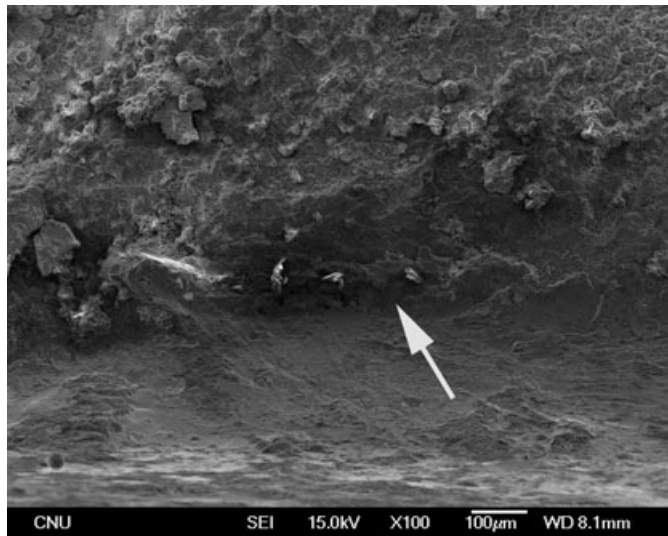
FIG. 6—SEM fractograph at $100\times$. The crack-initiation point (arrow) is severely damaged by erosion, etc.
