Explosion caused by flashing liquid in a process vessel

Russell A. Ogle*, Marcus V. Megerle, Delmar R. Morrison III, Andrew R. Carpenter

Exponent Failure Analysis Associates, 185 Hansen Court, Suite 100, Wood Dale, IL 60191, USA

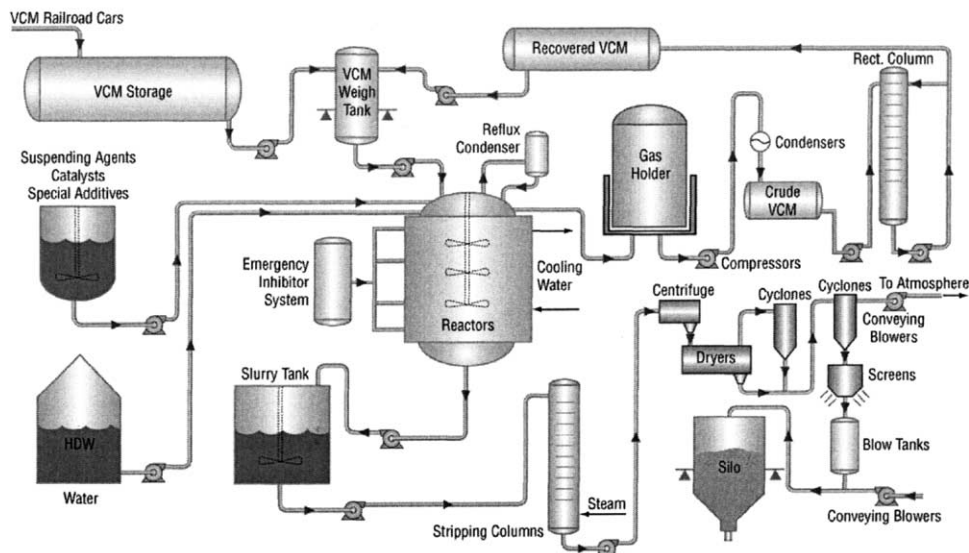
Fig. 1. Block flow diagram.

degree of conversion typically achieved in about 3–5 h. The product was a milky-white slurry of PVC resin particles in water. The product slurry was pressurized due to the presence of both unreacted VCM and water vapor. The vapor was vented to the primary gasholder (PGH) to relieve the reactor pressure. VCM was recycled from the PGH for reuse in the process. Residual VCM was removed from the product slurry by steam stripping. The stripped slurry was then centrifuged, dried and stored in silos for eventual loading and shipment. Fig. 1 is a block flow diagram of the process.

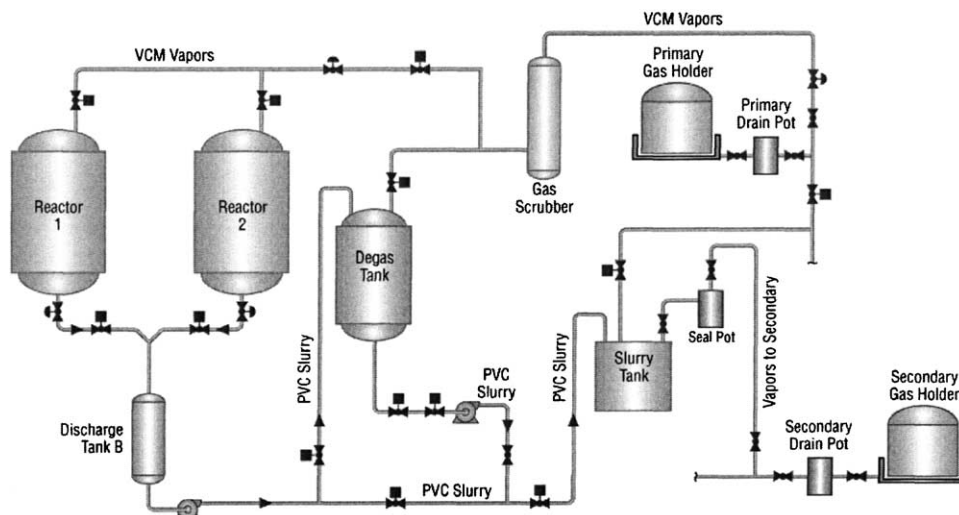
Fig. 2. Piping and equipment diagram for Reactor Discharge Operation.

The basic configuration of the equipment and piping is shown in Fig. 2.

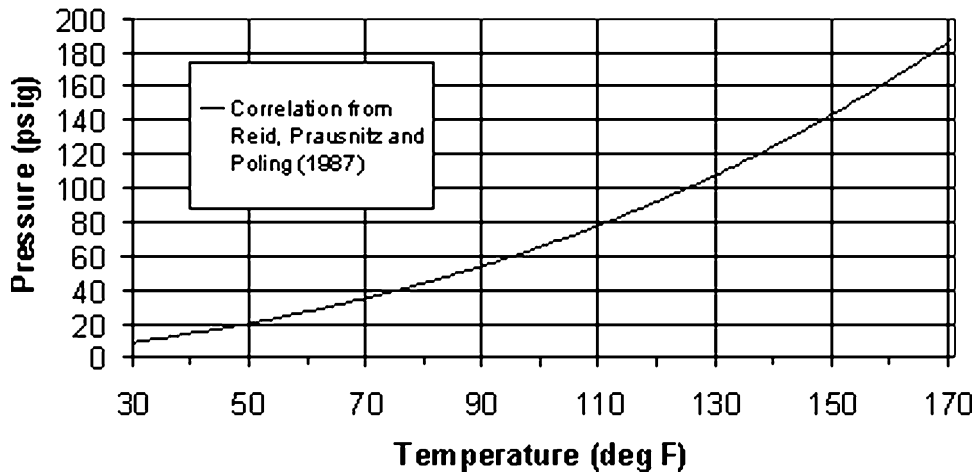
Fig. 3. Vapour pressure curve.

The expansion behavior of the VCM vapor depends on whether any liquid VCM is present. If no liquid is present, the pressure of VCM vapor can be treated as a nearly ideal gas over the pressure and temperature range of interest. If liquid VCM is present, the pressure of the system is determined by the VCM vapor pressure curve, a graph of which is shown below (Fig. 3) [5].

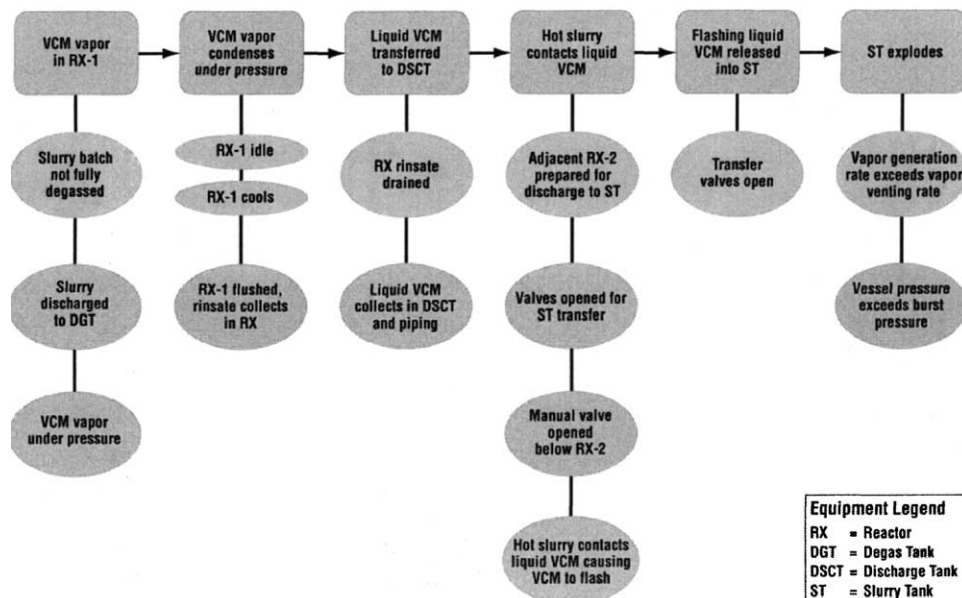
Fig. 4. Event and causal factors chart for Process Vessel Explosion.

The subject facility had operated for over 20 years and had produced on the order of 100,000 batches of product. Why did this particular batch cause an explosion? The answer, documented in the process data, was a series of small changes from the normal operating conditions. The sequence of events and causal factors are summarized in Fig. 4.

During this time Reactor 2 was charged, reacted and degassed. The appropriate valves were selected for a transfer from Reactor 2 of hot slurry (at approximately 190 °F) to the slurry tank. When the drain valve for Reactor 2 was opened, the hot slurry contacted the cold VCM liquid in the discharge tank/piping and caused it to flash abruptly. This flashing two-phase flow caused a rapid generation of vapor that exceeded the venting capacity of the slurry tank. The

internal pressure of the slurry tank exceeded its burst pressure and the tank ruptured.
