Failure Analysis of Beta-C Titanium Alloy High-Pressure Vessels

G.J. Feng, J.D. Rossi, and M.T. Gerusky

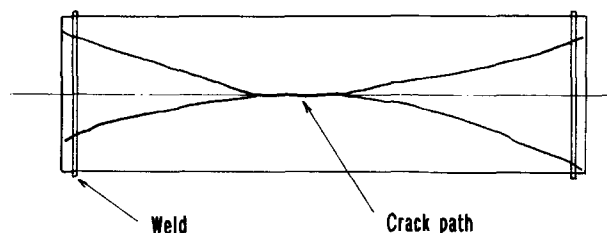
Figure 1 is a schematic illustration of the high-pressure vessel, which is a seamless tube with welds at either end in the circumferential directions. The investigation was conducted on two identical vessels—vessel 1, which failed at 94% proof pressure, and vessel 2, which was loaded to the proof pressure without fracture then uploaded until a burst occurred. The broken vessels were reassembled to map the fracture path and determine the origin of cracking. The crack paths of the two vessels were almost identical, and it consisted of a straight fracture of 200 mm long in the middle of the tube and followed by two separate fracture paths running at 45° through the base material to the welds at either end. One hypothesis was that the fracture may have originated from the weld. The fracture path as described above (see Fig. 1) is inconsistent with this hypothesis in that it indicates that fracture began in the center of the vessel at some point along the straight fracture area. A thorough examination of the fracture surface confirmed this fact. At the weld locations, the crack passed through the weld but never followed the fusion line or the heat-affected zone. No evidence of weld/parent metal separation was observed. Most importantly, a small semi-elliptical surface crack was found on the outer diameter of pressure vessel 1 (failed hydrotesting) in the straight fracture region. The crack measured 6.1 mm in length and had a maximum depth of 0.76 mm. Fracture surface examination using scanning electron microscopy (SEM) revealed that the fracture mode throughout the entire region defined by the semi-elliptical boundary was dominated by intergranular

Fig. 1 Schematic of the pressure vessel and its fracture paths.

The stress in Z direction, σ_z , is only one half of the stress in the hoop direction, σ_θ . σ_r is a small compressive stress that had no effect on the cracking of the vessels. The welds at either end are only subjected to one half of the stress applied on the wall of the tube in the hoop direction. This is consistent with the fracture examination that determined the crack was not from the welds. The stress in the hoop direction will reach a maximum value in the middle section of the vessels because less constraint is received from the end seals. Because the maximum stress is in the center section, any pre-existing flaw could be expected to nucleate a crack that would form along a relatively straight path in the longitudinal direction of the vessel. When the crack was propagated to certain length, shear deformation occurred, which created fracture paths 45° to the principal stress (hoop) direction. These shear crack paths are described in Fig. 1.

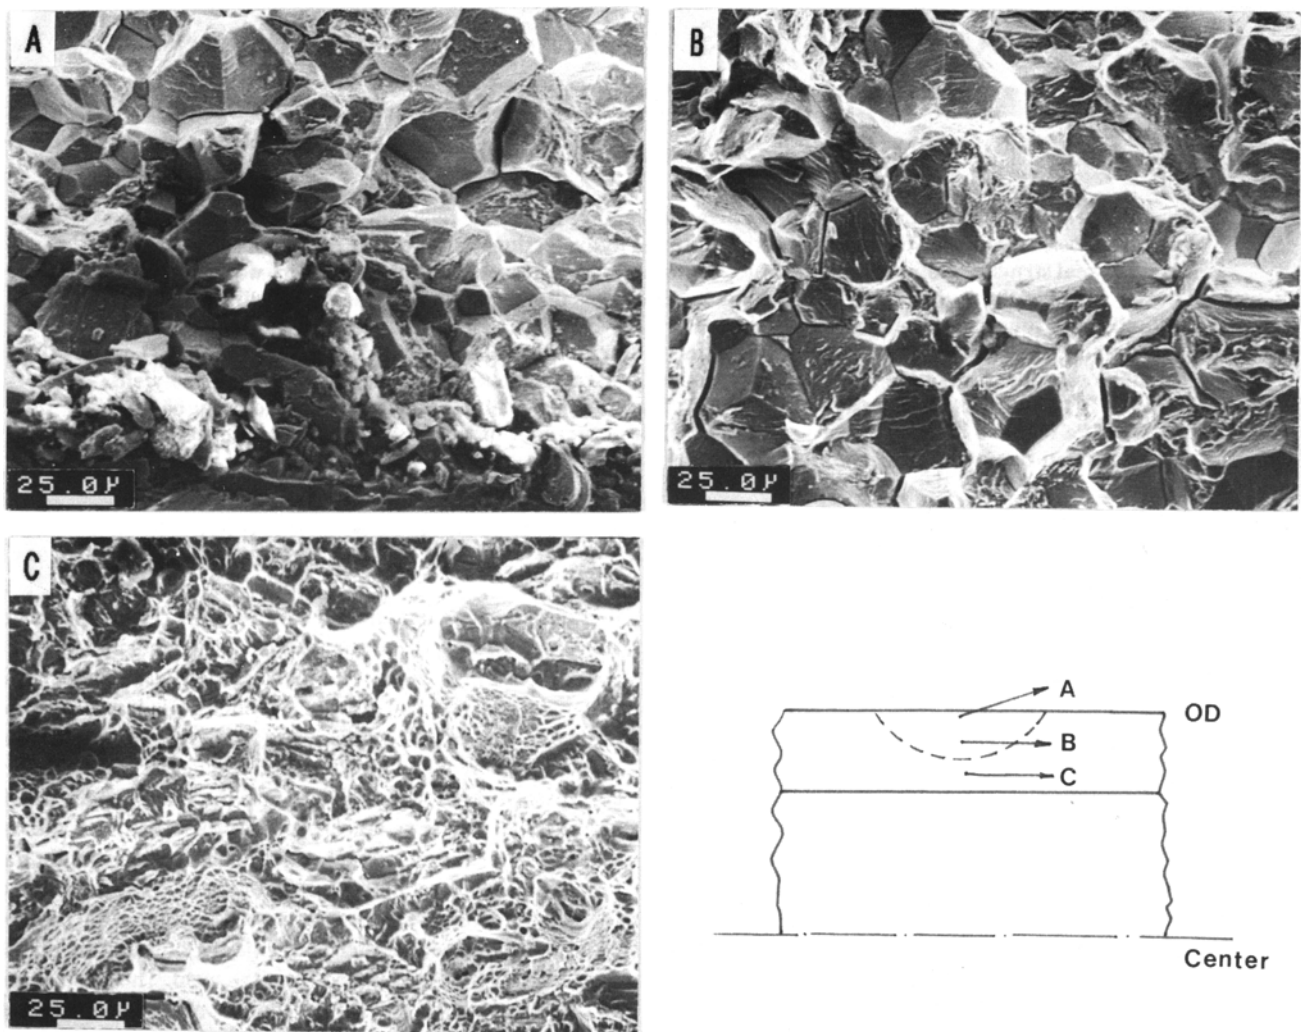
Fig. 2 SEM fracture surface exhibited a semi-elliptical crack region on vessel 1. The arrows indicate the locations of the observation.

cracks, and the fracture surface beyond this region was characterized by a primarily dimple type of ductile fracture. The SEM photographs of the fracture surface are shown in Fig. 2. The semi-elliptical intergranular crack region was associated with voids (see the black area in Fig. 2a), which are 25 to 50 μm from the outer diameter surface of the tube. Several such imperfections can be detected near the outer diameter surface within the intergranular crack region. In contrast to the vessel 1, the fracture surface of the vessel 2 which passed hydrotest presents a ductile fracture mode, as shown in Fig. 3. With the crack nucleation site clearly defined in the center of the vessel, a question arose as to whether this failure was some sort of anomaly, or could a non-through crack flaw with the observed dimensions consistently cause a brittle failure with this type of material under the service conditions? This question was all the more important considering the fact that the whole vessel was not undergoing NDT inspection, only the weldments. To answer this question, a stress and fracture toughness analysis was performed.

The brittle fracture of the high-pressure vessel that occurred during hydrotesting was caused by a surface defect. A complete intergranular fracture was observed in the area of the crack origin while the surrounding area exhibited microvoid coalescence. The presence of intergranular cracking in a localized area significantly reduced fracture toughness and led to a catastrophic fracture.

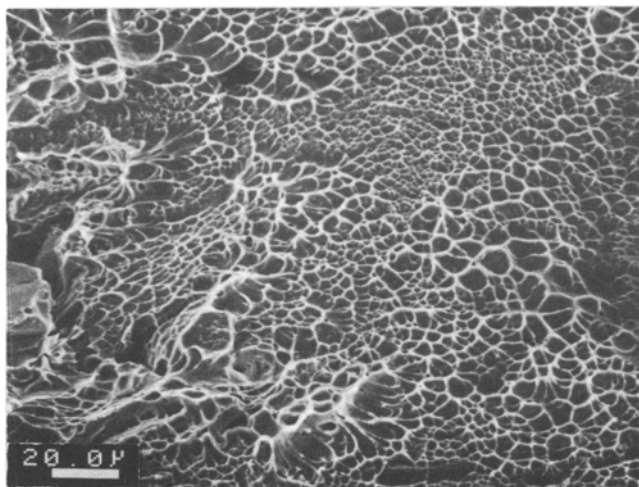
Fig. 3 SEM fracture surface of vessel 2 exhibiting a ductile fracture.

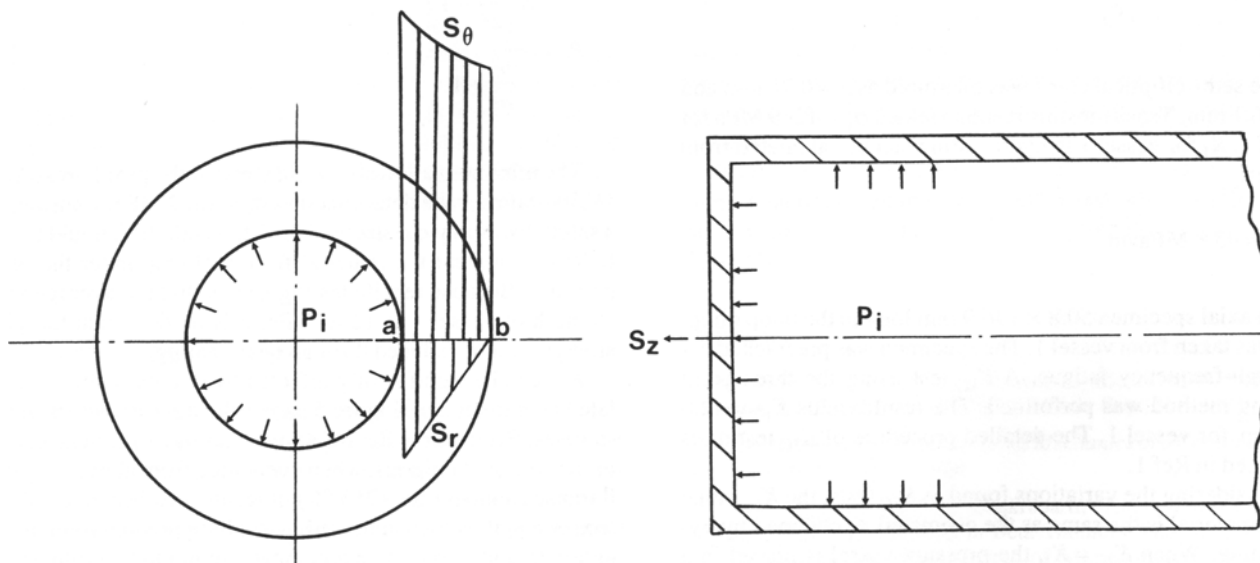
The stress distribution in the wall of the tube is shown in Fig. 4. If the pressure at which vessel 1 failed is taken into the calculation:

Fig. 4 Schematic of stress distributions on the pressure vessel.

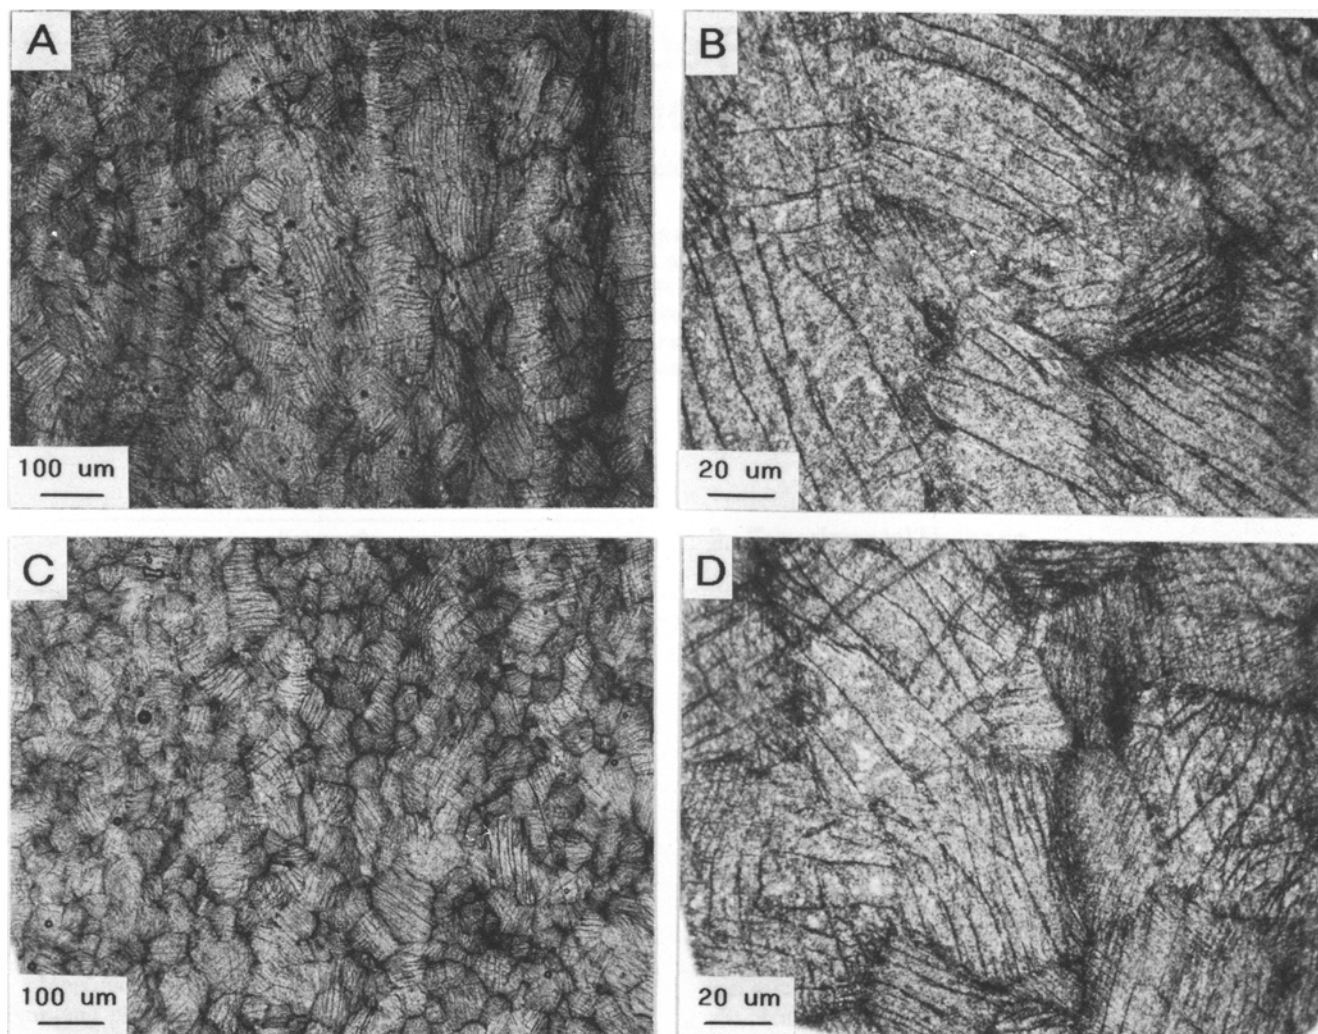
K_{IC} can be significantly affected by microstructure and related heat treatment. Figure 5 shows the microstructure of two samples. Because the Beta-C alloy contains a sufficient amount of beta phase stabilizers, when quenching from above the $\beta/\alpha + \beta$ transus temperature (755 °C), it results in a bcc lattice β matrix. Strength is then achieved by α phase precipitation during aging. In both samples, α precipitates exhibited a Widmanstätten structure, which consists of groups of α phase needles lying with their long axes parallel to crystalline planes of β matrix.

Fig. 5 Microstructure of the Beta-C titanium alloy. (a) and (b) From vessel 1. (c) and (d) From vessel 2.

Other types of α precipitates are very finely dispersed particles, which cannot be clearly distinguished by optical microscopy. These fine precipitates appear to be type 2 α precipitates. It was found that the β matrix of vessel 1 in some regions exhibited a duplex grain structure, whereas vessel 2 exhibited a uniform β grain structure. The duplex grain structure may reflect localized nonuniform deformation, which may have occurred during thermomechanical processing during fabrication of the vessel.^[3]

To avoid brittle fracture under the observed service conditions, heat treatment must be modified so as to increase toughness while maintaining a minimum yield strength of 1150 to 1200 MPa.
