Influence of Joining on the Fatigue and Fracture Behavior of High Density Polyethylene Pipe

H. Chen, R.J. Scavuzzo, and T.S. Srivatsan

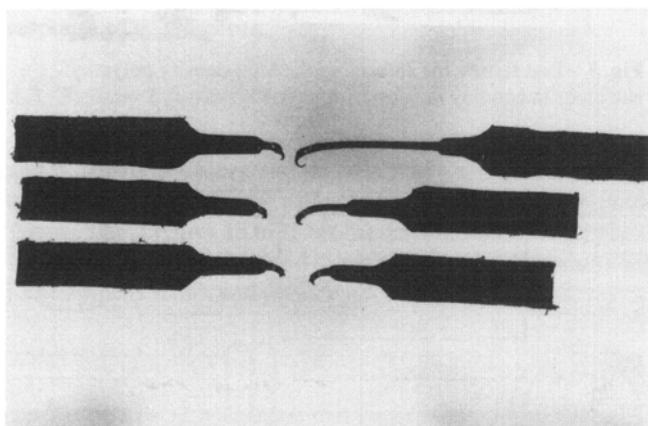
Figures 2-4 show failure of the pipe specimens. For test specimens of the plain unwelded pipe necking, failure occurred at different locations along the gage section (Fig. 2).

Fig. 2 Failure locations for the tensile test specimens of the plain unwelded pipe

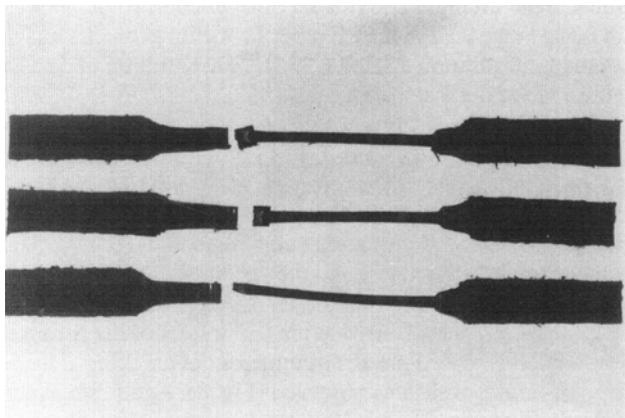
Fig. 3 Failure locations for the tensile specimens of the butt-fusion joined pipe

Failure of the B/F joined specimens almost always occurred at the fusion zone (Fig. 3). Macroscopic and microscopic observations revealed features reminiscent of local ductile failure. Failure of the E/F joined specimens occurred at the location of the fusion joint (Fig. 4). Failure of this specimen revealed distinct similarity to the plain unwelded counterpart. The conformity suggests a similarity in the yield strength (σ_{ys}) and elongation-to-failure (ϵ_f) of the E/F and the plain unwelded test specimens, with only a marginal difference in ultimate tensile strength (σ_{UTS}). The stress-strain response of the E/F specimen is distinctly different. The yield strength, ultimate tensile strength, and elongation-to-failure are inferior to the

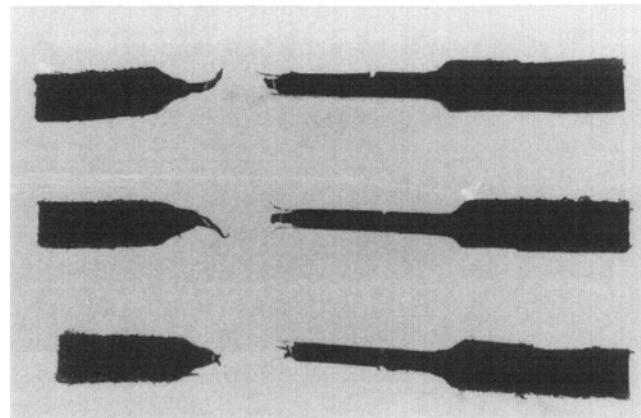
Fig. 4 Failure location for the tensile specimens of the electro-fusion joined pipes

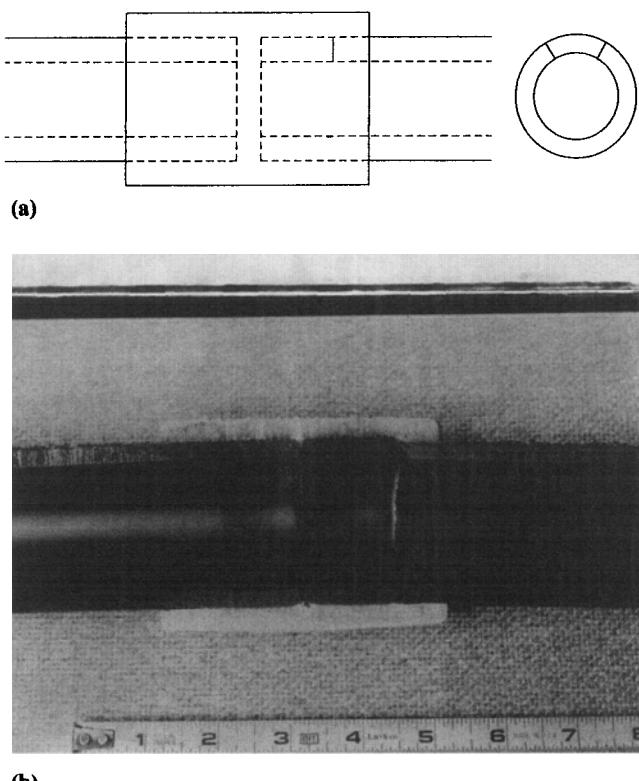
For the E/F joined pipes, failure was localized at the edge of the fusion joint (Fig. 6a, b). The failure mode for this type of pipe specimen was consistent with the joint characteristics. As shown in Fig. 7, two pieces of HDPE pipe were joined by an E/F coupler with a thicker wall than that of the pipe and thus, a larger section modulus. This design assures that failure will be located on either piece of the joined pipes rather than on the coupler itself. Only the central section of the coupler was joined to the PE pipe. The end-sections of the E/F coupler were not fused to the wall of the PE pipe. This joint geometry and resultant configuration caused a stress concentration to develop at the edge of the fused area.

Fig. 6 (a) Schematic showing the failure location for the electro-fusion joined pipe. (b) Actual failure location for the electro-fusion joined pipe

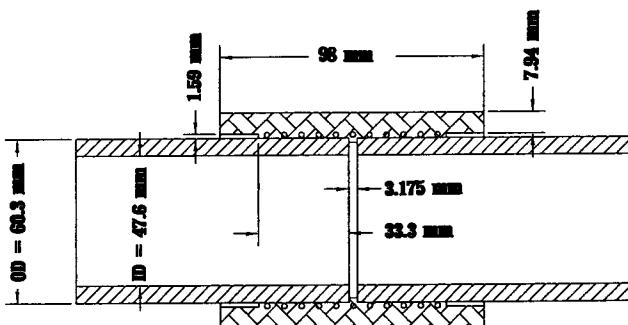
Fig. 7 Schematic showing layout of the electro-fusion joint

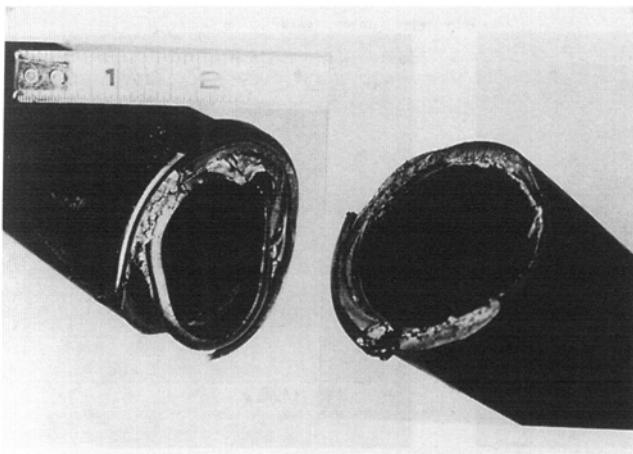
Three B/F joined PE pipes were deformed at displacement amplitudes of 89 mm (3.5 in.), 114 mm (4.5 in.), and 122 mm (4.8 in.). For the specimen deformed at 89 mm (3.5 in.) amplitude, the test was stopped after 35,090 cycles. The test specimen deformed at a displacement amplitude of 114 mm (4.5 in.) failed after 28,183 cycles, and the specimen subjected to 122 mm (4.8 in.) amplitude failed after 10,987 cycles. Failure for all three specimens occurred at the B/F joint. For the deformed and failed B/F joined pipes, circumferential cracking at the region of the butt-weld was observed (Fig. 8). Again, stress concentration occurs in this region. For the pipe specimen subjected to 112 mm (4.8 in.) actuator amplitude, the cracks initiated at the outer weld bead on the pipe bore (Fig. 9) and

propagated through the heat-affected zone (HAZ) and onto the internal weld bead notch prior to catastrophic failure. The cracks traversed completely through the HAZ. However, there was little or no tendency for the crack to move along either the boundary of the HAZ or the center of the B/F joint. For one specimen, which failed earlier than expected, the circumferential cracks initiated at the notch on the inner weld bead and propagated rapidly through the pipe wall adjacent to the HAZ rather than traversing through it.

Fig. 9 Actual failure morphology of the butt-fusion joined pipe

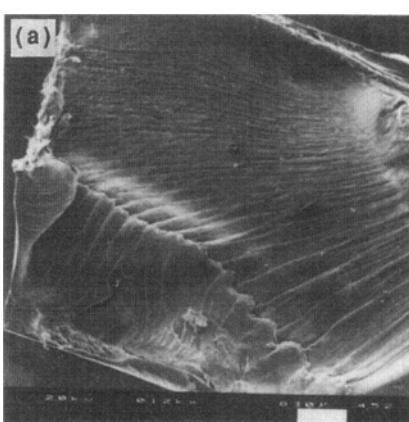
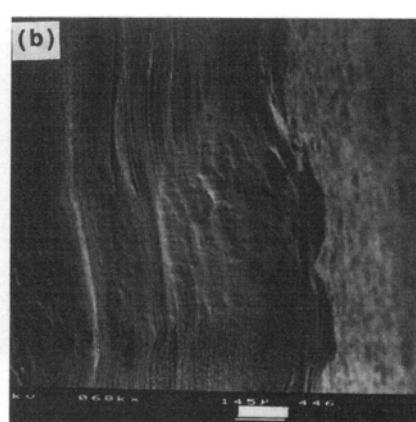
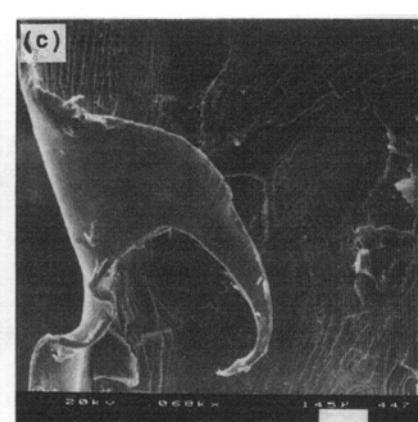
Figure 13(a) is an overall view showing the failure surface (transverse section of the crack) of the unpressurized E/F joined pipe. This micrograph reveals the presence of distinct striationlike features at and near the outer surface of the failed pipe. These striations were long and regularly spaced, while those at and near the inner surface were short and irregularly spaced. Also, the striations at and near the outer surface were parallel with the plane of the pipe surface. Figure 13(b) and (c) show the outer and inner surfaces of the failed E/F pipe. The outer surface also revealed the presence of many short and irregularly spaced striations positioned perpendicular to the pipe surface. The distinct lines on the fracture surface, which were orthogonal to the propagation of the crack, were the end result of an arrested crack front. During the early stages of crack propagation, the outer surface was macroscopically flat with many arrest lines (features indicative of brittle failure). The arrest lines and the associated propagation bands display a structure similar to the other arrest lines and bands. High magnification observations revealed the macroscopically flat propagation band to be microscopically rough. However, the surface of the band becomes progressively smooth. The change in microscopic fracture surface features is repetitive in each

propagation band. The distinct difference between the bands is an increased band width coupled with orientation relative to the pipe surface. Continued propagation of the crack resulted in a rough fracture surface. The transition in fracture surface topography is indicative of a change in microscopic fracture mechanism from ductile to brittle. The inner fracture surface revealed short and irregular striations on the face and pipe threads at the fringes. The threads were a result of the pipe being torn at the end of the failure process.

Fig. 13 Scanning electron micrographs of the deformed and failed unpressurized electro-fusion (E/F) joined pipe showing (a) an overall morphology of the failure surface, (b) the outer surface, and (c) the inner surface

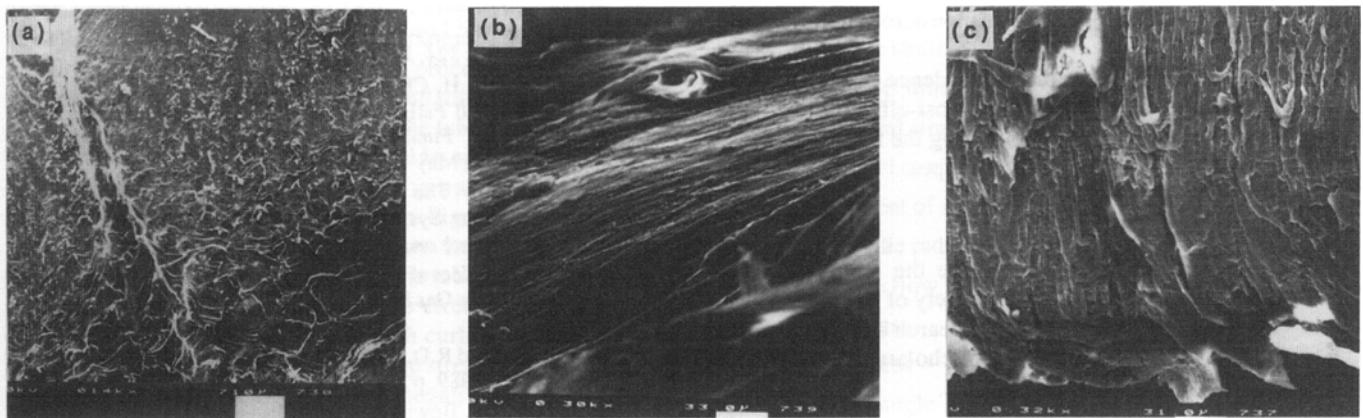
Figure 14 shows the overall view of the failure surface of the pressurized 1.1 MPa (160 psi) E/F joined pipe. The striations on the fracture surface were much shorter and less regularly spaced than those on the fracture surface of the unpressurized pipe. Furthermore, there was no evidence of arrest lines. While the striations on the outer surface were long and regularly spaced (Fig. 14b), the striations on the inner surface (Fig. 14c) were short and unevenly spaced. The striations on the edge of the inner surface appeared perpendicular to the pipe surface plane. In addition, many small threads were observed at the edge of the inner surface. This feature was also observed for the unpressurized pipe and is believed to occur when the last section of the pipe is torn prior to complete failure. Furthermore,

the striations on the fracture surface of the pressurized pipe were shorter and less regularly spaced than those on the surface of the unpressurized pipe.

The difference in both number and spacing of the striations is attributed to the fact that for the unpressurized pipe, there is only bending stress acting on the wall of the pipe. While for the pressurized pipe, static hoop and radial stresses exist in the pipe with the external bending stresses, which are superimposed onto the static axial stress. Internal pressure in the pipes tends to decrease the plastic bending strain (Ref 14) and thus, increase bending fatigue resistance quantified in terms of cycles to failure. Additional study is planned for the near future to substantiate and/or validate the observed trend.

Fig. 14 Scanning electron micrographs of the deformed and failed pressurized electro-fusion joined pipe showing (a) overall morphology of the failure surface, (b) the outer surface, and (c) the inner surface

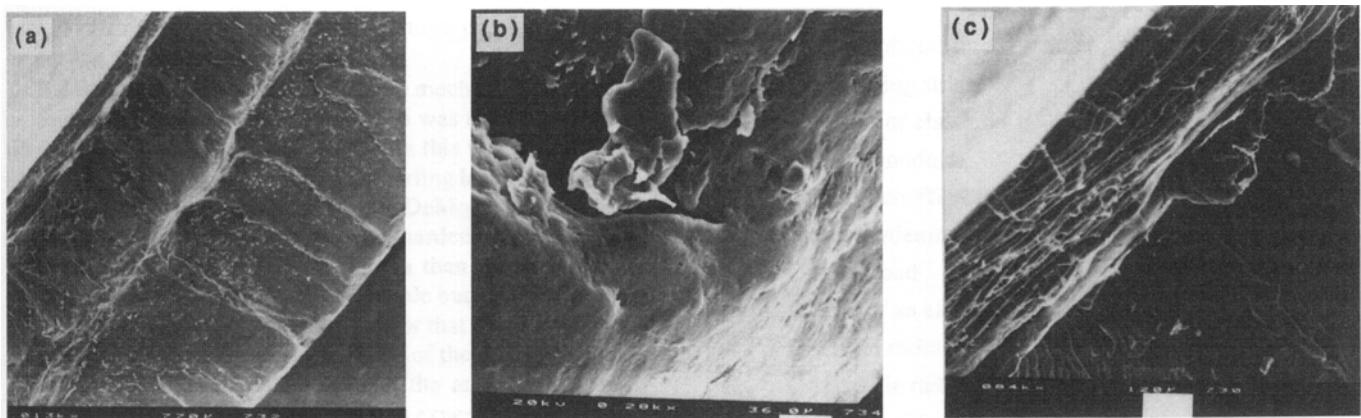
Figure 15(a) shows an overall view of the fracture surface of the B/F joined pipe. The crack originated at the outer surface and progressively propagated inward. Figures 15(b) and (c) show the outer and inner surfaces of the fracture and confirm the observation. The striations on the surface were long with a higher density at and near the outer surface than on the inner surface. The longest striations were near the origin of the crack, with their length decreasing as the crack propagated inward. However, unlike the E/F joined pipes, the striations at the edge of the inner surface (near the region of the butt-weld) were long

and regularly spaced. During the butt-welding sequence, the material at and near the root of the joint undergoes microstructural transformation. The intrinsic material properties in this region are different from those of the substrate material. Thus, near the B/F bead, a second-phase of fatigue failure that resembles the first failure but is much shorter exists. The microstructural changes result in the presence of voids, microscopic pores, and other heterogeneities. Butt-fusion mechanics assumes that under the influence of an external load, an engineering component will fail as a direct result of the "weakest link" theory. Because the presence of material defects increases the probability of "weakest links," the section of pipe near the butt-joint reveals less strength and fatigue durability than the plain unwelded pipe material. Under bending fatigue testing, the B/F joined pipe failed after considerably fewer cycles in comparison with the plain unwelded pipe.

Fig. 15 Scanning electron micrographs of the deformed and failed pressurized butt-fusion joined pipe showing (a) overall morphology of the surface, (b) high magnification of the outer surface, and (c) the inner surface region
