Investigation of Stainless Steel Corrosion in Ultrahigh-Purity Water and Steam Systems by Surface Analytical Techniques

Xia Dong, Ronald G. Iacocca, Bethany L. Bustard, and Craig A. J. Kemp

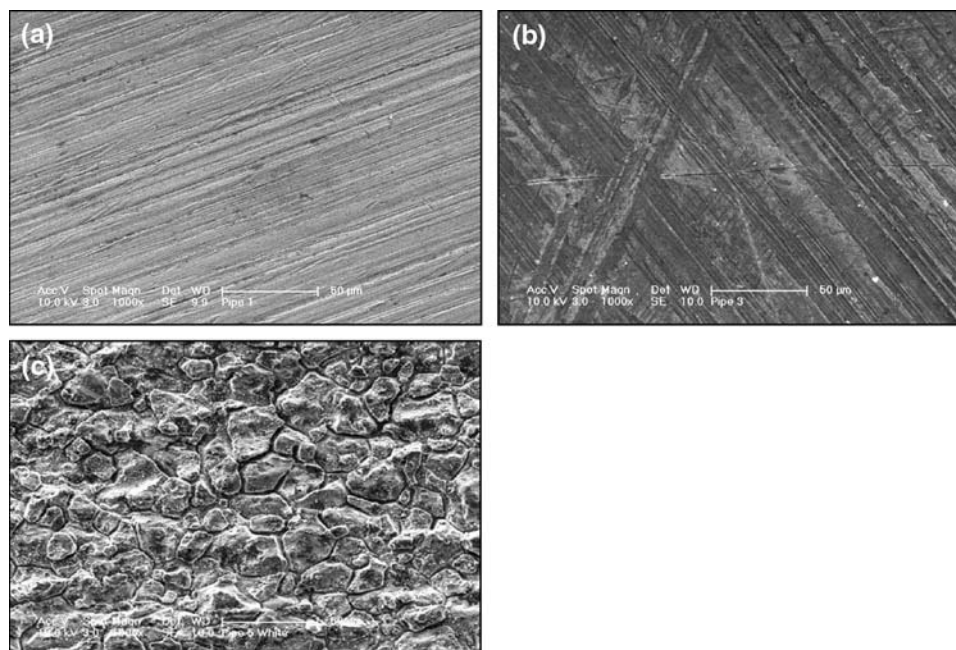
To understand the extent of rouging, SEM micrographs of the three pipe samples were obtained, as shown in Fig. 1. Pipe 1 received no exposure to high-temperature water or steam, Pipe 2 is in the preliminary stages of rouging, exhibiting a yellow-colored oxide scale, and Pipe 3 is at a more advanced stage of rouge, exhibiting a red-colored oxide scale. In SEM micrographs, the control sample surface (Fig. 1a) exhibits the original mechanical polishing features that would be expected in a mechanically polished material. The micrograph of Pipe 2 (Fig. 1b) shows the same polishing features, though to a more severe extent. This increased severity is not caused by exposure to a corrosive environment but rather is an artifact of mechanical polishing. Because these features are readily visible, this material is in the early stages of oxidation. The Pipe 3 surface contains “island” features, as shown in Fig. 1c, and appears rougher than the other two pipes, indicating more severe degradation occurring on this sample.

Fig. 1 Scanning electron micrograph of stainless steel pipes with various rouge extent. (a) Pipe 1—mechanical polished pipe used as a control. (b) Pipe 2—mechanical polished pipe exposed to 80 °C H₂O. (c) Pipe 3—pipe after long service

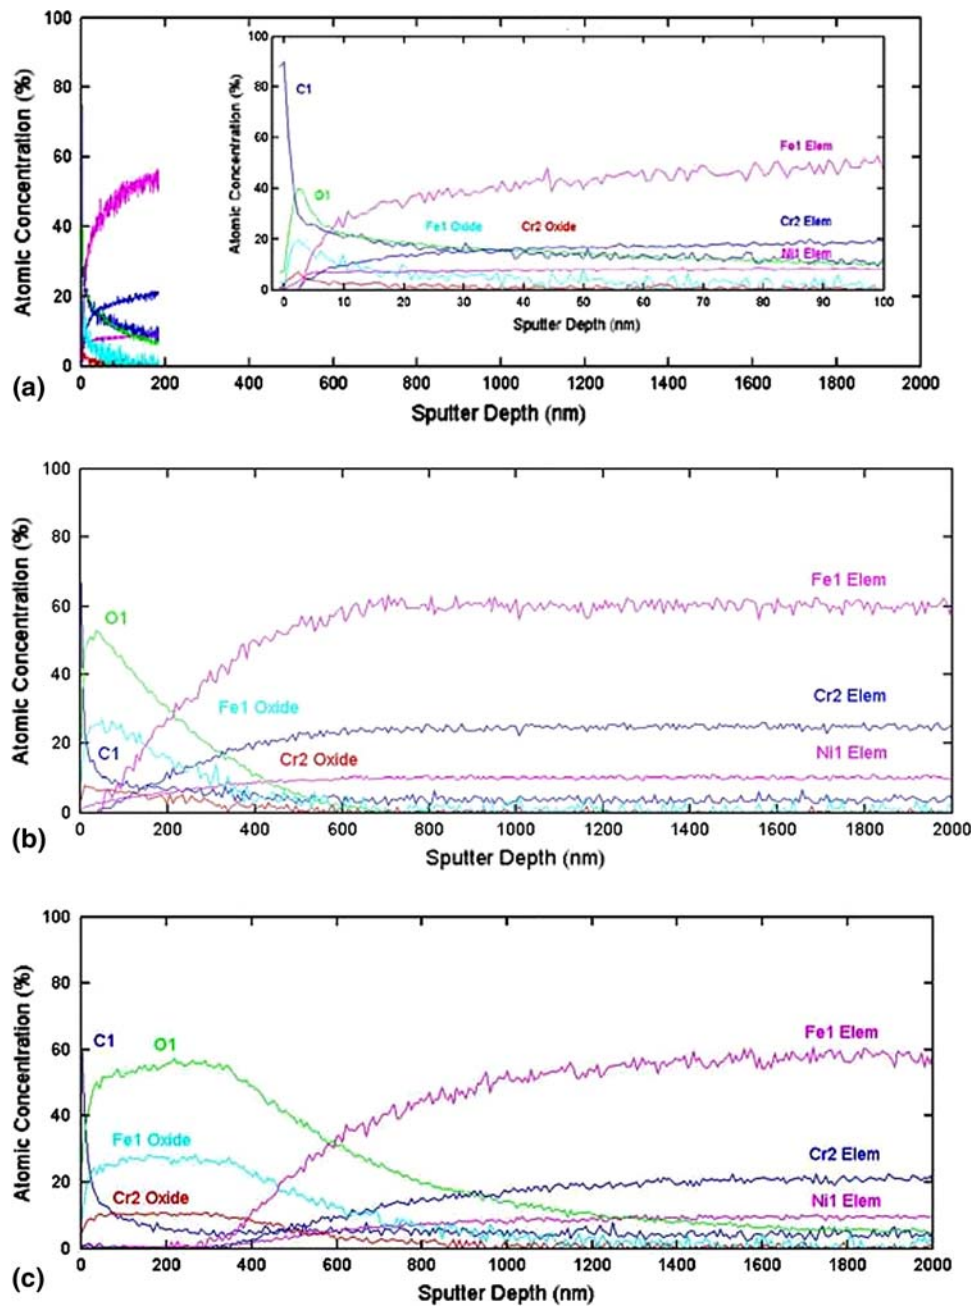
As discussed earlier, the rouging phenomenon involves the formation of iron oxide, regardless of the mechanisms behind it. Figure 2 compares the AES depth profiles of certain elements obtained from the three pipes. The control sample (Pipe 1) has the thinnest oxide layer at approximately 25 nm (Fig. 2a). Depth profiles taken from Pipe 2 in an area where the oxide layer appears yellow in color has been oxidized to a depth of approximately 200 nm (Fig. 2b). In comparison, depth profiles obtained from Pipe 3 (Fig. 2c), where the oxide layer was red in color, had an oxide layer varying from 600 to 1200 nm. The SEM picture of Pipe 3 shows island-like structures, and the surface appearance is not uniform. The variable thickness and location of the oxide is most likely caused by localized differences in the stainless steel surface. The spectra in Fig. 2 also reveal that there is no preferential oxidation occurring in the sample, as evidenced by the profiles obtained for chromium oxide. (Note that the thicknesses of the

oxide layer were calculated based on the sputtering rate obtained from a silicon oxide standard; therefore, the absolute measurement may not be accurate. However, the relative comparison between different samples is still valid.)

Fig. 2 AES depth profiles of stainless steel pipes with various rouge extent. (a) (top) Mechanically polished pipe used as a control. (b) (middle) Mechanically polished pipe exposed to 80 °C H₂O. (c) (bottom) Pipe after long service

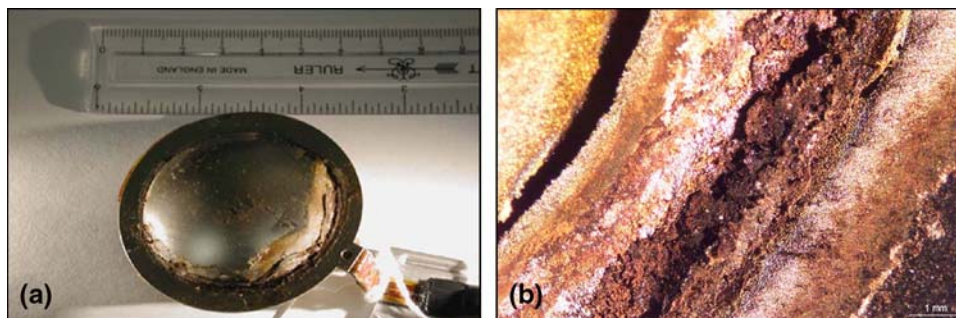
Figure 3 shows the optical images of a corroded rupture disc (coated with Teflon) that was installed in a stainless steel tank used as a water container. Discoloration occurred on multiple discs shortly after installation. In service, these discs were exposed to clean steam and water. Note the severity and localized nature of the degradation. Cracking and holes caused by corrosion were confined to the rim area of the disc, where the Teflon gaskets are located. Figure 4(a) to (c) shows the ESEM micrographs of the corroded surface, revealing the granular surface structure that is encountered with the corrosion of ferrous alloys (Fig. 4a), the detail on the cracking of the surface that takes place during corrosion, often referred to as “mud cracking” (Fig. 4b), and an area containing pits (Fig. 4c). Figure 4d shows the same corroded microstructure in close proximity to the Teflon coating, which has lost its integrity as a protective surface.

Fig. 3 Optical macroscopic images of corroded rupture disc

In addition to removing the Teflon coating to eliminate the crevice corrosion environment, one could substitute nickel-base alloys as such materials exhibit a greater resistance to corrosion (Ref 9). However, because the vast majority of this system is stainless steel, such a materials substitution might well create a galvanic couple.

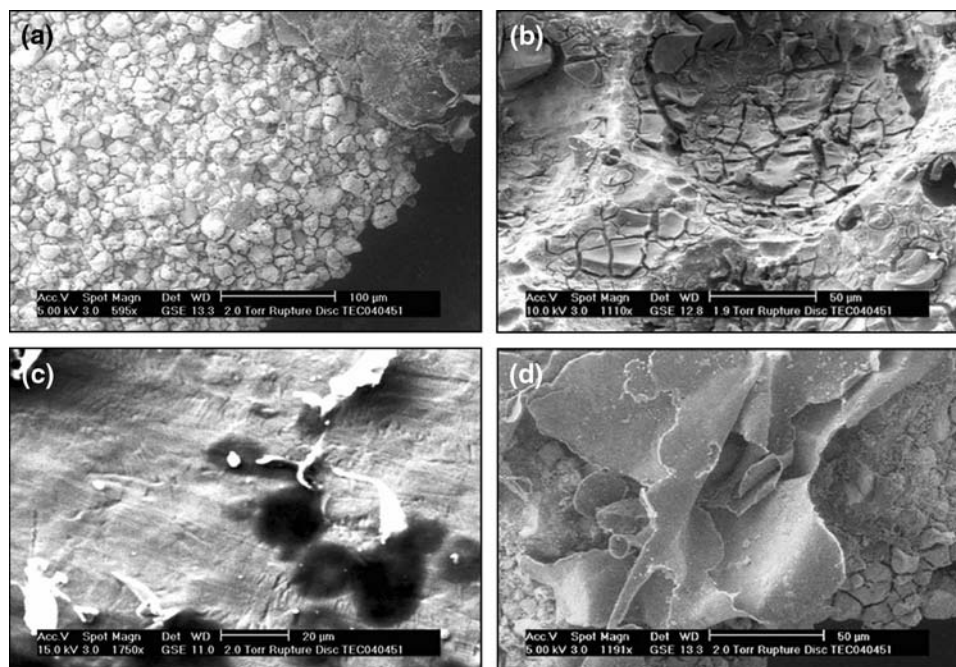
Fig. 4 Scanning electron micrographs of the surface of a rupture disc, showing a breach in the coating and the corrosion that ensued

The results obtained from the optical imaging, SEM/EDS, and TOF-SIMS suggest that the loss of integrity of the Teflon-coated layer has allowed water or other chemicals used in the cleaning process to concentrate at the Teflon/metal interface, creating an extremely aggressive environment, combining the mechanisms of crevice corrosion and rouging. Because of the physical location of the corrosion, it is also believed that the Teflon gasket used in the sanitary fitting accelerated the corrosion. Therefore, it is proposed that the Teflon coating, combined with the existence of the Teflon gasket, has created

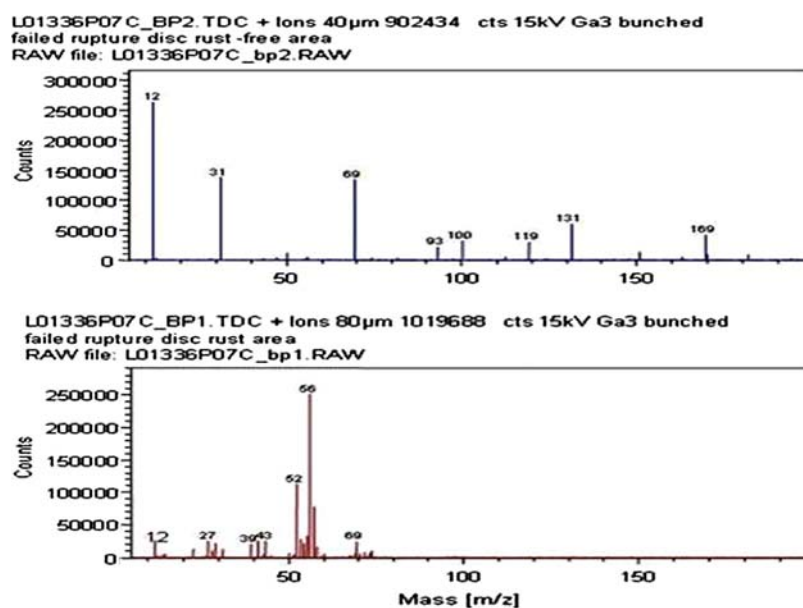
The positive ion spectra collected from two areas on the rupture disc—one where corrosion had occurred and another where corrosion was not yet evident—are presented in Fig. 5. The spectrum from the corroded area is dominated by m/z 56 ($^{56}\text{Fe}^+$) and m/z 52 ($^{52}\text{Cr}^+$) ions from the exposed metal surface. The spectrum from the noncorroded area contains intense ions at m/z 12 (C^+), 31 (CF^+), 69 (CF_3^+), 119 (C_2F_5^+), 131 (C_3F_5^+), and resembles a library spectrum of Teflon (Ref 8). The peak intensities are represented by the secondary ion counts detected from the analytical area.

Fig. 5 Positive ion TOF-SIMS spectra taken from two areas on the failed rupture disc. Top: no visible corrosion. Bottom: corroded area

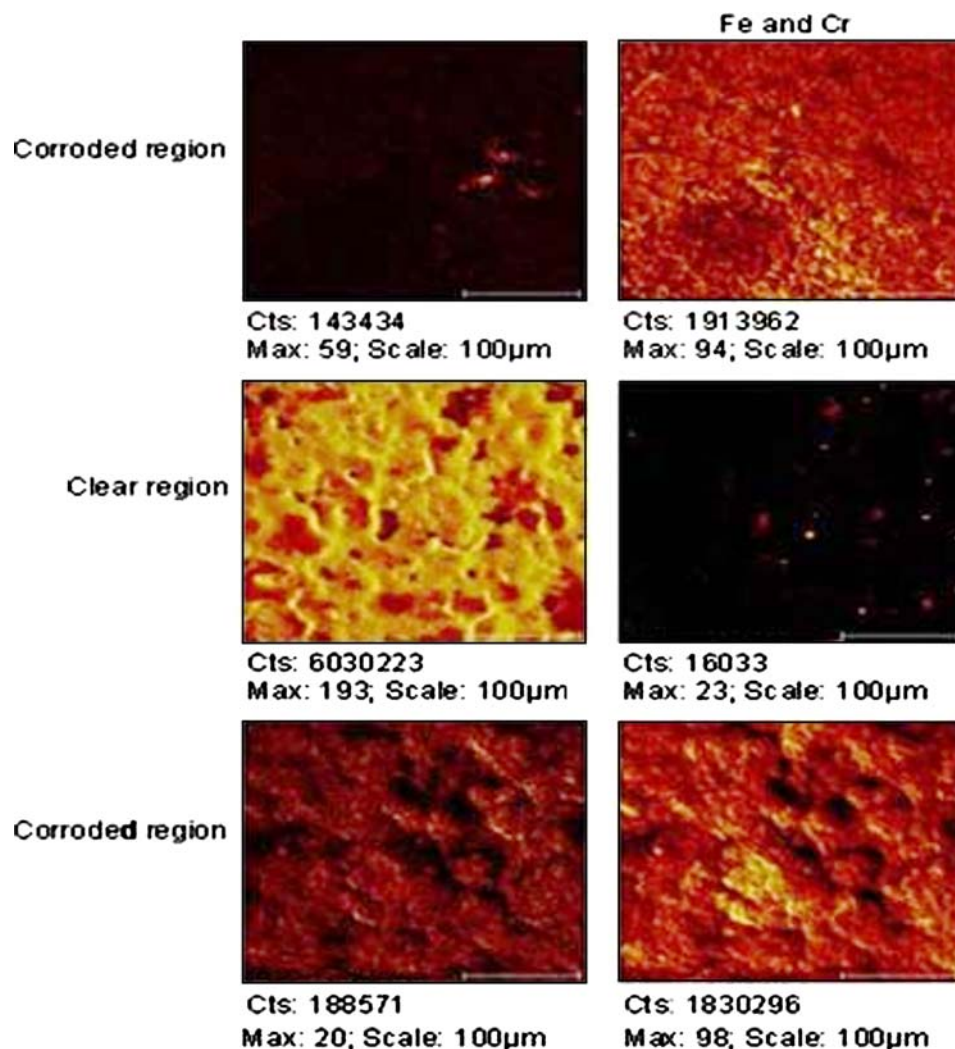
The high spatial resolution images were collected from several areas on the sample. Ion images are presented for three different areas in Fig. 6. The left column represents the summation of the intensities of the most abundant fluorocarbon ions (see above), and the right column represents the summation of the intensities of m/z 52 and 56 (Cr^+ and Fe^+ , respectively). The middle row of images was produced from a clear, corrosion-free region. The top and bottom rows were produced from corroded regions.

Fig. 6 TOF-SIMS ion images from two areas in the corroded region of the rupture disc (top and bottom rows) and the noncorroded region (middle row). The images in the left column of images are derived from signals from m/z 31, 69, 119, 131, and 169 (fluorocarbon-related peaks), and images in the right column are derived from m/z 52 and 56 (Cr^+ and Fe^+ , respectively)

corrosion-free region while spots enriched with Fe/Cr were also detected. The top row of images in Fig. 6 reveals the presence of a residual ragged patch of fluorocarbon on the corroded metal; whereas the bottom row indicates that the area from which those maps were produced contains no distinct fluorocarbon “islands,” and a low-level signal in the fluorocarbon map matches the appearance of Fe/Cr maps. The TOF-SIMS results suggest that the Teflon layer is relatively intact in the corrosion-free area; however, its integrity was compromised in the corroded area. These results are consistent with ESEM observation.
