Investigations on the Suitability of Coated Steel Piping System for High Pressure Seawater Reverse Osmosis Application

Mohammad Mobin

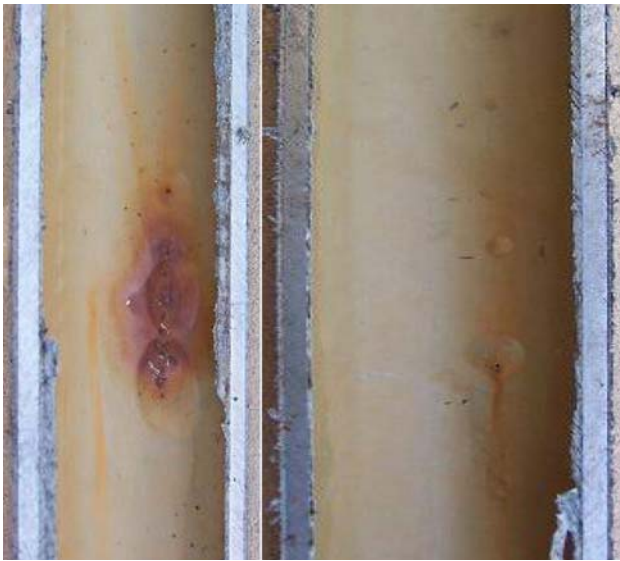
The thermoplastic piping taken out after the exposure to pilot plant tests were subjected to thorough physical examination. The external coating did not show any change in physical appearance, adhesion loss, or blistering effect. To examine the integrity of the internal coating, the tubes were splitted. The internal coating was found covered with some dark brown products probably from the feed water and was easily cleaned with water. The coating after cleaning did not show any color change. A careful examination of the splitted tubes showed the presence of some round blisters on the internal surface of the tubes. The blister were broken initiating the corrosion of the underneath steel. The coating appears to be nonuniform over the weld seam. The photographs of the splitted tubes showing blister formation is shown in Fig. 3.

Blistering is one of the most common type of coating failure related to adhesion. The usual cause of the blistering is the penetration of moisture through the coating into the areas of poor adhesion. The moisture vapor may condense and form a liquid blister, or the vapor pressure of the moisture at the interface between the coating and the surface may be sufficient to lift the coating away from the substrate. Blisters are either formed from the substrate with the coating separating from the substrate or formed between coats where the top-coat separates from an under-coat. A number of conditions can cause

Fig. 3 Split view of the tubes showing blisters formation

blistering. It includes soluble pigments in the primer, soluble salts contaminating the substrate or contaminating the surface between coats of the coating or contamination of the surface by materials (oils, waxes, dust, etc.) that will not allow proper adhesion of the coating; selection of an improper primer for the surface; incompatible coatings; poor or inadequate solvent release by the coating. It appears that the coated steel pipes were already having areas of poor adhesion as a result of poor application of coating on relatively low diameter pipes allowing the penetration of moisture in that areas.

2. Keeping in view the formation of some blisters on the internal surface of pipes and test coupons during the present testing, it is recommended to test the coated pipes in commercial SWRO plants before their final selection as candidate material for high pressure SWRO application. In commercial SWRO plants, the diameter of pipes is higher than the pilot plant, this will address the drawback associated the application of coating on smaller diameter pipes.

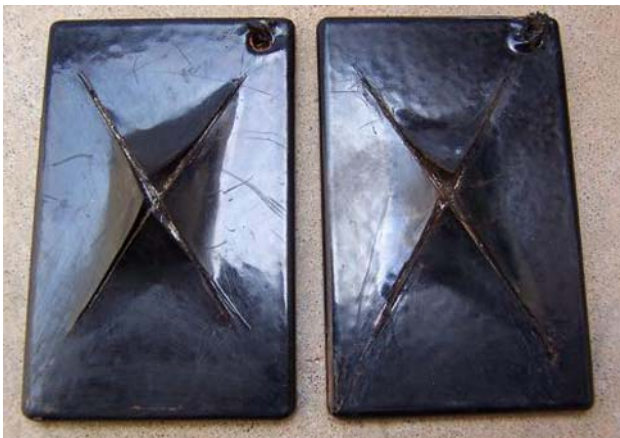
Fig. 4 Photograph of the coupons taken after 30 days of exposure in salt fog chamber. Loss of adhesion at the scribed mark can be seen

The representative mean creepage (from scribe) for the coating after 30 days exposure to salt fog is 12.79 mm giving a

rating of 2. However, the coating did not show blistering on either side of the specimens. After 60 days of exposure to salt fog, the mean creepage is increased considerably (20.86 mm) giving a rating of zero. The coating also showed formation of blisters on either side of the specimens. The specimens exposed to salt fog for 90 days showed the formation of many blisters on either side. However, the blistering was more pronounced on the scribed side. The evaluation of unscribed samples exposed to salt fog also showed formation of blisters on the specimens.

investigation, the coating was subjected to salt spray test following designation ASTM B117 which is identical to ISO 7253 as both uses 5% aqueous solution of sodium chloride and operation of cabinet at 35 °C. The result after 30 days (720 h) of exposure showed loss of adhesion more than 10 mm from the scribe. Though the poor performance of coating under salt fog tests may not be denied, it may be noted that in different standards used to test the resistance of coating to salt spray (fog) tests pass/fail criteria is not defined. This is just a matter of agreement between concerned parties.

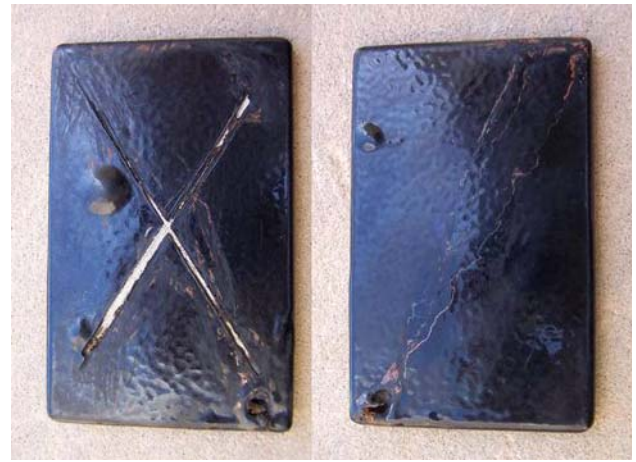
Fig. 5 Photograph of the coupon showing blister formation on the scribed and unscribed side. Coupons were taken after 60 days of exposure in salt fog chamber

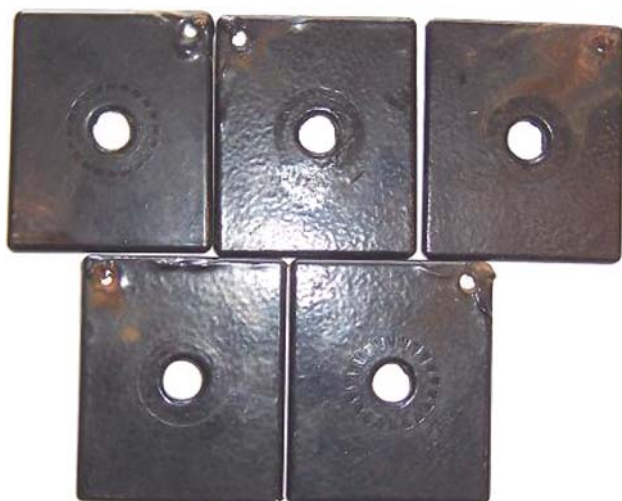
The coupons obtained after subjecting to crevice corrosion tests both in the pilot plant and laboratory were physically examined and photographed. Figure 6 shows the photograph of the coupons after crevice corrosion test in the laboratory. The results are summarized in Table 5 and 6. In majority of the samples exposed to crevice corrosion test, the coating did not

Fig. 6 Photograph of the coupons after crevice corrosion test in the laboratory. Absence of corrosion under crevice area can be seen

show any visible change in physical appearance and the performance of coating under the crevice was satisfactory. However, blisters were formed on both sides of the samples, thus putting a question mark on the adhesion property of the coating.

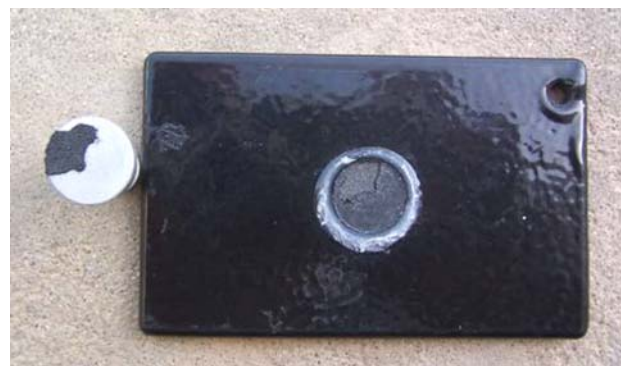
During the test, at one location a plug of the coating was detached from the substrate at 999.8 psi (Fig. 7). This indicated

Fig. 7 Photograph showing the coated panel after pull-off adhesion test. A plug of coating detached from the substrate can be seen

that the strength of adhesive was sufficient to pull off the coating from the substrate. However, at other two locations, the pull stub was detached at the coating/pull stub interface at 1399 and 1600 psi, respectively, confirming that the bonding between the metal substrate and coating was more than the coating and pull stub. This again shows that coating was not uniformly applied on the substrate.

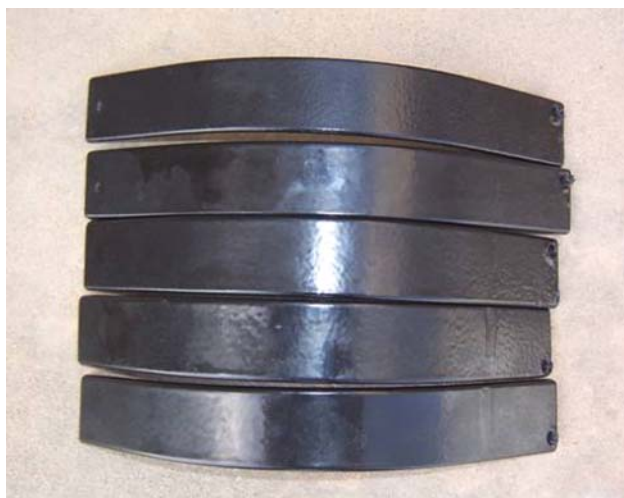
Fig. 8 Photograph showing the coated panels after bending test

The photograph of samples obtained after subjecting to bending is shown in Fig. 8. The visual examination of samples did not show any defect at the bending site. The calculated values of % strain and °/PD are as follows:
