# Microscopic Observations on the Origin of Defects During Machining of Direct Aged (DA) Inconel 718 Superalloy

G.K. Dosbaeva, S.C. Veldhuis, A. Elfizy, G. Fox-Rabinovich, and T. Wagg

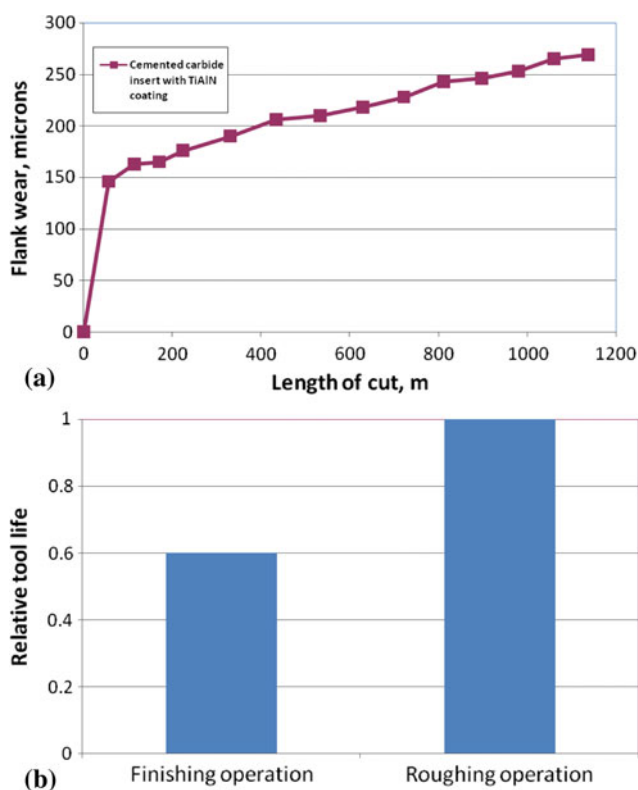
Figure 1(a) shows that tool life for the cemented carbide cutting inserts is quite sufficient during roughing operation. However, if the finishing operation is performed, tool life is reduced significantly (Fig. 1b) due to work hardening within the surface layer (Ref 7, 12, 13), along with higher general hardness of DA 718. To estimate work harden zone, microhardness tests were conducted. Figure 2 presents the microhardness depth profile of the DA and Inconel 718 workpiece surface from finishing operation. The Inconel 718 workpiece surface hardness was increased compared to bulk with a return to bulk values within the first 50  $\mu\text{m}$  depth below the surface. The data obtained for the DA 718 indicate the effect of work hardening of the first 100  $\mu\text{m}$  beneath the workpiece surface. The depth of the work-hardened layer is higher for DA 718 than for Inconel 718. Thus finishing operation is more challenging for the DA 718 alloy particularly in terms of complete elimination of the surface defects. Unfortunately, there is a lack of data on machining of advanced super alloys such as DA 718. Based on industrial practice tool life above 15 min is agreeable for machining of aerospace alloys. Recalculating the length of cut (m) into time (min) yields a tool life (Fig. 1a) greater than 40 min.

**Fig. 1** Tool life for the coated cemented carbide inserts during machining of DA 718 alloy (cutting speed 30 m/min; depth of cut 0.7 mm): (a) roughing operation and (b) relative tool life during finishing and roughing operations

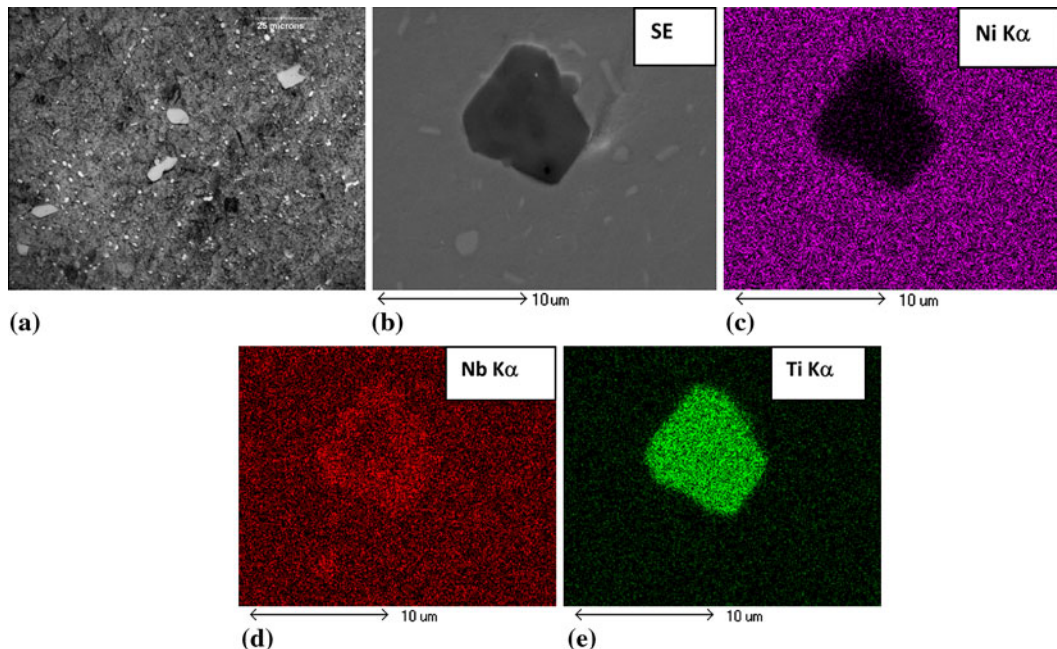
Optical studies of the DA 718 alloy microstructure indicate the presence of large primary carbides (Fig. 4a). These primary carbides, as SEM/EDS data show, are mostly complex TiC/NbC carbides (Fig. 4b, d, and e). The carbides were distributed randomly, with a size of 1-15  $\mu\text{m}$ .

**Fig. 4** Optical microphotograph: (a) large primary carbides (magnification 1000×); EDS elemental maps (magnification 5000×): (b, c, d, e) complex TiC/NbC carbides on the machined part of DA 718 alloy

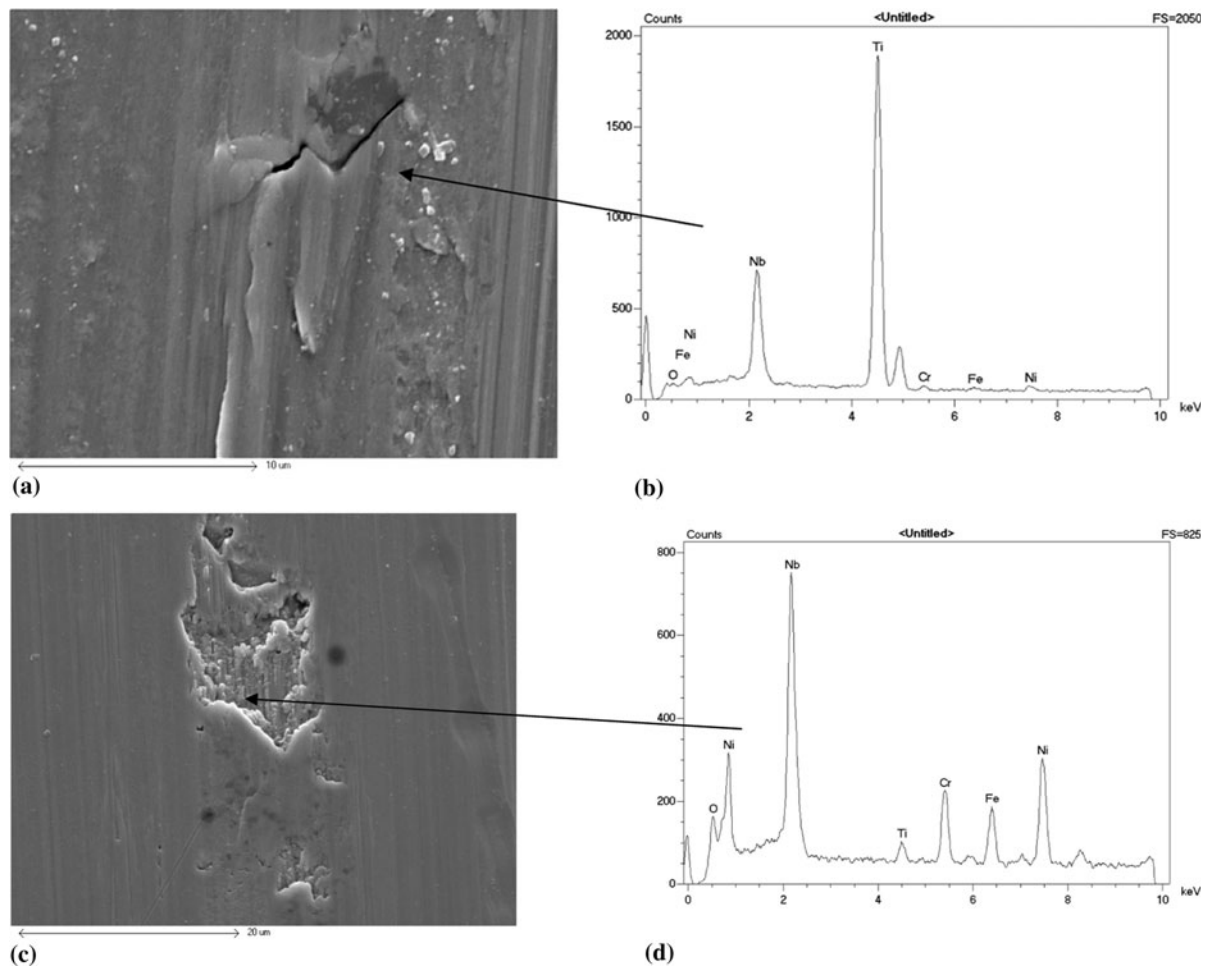
Investigation of surface morphology of the machined surface was made after finishing and the average number of surface microdefects was three to four defects per square centimeter. There are two typical defects on the surface of DA 718 after machining: (1) cracks (Fig. 5a) and (2) tears (Fig. 5c). Cracks on the machined surface are associated with both types of carbides: TiC and NbC. Surface morphology observation revealed that microcracks are preferably forming on TiC or Ti-rich regions of the complex Ti/NbC particles (Fig. 5a and b). In contrast, the tears (Fig. 5c) are related to the oxidation of NbC (Fig. 5d).

**Fig. 5** SEM EDS data on surface morphology and defects formation on the machined surface of DA 718 alloy: (a, b) cracks and (c, d) tears

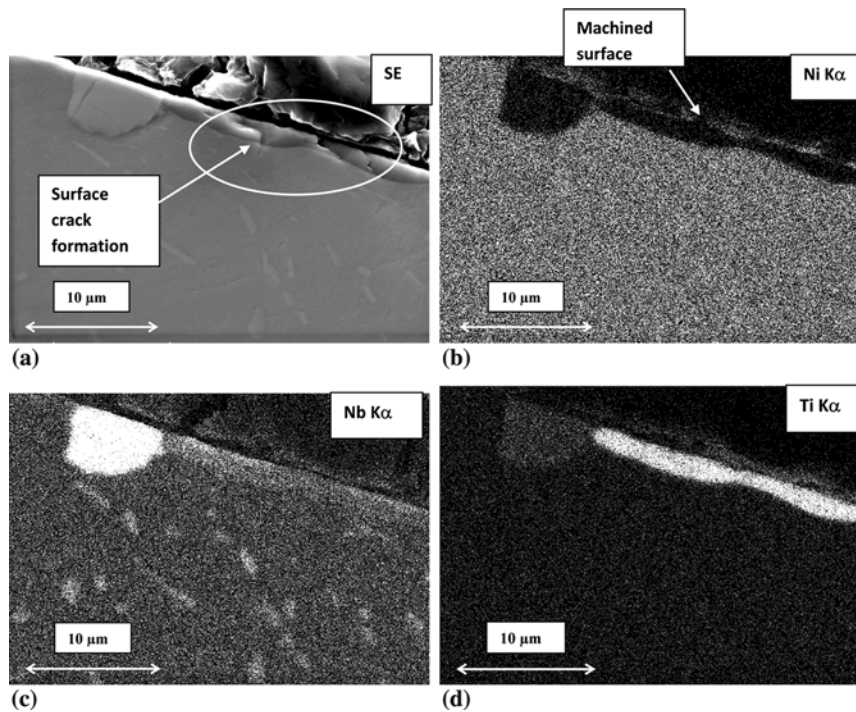
Cross sections of different spots of the machined surface show crack-progression and surface flow formation in a zone with large carbide concentrations (Fig. 6 and 7). High temperatures, around 600-800  $^{\circ}\text{C}$ , are generated on the tool/workpiece interface during machining of Ni-based super-alloys (Ref 12). At these temperatures, intensive oxidation of the machined surface is taking place even under intensive coolant flow (Ref 13). It was shown elsewhere that NbC intensively oxidizes at temperatures above 400  $^{\circ}\text{C}$  (Ref 11, 14). The EDS spectrum in Fig. 5(b) indicates that TiC oxidizes as well but more slowly (Ref 10). Figure 6(a and d) is related to Fig. 5(a and b) and shows that cracks on the outer surface of DA 718 are a result of shearing while cutting carbide particles, mostly TiC. Nb oxides layers form on the NbC-metal matrix interface of the Ni-based superalloy during high-temperature oxidation. Niobium oxide formation on the machined surface is confirmed by EDS data

**Fig. 6** SEM/EDS elemental map of the cross section of the machined surface of DA 718 alloy with surface and interior microcrack formation (magnification 5000×)

Figure 7(a and c) shows flow formation and crack propagation into the interior of the carbide when the outer surface of the two-phase carbide contains a relative abundance of Nb. Figure 6(a) also confirms that sheared NbC carbide is susceptible to have interiorly propagating microcracks (Ref 11).

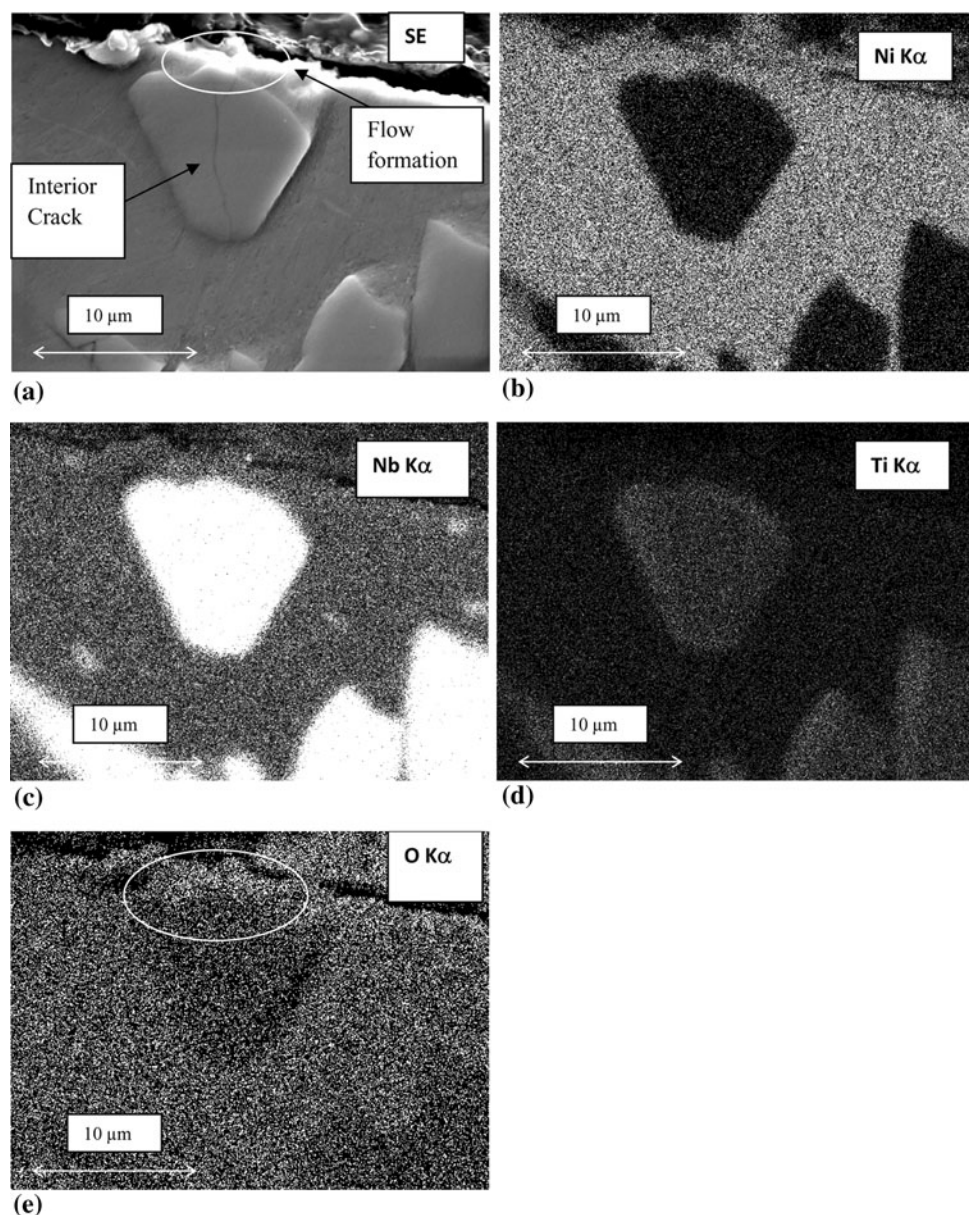
(Fig. 5d) as well as by elemental mapping of the carbides concentration area (Fig. 7c and e). These oxides are not strong enough to sustain large strains generated on the tool/workpiece interface, in particular during machining of DA 718 superalloy (Ref 15, 16). As a result, the tears form (Fig. 6a and c).

**Fig. 7** SEM/EDS elemental map of the cross section of the machined surface of DA 718 alloy with flow formation (magnification 5000×)
