Al-rich Precipitation in CoNiCrAlY Bondcoat at High Temperature

T. Koomparkping, S. Damrongrat, and P. Niranalumpong

The investigation was performed on a first-stage high-pressure turbine blade from a gas turbine engine model Mitsubishi 701F, Gas Turbine WN-C 102 (Mitsubishi Heavy Industry, Japan), which was obtained from the Electricity Generating Authority of Thailand (EGAT). The turbine blade was produced from IN738LC and was air plasma-sprayed with TBC. The TBC consists of Co-32Ni-21Cr-8Al-0.5Y (wt.%) bondcoat with a thickness of 150-200 μm and ZrO_2 -20 wt.% Y_2O_3 topcoat with a thickness of 300-400 μm . The turbine blade has been operating isothermally for 4000 h in the gas turbine engine at a service temperature of about 1200 °C and a gas pressure between 127.5 and 137 MPa.

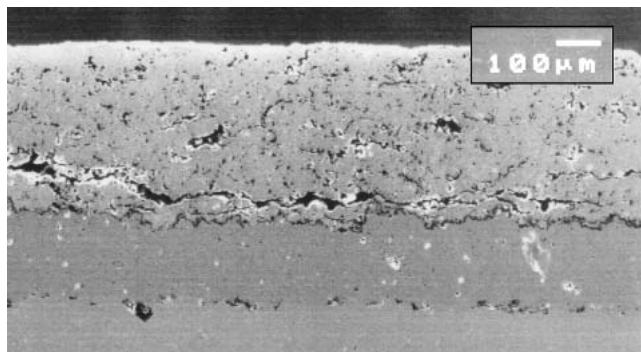
Spallation of the ceramic topcoat was observed in the leading and trailing edge regions. Examination using SEM revealed a large number of macroscopic cracks parallel to the bondcoat/topcoat interface, traveling at a small angle towards the outer surface, as shown in Fig 1. These cracks were found mainly in the leading edge and trailing edge regions of the turbine blade. Further propagation of these cracks may lead to spallation of the topcoat.

Fig. 1 Microstructure of TBC on the leading edge of the turbine blade showing a large crack within the topcoat after 4000 h at 1200 °C

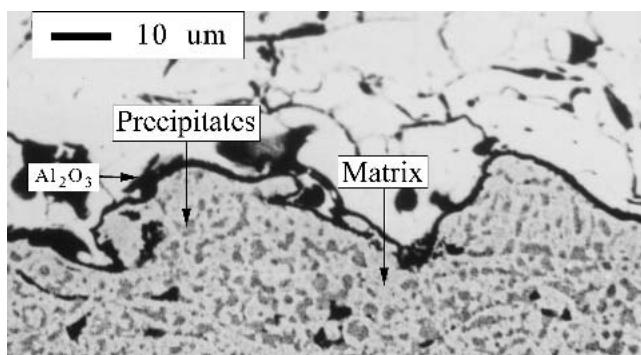
Fig. 3 SEM micrographs of the bondcoat/topcoat interface showing the second phase precipitated within the bondcoat: (a) convex region, (b) concave region, near the leading edge, (c) convex region, near the trailing edge, (d) concave region, near the trailing edge

On examining the microstructure of the bondcoat, it was found that sintering of the bondcoat had occurred throughout the blade. This is identified by the disappearance of the splat boundaries (Fig. 1). Some splat boundaries were still evident mostly on the convex side of the blade, possibly due to the lower operating temperature and gas pressure on this side. Vague outlines of the splat boundaries are still visible in Fig. 3(a) and (b). These are less evident in Fig. 3(d).

One other major change in the bondcoat was the precipitation of a second phase as a dark colored precipitation (Fig. 3). Although these precipitates were observed scattered throughout the bondcoat, some areas adjacent to the oxide scale were found to be free of these precipitates. Similar findings were observed in a work done by Teratani, et al., where samples, coated with low pressure plasma sprayed MCRAIY, were oxidized isothermally for short periods of time (Ref 12). It was found that an "Al-lacking layer" was formed within the bondcoat adjacent to the thermally grown oxide between the bondcoat and the topcoat. The thickness of the Al-lacking layer was dependent on the testing time and temperature. For the TBC studied in this exper-

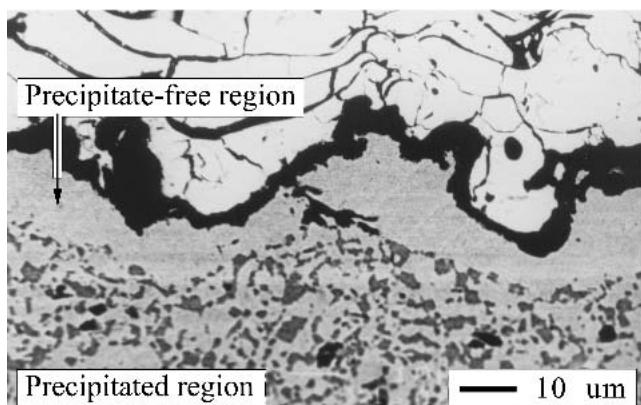
(c)

In some areas, particularly in the coating on the trailing edge where a large amount of secondary oxide was found, the precipitates were not present in the bondcoat adjacent to the protective oxide but were found about 10-20 μm lower, existing all the way to the bondcoat/substrate interface (Fig. 3c and d). Since the matrix of the precipitated region and the precipitate-free region are the same phase, it can, therefore, be concluded that the precipitate-free region has been exhausted of Al because no Al-rich precipitate has formed.

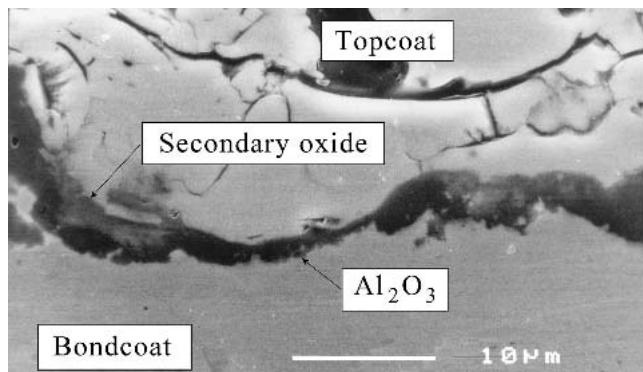
A protective Al_2O_3 scale was formed at the interface throughout the turbine blade, but the secondary oxide layer was observed only in some areas; in particular, the leading and trailing edges of the blade (Fig. 2). Since the presence of the secondary oxide can lead to crack initiation in the ceramic topcoat, this observation agrees with the cracked structure found in Fig. 1. Formation of the secondary oxide scale also indicates an insufficient Al within the bondcoat to continue formation of the protective Al_2O_3 scale.

Fig. 2 Microstructure of the bondcoat/topcoat interface showing thermally grown oxide scales

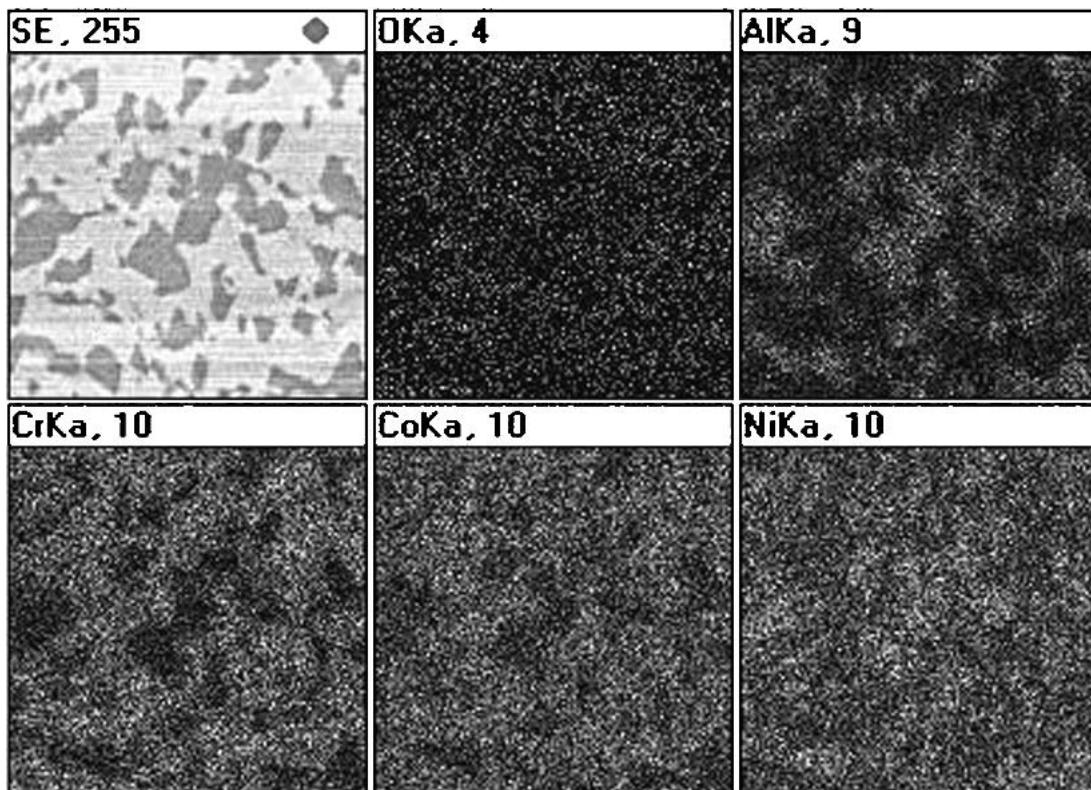
EDX mapping (Fig. 4) shows that the precipitates consist mostly of Ni and Al, represented by the high concentration of white specks. The lighter colored matrix is, in turn, made up mainly of Ni, Co, and Cr. The quantitative TEM-EDX analysis (Tables 1 and 2) confirms the darker phase to be rich in Al in comparison to the matrix.

Fig. 4 EDX mapping showing the concentration of each element in the precipitated region in the bondcoat. EDX analysis was carried out at the convex region, near the trailing edge (Fig. 3c), at the midpoint along the thickness of the bondcoats
