SEALY ENGINEERING

January 14, 2009

Enclosed is the report of the visual inspection that was conducted on the structural components of the residence located at 11727 Wickhollow Ln., Houston, Texas 77043, by Taylor Sealy, PE. This inspection was conducted for you on the date of January 14, 2009.

STRUCTURAL INSPECTION REPORT

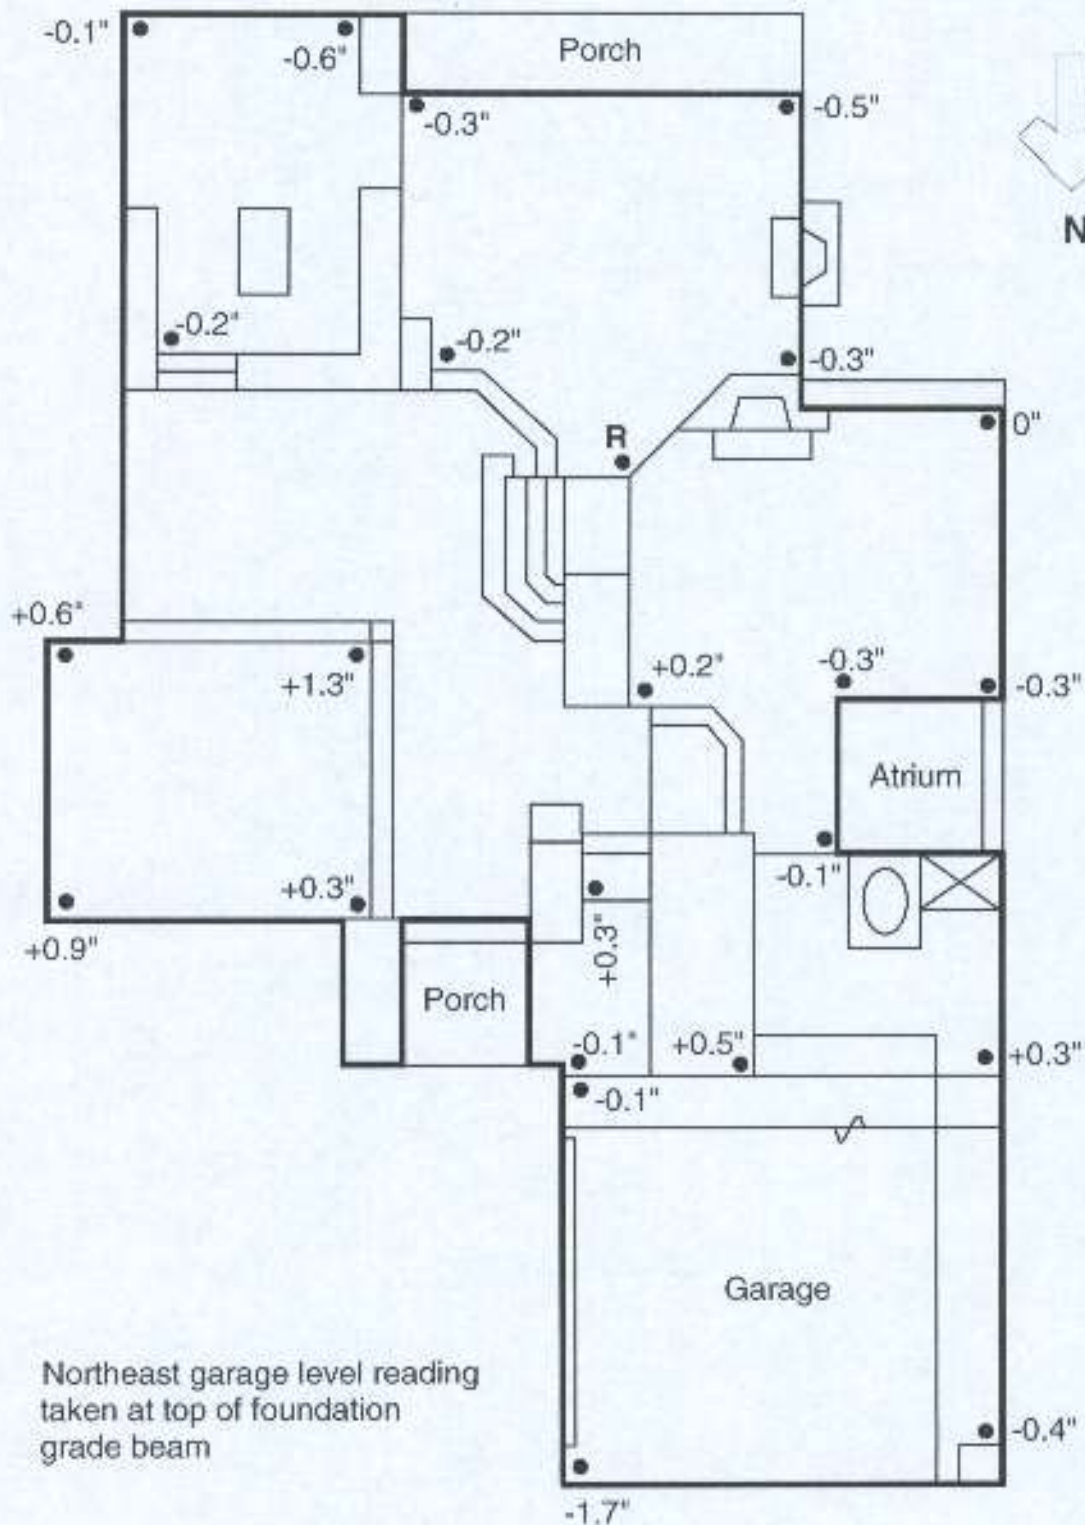
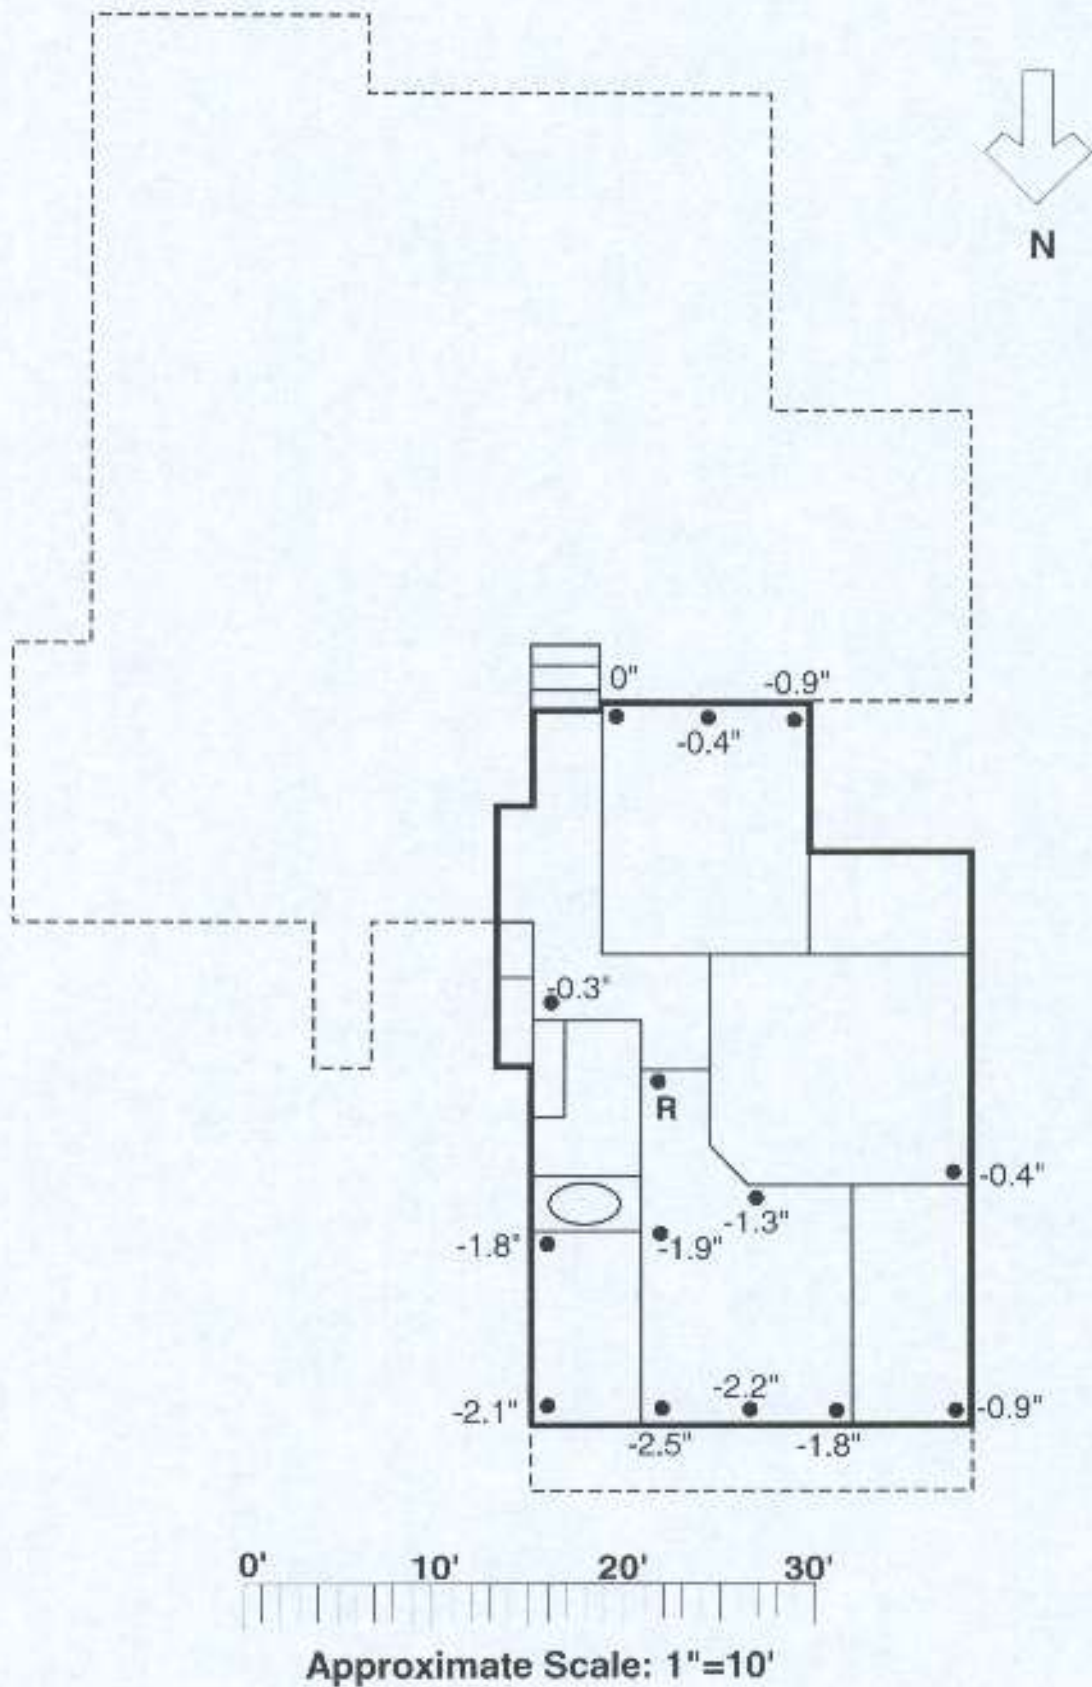
11727 Wickhollow Ln.
Level Readings

The foundation of this residence was observed to have incurred deflections which caused damage to other structural components. The level deviations were measured using an electronic version of a waterlevel, a Zipllevel by Technidea in this case, and the results have been superimposed upon an attached sketch. Compensation was made for variations in the height of the floor coverings so that the measurements shown should reflect the relative height of the top of the concrete slab. From this sketch, it can be seen that the slab was measured to be level within approximately 3.0 inches from the high point to the low point. Based upon my experience, this is more than would normally be expected, with a more typical average usually being in the range of about 1.5". That also is the recommended slab construction tolerance given by the American Concrete Institute. The high area was located in the front living room by the support column and the low area at the north side of the garage. Brick cracks or separations to about 1/4" were noted. Sheetrock cracks were seen upstairs over the garage, along with door misalignments in that area also. We observed no exposed slab reinforcement steel or honeycombing in the edge of the slab. Large cracks were not observed in the visible part of the foundation grade beam. Cosmetic slab corner cracks are present. As far as other cracks which may be present in the grade beam it should be understood that cracks can be extremely difficult to see and could possibly be detected by the client at some time after the inspection has been completed. Since cracking is a normal property of brittle materials such as concrete, neither the author nor Sealy Engineering assume any responsibility whatsoever should cracks be found which were not mentioned. It is our opinion that other indications are more important in determining whether a house has a foundation problem since cracks may be present in slabs due to shrinkage or minor movements.

6. Sufficient foundation unlevelness was a was measured in the garage area, along with damage on both floors, to warrant foundation repairs in my opinion as described in section 3.1.

Northeast garage level reading
taken at top of foundation
grade beam

In my opinion, the deflections in the foundation of this residential building are of a sufficient magnitude and the damage these deflections have caused is sufficiently severe that restoration procedures are in order. It is also my opinion that restoration of foundation integrity can best be accomplished through the correct application of driven piles. The reason for that is to minimize further damage to the foundation which can sometimes limit the degree of levelness that can be obtained during the repairs. Piles tend to be "self-testing" as far as capacity due to the method of installation. This is true as long as any hard upper clay layer, such as occurs in dry weather, is penetrated. This usually requires a penetration of at least 10' unless sandy soils are involved. The attached sketch shows a reasonable arrangement for the piles. This information may be used by the client for the process of obtaining bids for this work. It is important to understand that this arrangement is based upon our engineering judgement; however, the warranty will be provided by the contractor who is solely responsible for the work and should, therefore, make the final selection. Any prospective contractor should be given a complete copy of this report in order that they may understand the goals desired here. The client may wish to resolve any significant differences between our suggestions and the recommendations made by the contractor. In any case, neither the author nor Sealy Engineering assumes any responsibility whatsoever for the results of the work of the contractor.

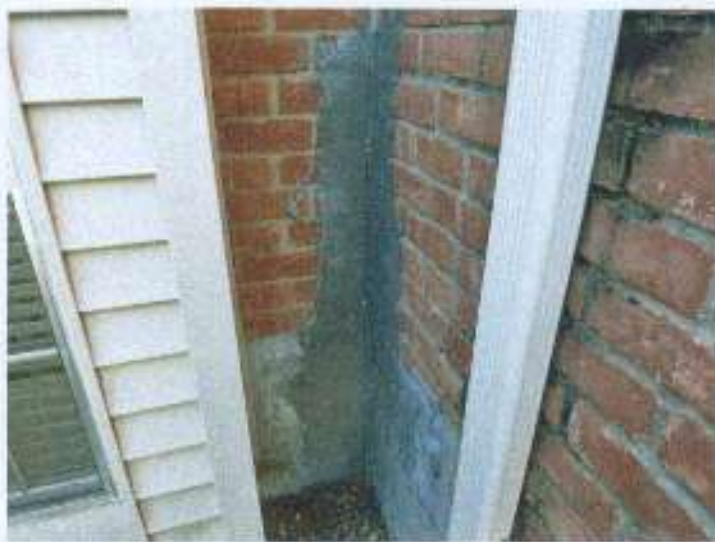
Soil levels are excessively high around parts of the foundation and should be lowered to expose several inches of slab, with provisions made to assure proper drainage away from the house. Leaking from the high soil levels may be part of the reason that mortar was used cover the weep holes and lower courses the brick around the house. The weep holes at least should be cleared to allow any moisture behind the brick to escape. Window frames need to be touchup caulked. Loose vinyl siding was observed at the rear of the breakfast room and should be resecured. There was an absence of water spotting on the surface of the interior floors and upon the inside of the exterior walls, nor were any other indications of water penetration through the walls of the structure observed. It should be noted that wall stains are often difficult to see and depend on lighting conditions at that point. Also, while we check for gaps around lower story window frames, the upper frames are poorly accessible and are not checked except from the ground. Any sprinklers should be prevented from spraying onto the house to avoid water penetration.

1/14/2009
Mortar or some material on side of house

4. Soil levels are excessively high around parts of the foundation and should be lowered to expose several inches of slab, with provisions made to assure proper drainage away from the house. Leaking from the high soil levels may be part of the reason that mortar was used cover the weep holes and lower courses the brick around the house. The weep holes at least should be cleared to allow any moisture behind the brick to escape. Window frames need to be touchup caulked. Loose vinyl siding was observed at the rear of the breakfast room and should be resecured.

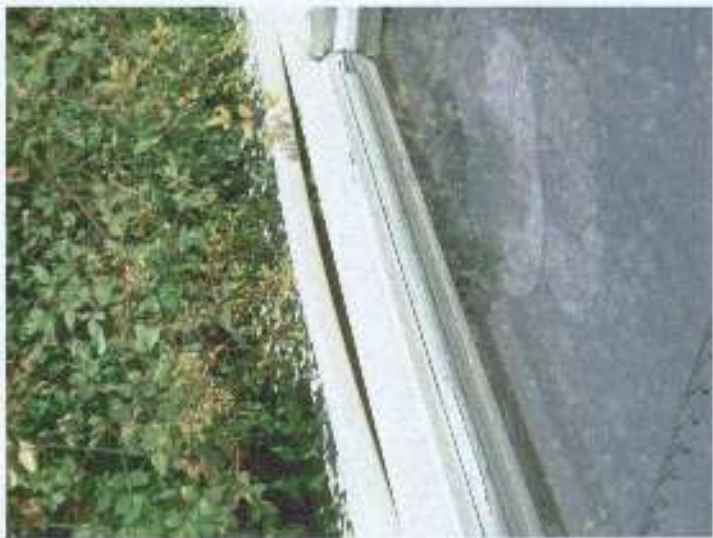
1/14/2009
Loose vinyl siding at back of breakfast room

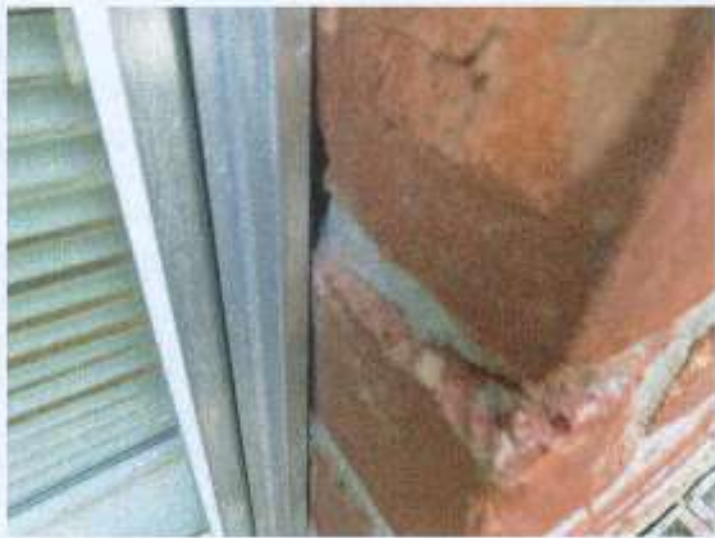
1/14/2009
Caulk window frames

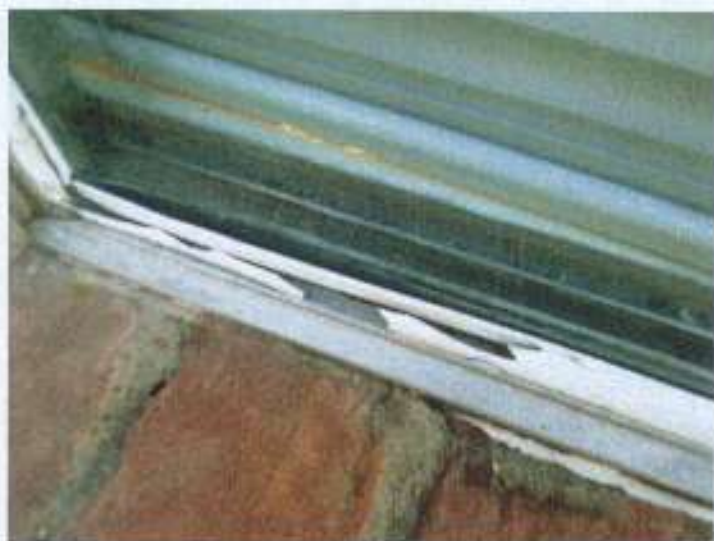
1/14/2009
Decayed plastic window pane strips

1. The plastic window pane retaining strips on most windows are deteriorated and need to be replaced. Windows in the breakfast room have a plastic film installed over them which is wrinkled and damaged and needs to be removed.

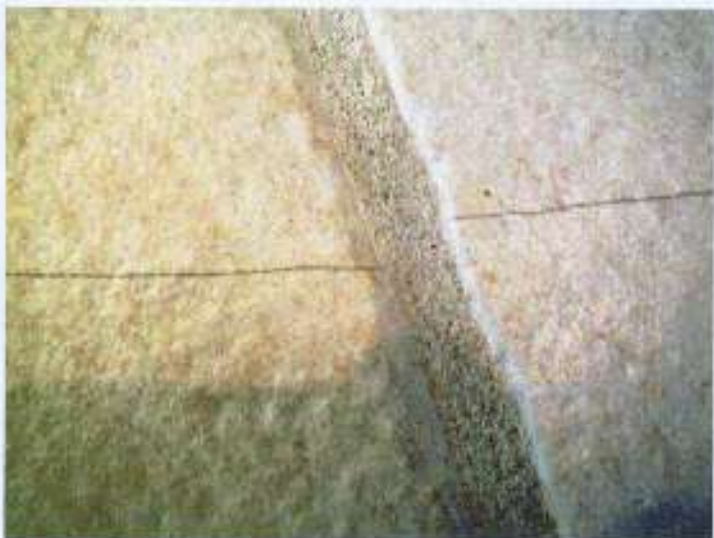
1/14/2009
Cracked floor tiles

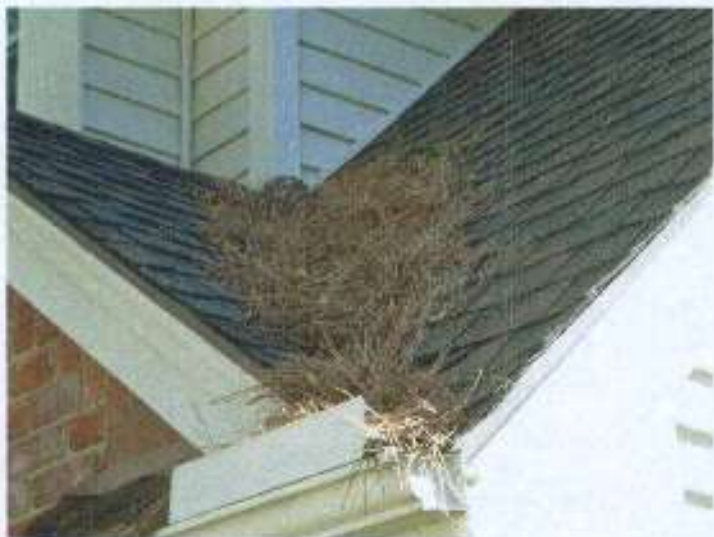
1/14/2009
Pine needles on roof

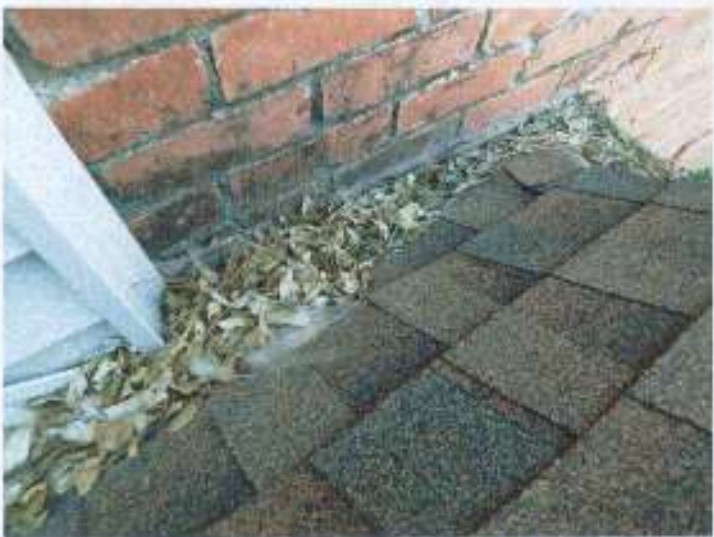
The composition shingles were observed to be laying properly on the roof. Shingles were not excessively deteriorated or damaged, as would be expected with what was reported to be a 5 year old roof. Leaves and pine needles are building up and roof valleys at the front of the house and should be clear to avoid water backups. Rusted sheet metal on the roof should be painted to prolong its life. There was no sign that rain had penetrated into the attic nor were water spots found on interior ceilings. Detection of ceiling stains are usually very difficult unless major leaks are present since the lighting has to be just right to see faint stains. The amount of attic ventilation opening appears to be sufficient for a house of this size. It must be emphasized that these observations were based on those component parts that were visible and the existence of latent defects which could feasibly produce a leak cannot be discounted.

1/14/2009
Leaves on front roof valley

2. The fireplace dampers opened and closed freely, but the one in the rear fireplace was not stay in the closed position and adjustments are needed.
3. Leaves and pine needles are building up and roof valleys at the front of the house and should be clear to avoid water backups. Rusted sheet metal on the roof should be painted to prolong its life.

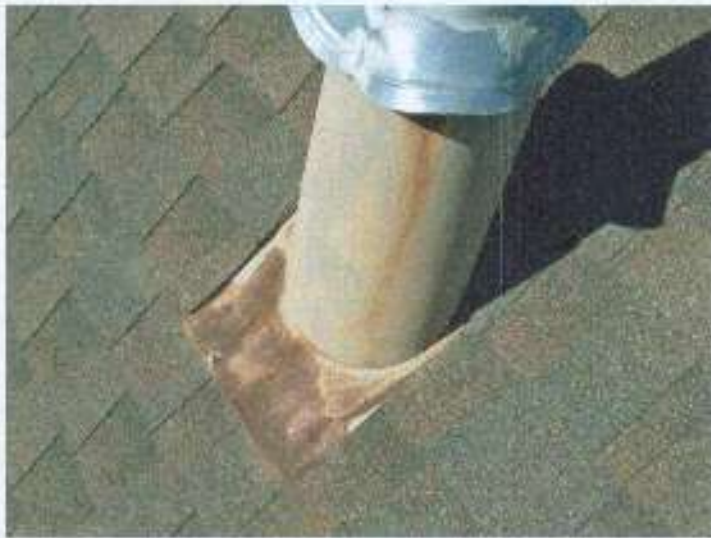
1/14/2009
Rusted roof jack

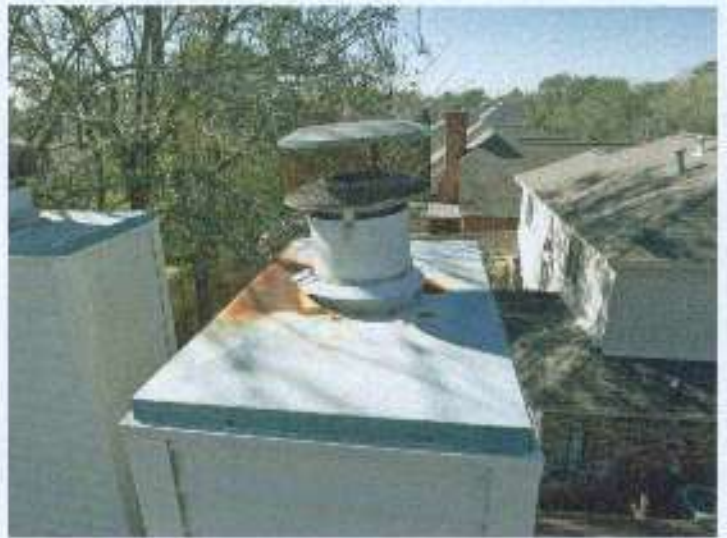
1/14/2009
Rust on chimney cap

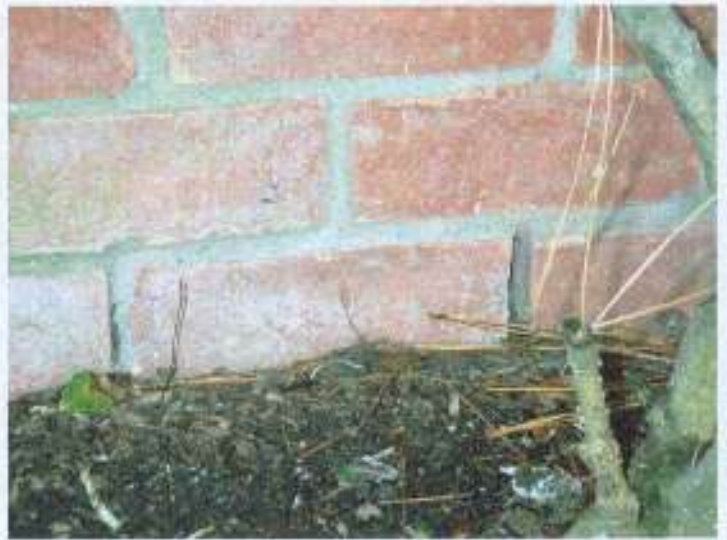
1/14/2009
Soil above slab in spots

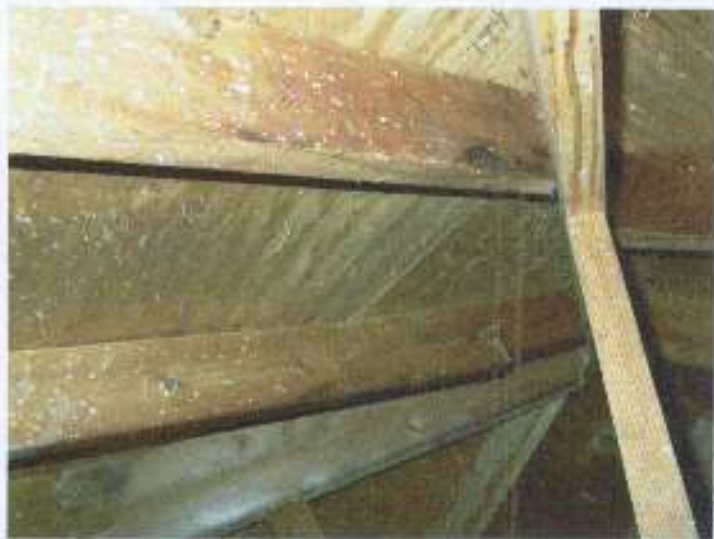
1/14/2009
Cracked rafter in front attic

5. A cracked rafter is present in the front attic space and should be lifted back into position and reinforced by the addition of more 2 x 6 lumber alongside us of the rafter, extending several feet from the affected area.
