Field Service Report For

LM 2500 Repair

**Facility: WG-Pratt & Whitney
Unit: 481-642**

Final Customer Report

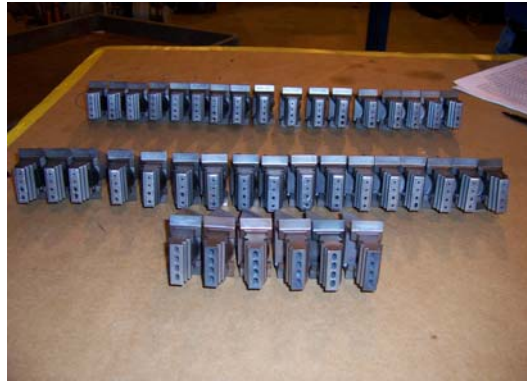
Stage 1 Blades

Discrepancy: Significant wear on Stage 1 HPT blade tips.			
Picture in Folder			
Corrective Action: Replaced stg 1 blades with 48 ea. From WGPW stock and 40 ea. CFM			
		Completed By: RM	Date:

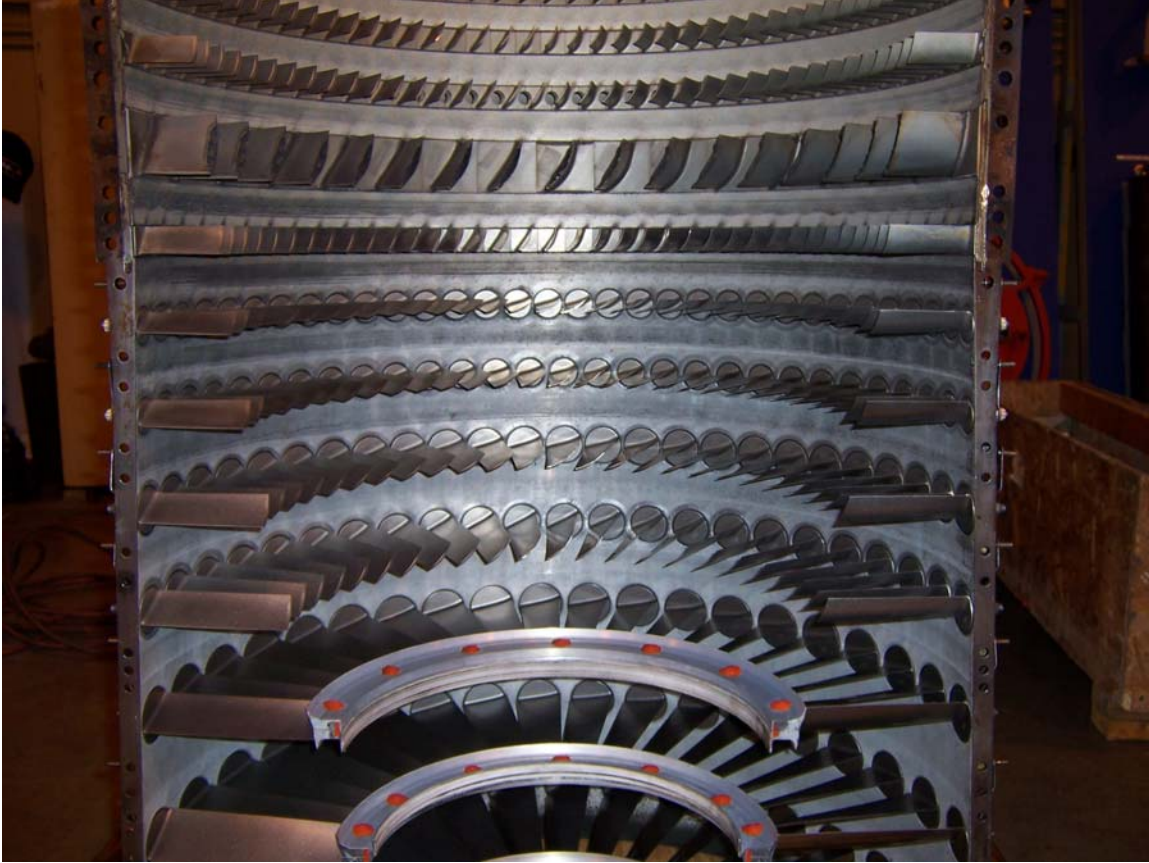
HIGH PRESSURE COMPRESSOR CASE PRIOR TO CLEANING

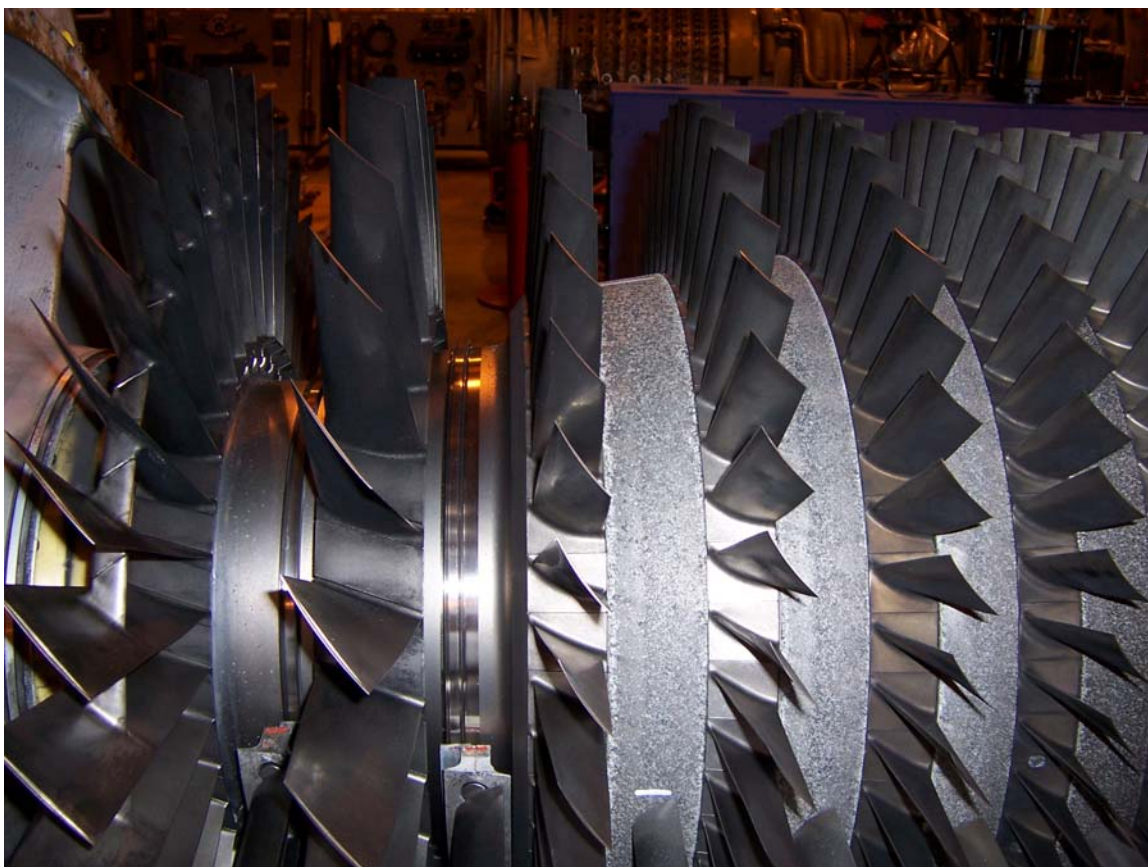
FORWARD COMPRESSOR BLADES PRIOR TO CLEANING

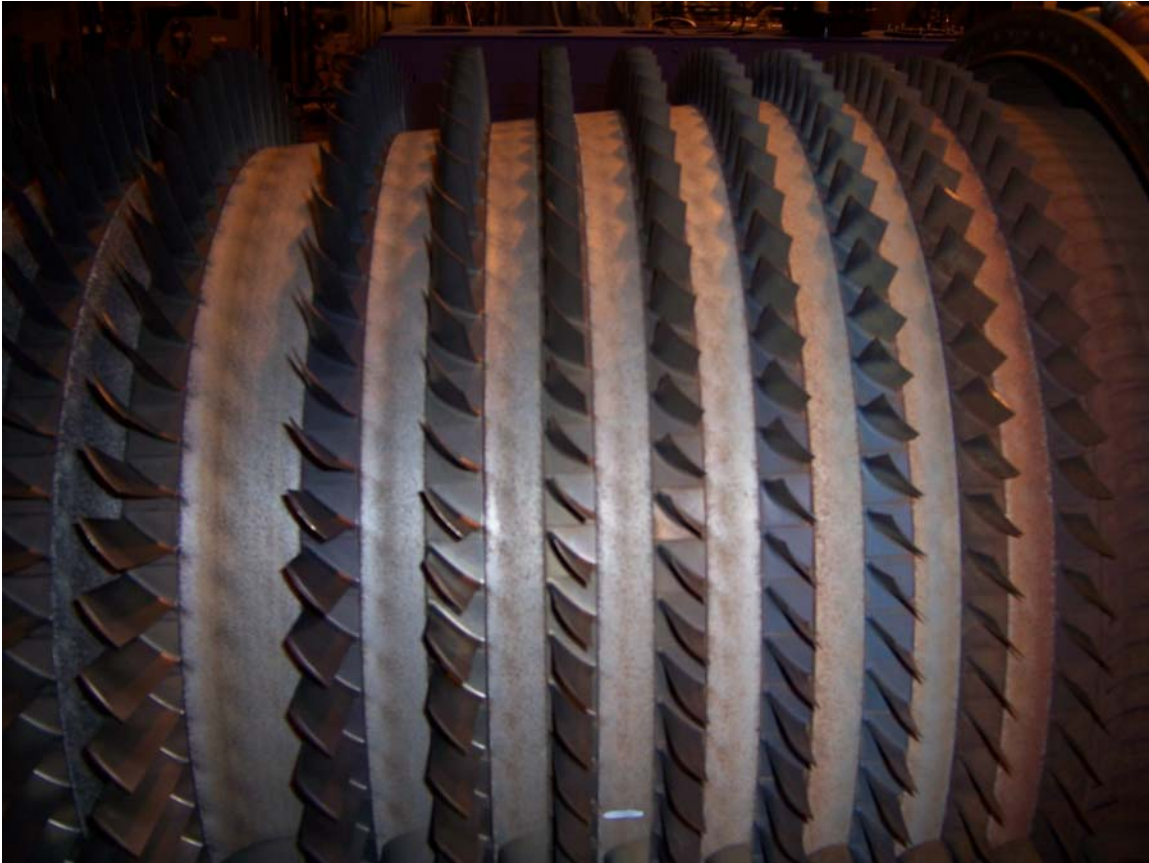
AFT COMPRESSOR STAGES PRIOR TO CLEANING

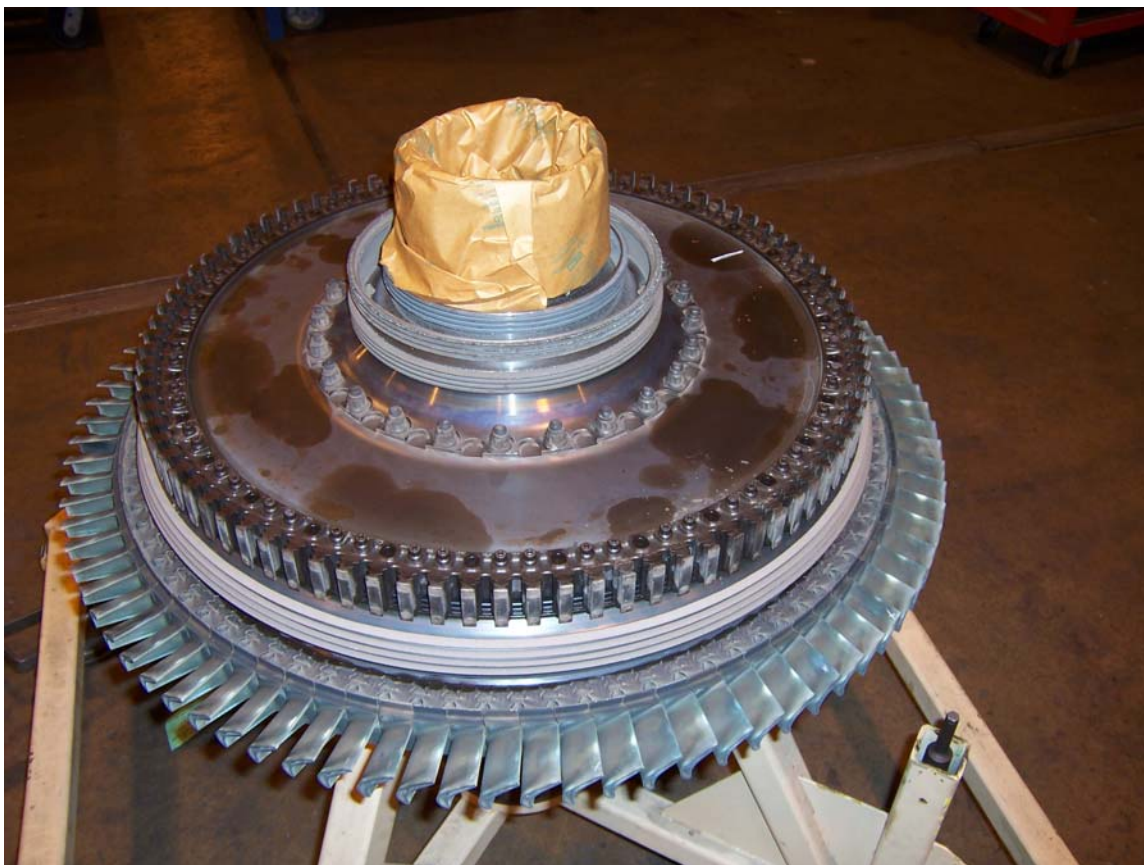
HPT ROTOR PRIOR TO CLEANING AND REPAIR

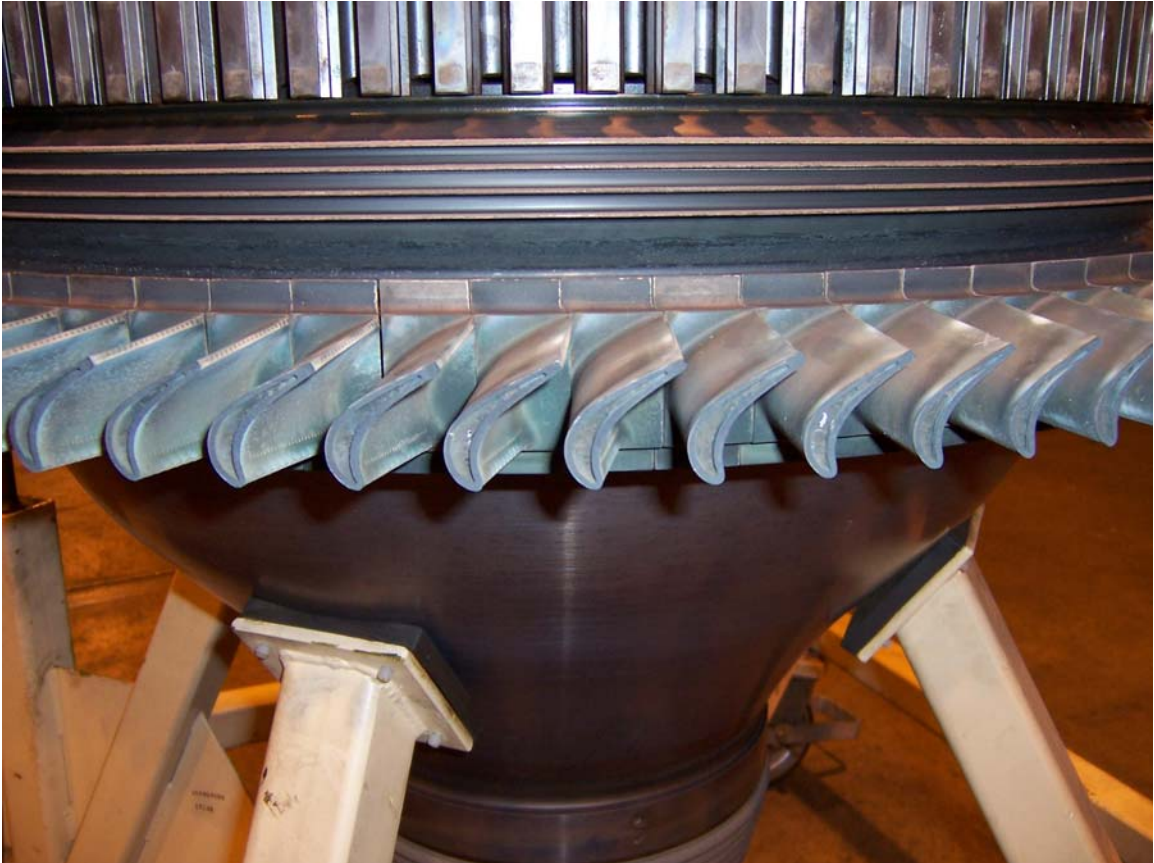
HPT ROTOR STAGE 1 BLADES

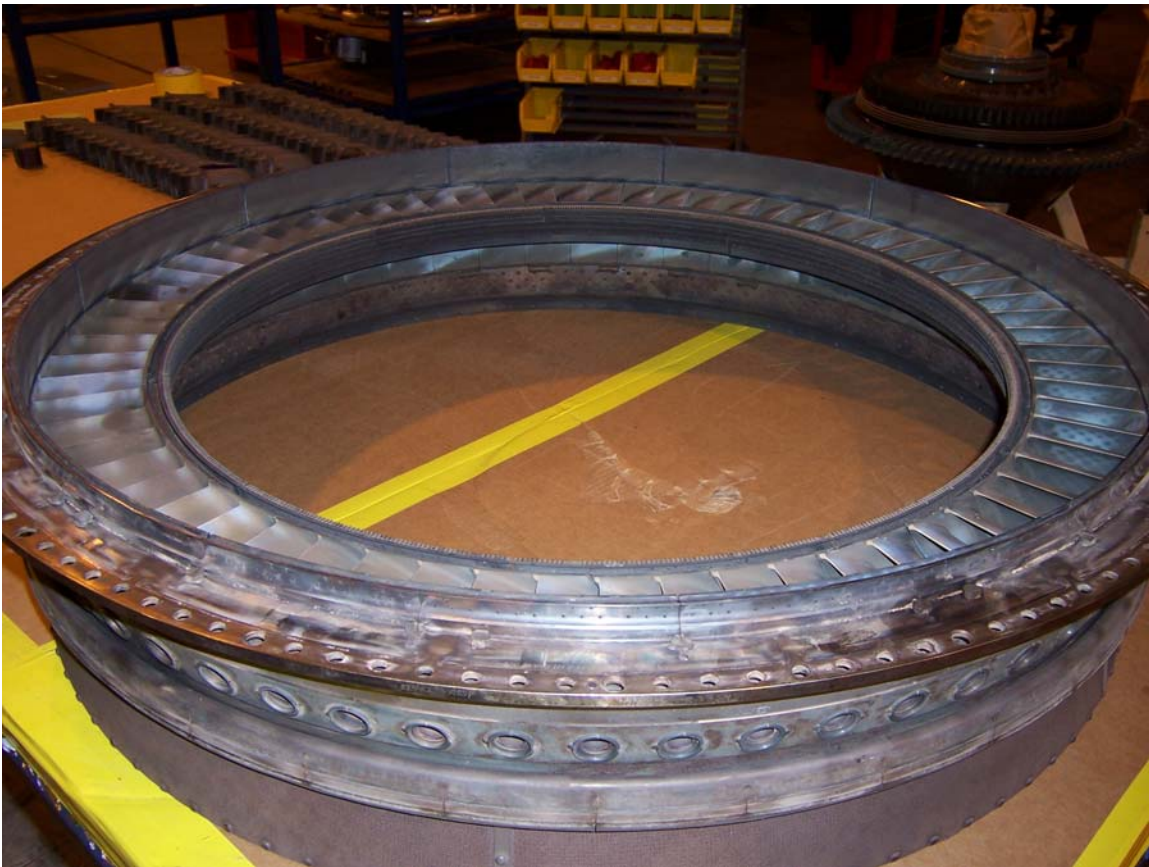
STAGE 2 NOZZLE ASSEMBLY PRIOR TO CLEAN UP AND REPAIR

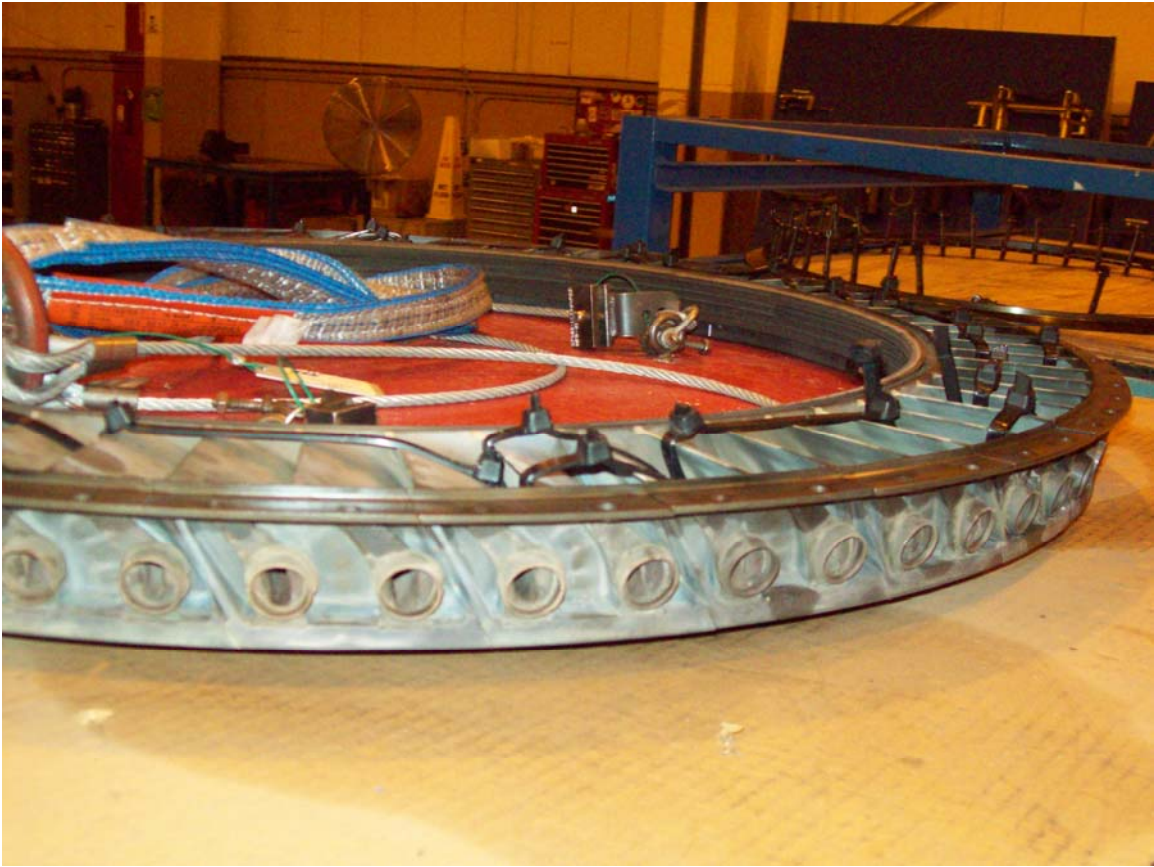
STAGE 2 NOZZLE ASSEMBLY DISSASSEMBLED

2. The stage 2 nozzle assembly is being disassembled today since it arrived from Chromalloy. It was shipped back due to no facility in the US. The damaged shrouds will be removed and replaced. This will take a few days. When finished the nozzle will need to ship out for grind. I forwarded Cost for this earlier but will attach it again. We have a few options on what shrouds to use and we should try and keep the cost down by using their Pratt parts. When the nozzle returns it will be reassembled and installed.

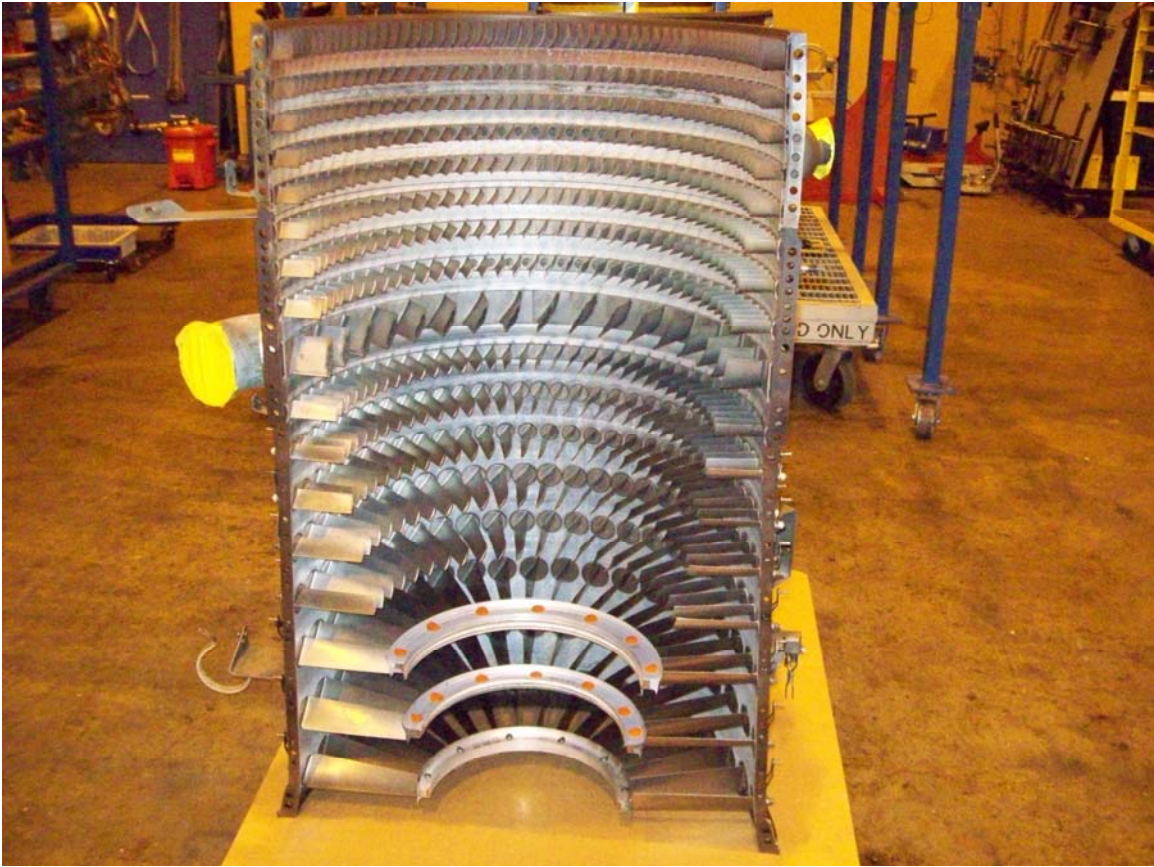
UPPER COMPRESSOR CASE AFTER REMOVAL

3. The compressor cases are being removed due to the case rub which is in serviceable limits. The reason for this is that Rolando and Neill brought this issue to attention for the customer. The plan for the cases is that we are going to try and clean it up. The risk of doing that is possible loss of performance due to opening the blade to case clearances. The only other option would be to rework the cases which is very costly and time consuming. We will measure before and after clearances to have an idea where we will be at after repair.

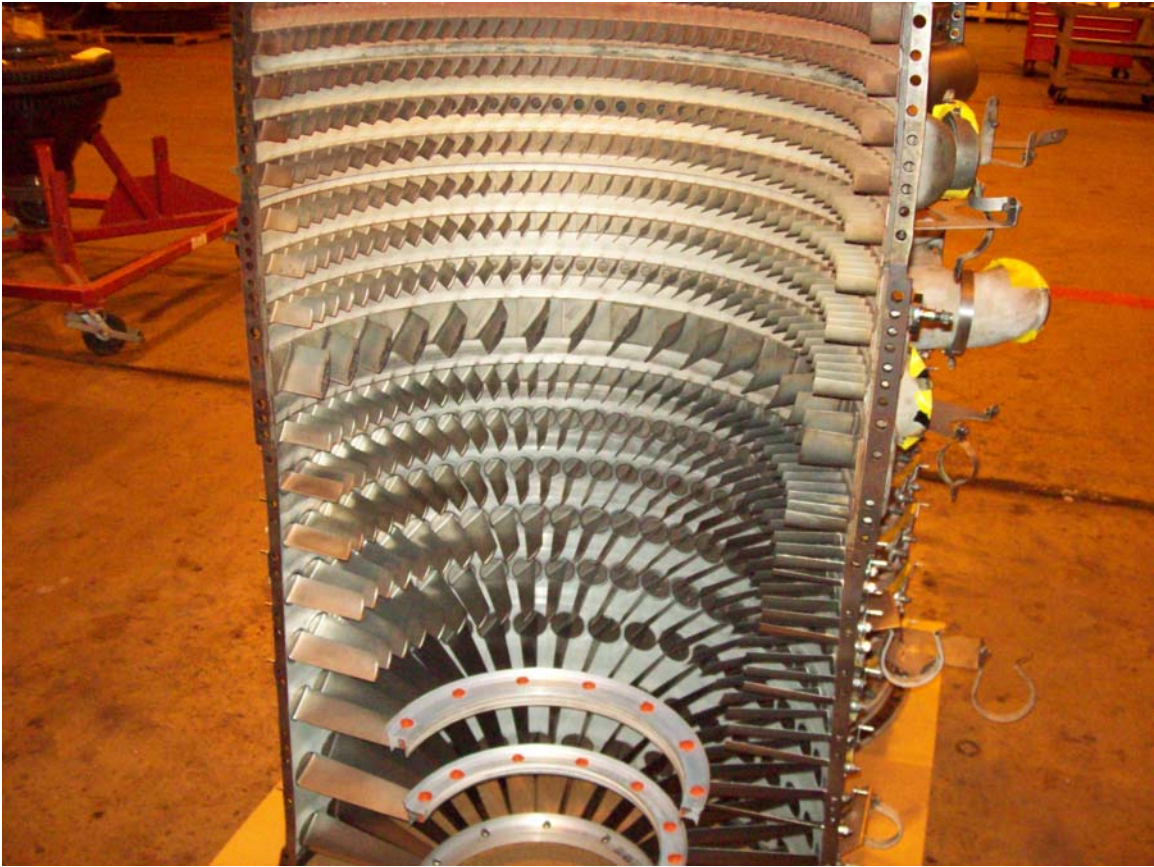
LOWER COMPRESSOR CASE AFTER REMOVAL

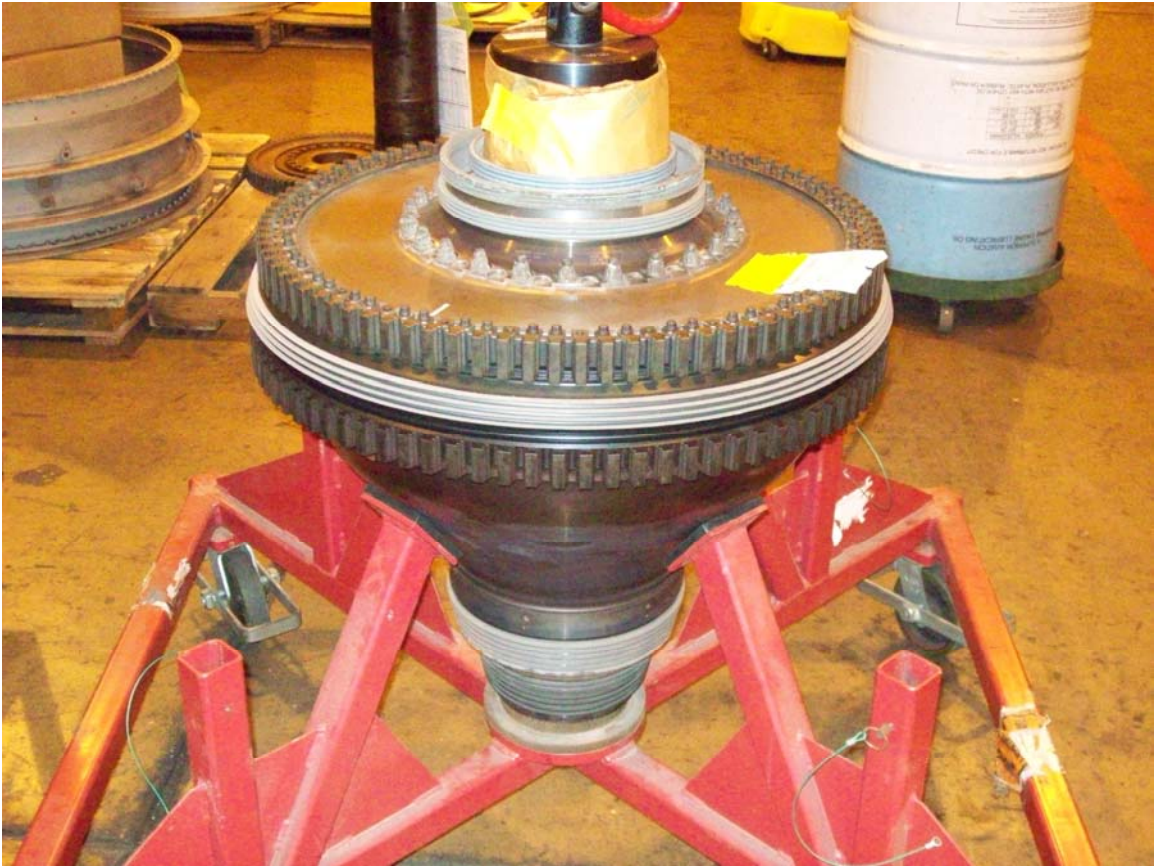
**DEBLADED HPT ROTOR WAITING FOR BLADES TO
COME BACK FROM REPAIR**
