General Electric LM2500 Gas Turbine

LM2500 SAC Borescope Inspection UNIT TM42

ENGINE SERIAL NUMBER:
481-757

LM2500 SAC BORESCOPE REPORT	
Location:	Dar ES Salaam, Tanzania
Purchase order:	TBC, W/O UK80000157
Date of visit:	13-18 May 2008
Purpose:	Borescope inspection in accordance with GEK 97310, Vol. 1, Table 5-4 to Table 5-11
Purpose:	Lube and Scavenge Pump Inlet Screens Inspection and Cleaning in accordance with GEK 97310, Vol. 1, Table 5-3.18
Written by:	Mark Devine
Engine hours:	1281.28
Starts:	N/K
Fuel type:	Dual
Overview:	Engine is acceptable for further operation.

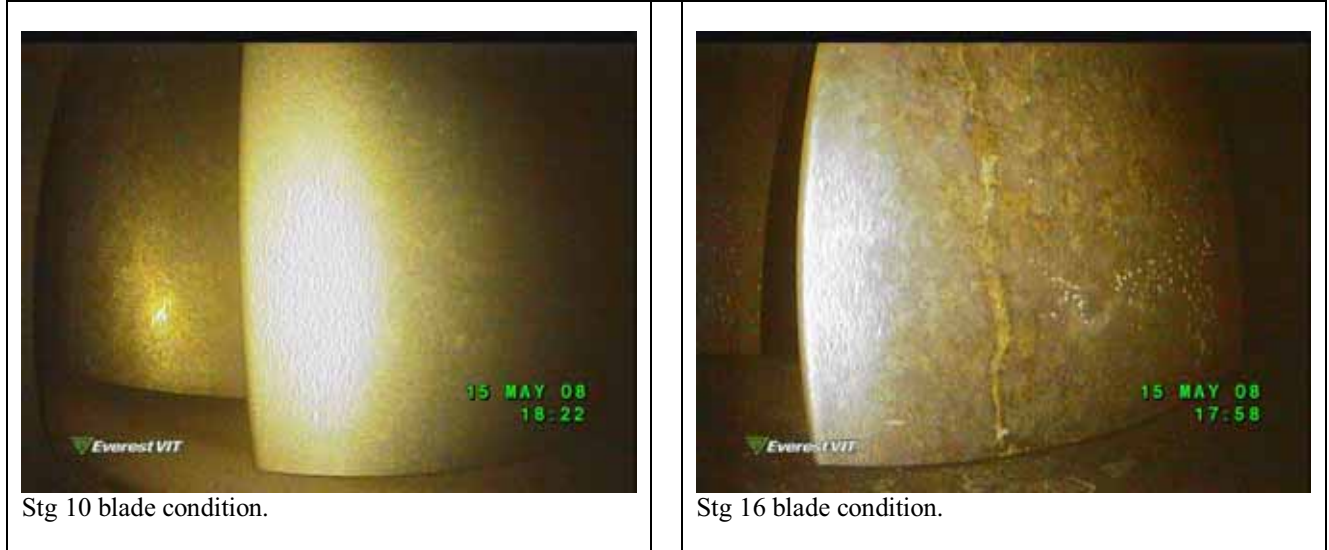
Reference Photographs - HPC Blades and Vanes

Stages 10 through 16 Blades	<ul style="list-style-type: none"> • Stage 10 blades, no damage found. • Stage 15 blades, no damage found. • Stage 16 blades, no defects found. • Acceptable in accordance with GEK 97310 Vol. 1 table 5-4.
Tip clanging contact stages 3-6	<ul style="list-style-type: none"> • No defects found. • Acceptable.
Stator Vanes (all)	<ul style="list-style-type: none"> • No defects found. • Acceptable.
All VSV Vanes	<ul style="list-style-type: none"> • No defects found. • Acceptable.
HPC Rotor and Stator Airflow Path Surfaces	<ul style="list-style-type: none"> • Normal levels of dirt/corrosion present. • Acceptable.

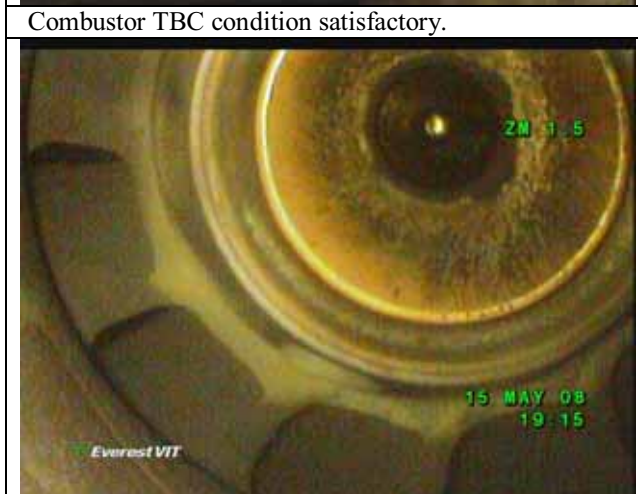
Swirler/nozzle condition.	Fuel nozzle condition.

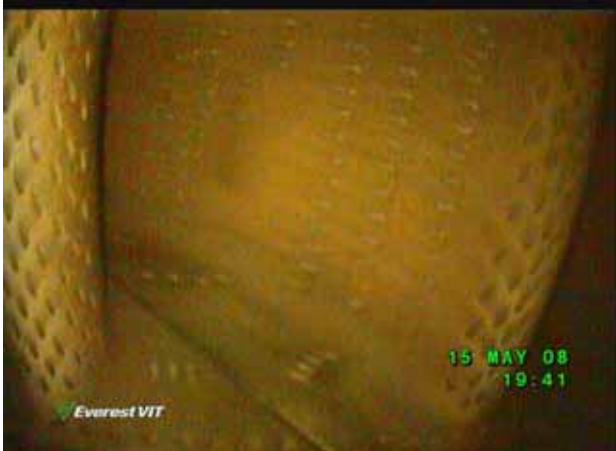
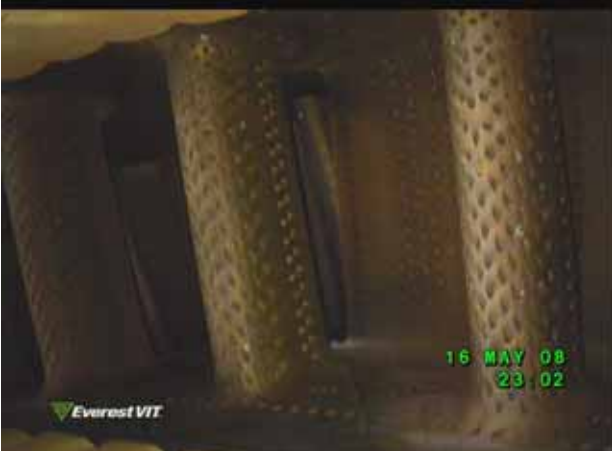
<p>Stg 1 Nozzle condition satisfactory.</p>	<p>Stg 1 Nozzle condition satisfactory.</p>

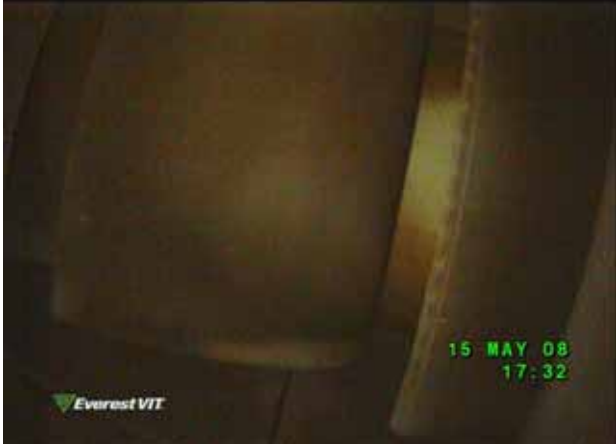
<p>Stg 1 Blade T/E condition satisfactory.</p>	<p>Stg 2 Blade L/E condition satisfactory.</p>

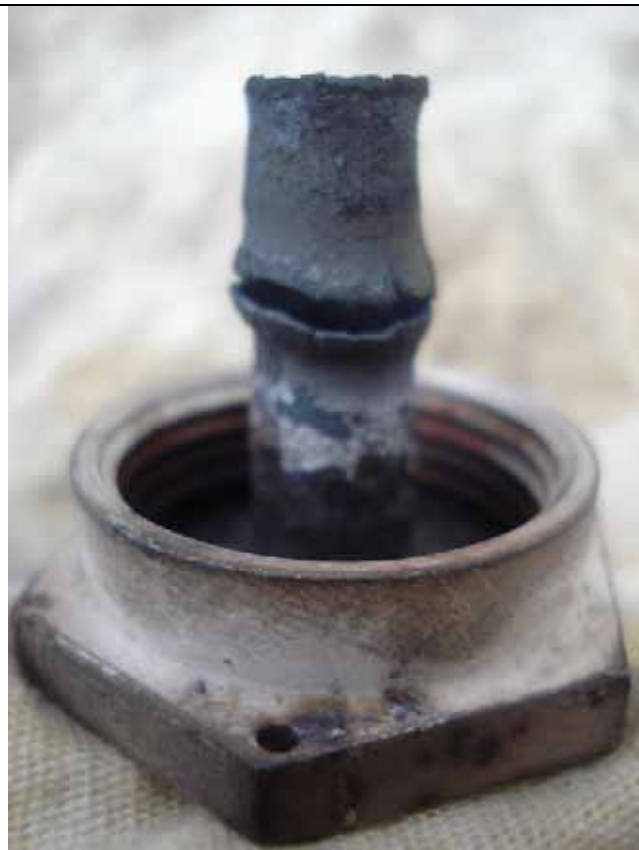
Component	Condition
Lube and Scavenge Pump Inlet Screens Inspection.	<ul style="list-style-type: none"> • B sump screen, minor contamination not metallic. • AGB screen, minor contamination x 1 metallic shard. • Acceptable
Gas Turbine External Inspection.	<ul style="list-style-type: none"> • Stud loose x 2 on power turbine stator case. Unable to tighten without risk of damage/shearing stud. Monitor for continued security, acceptable for continued use. • Thermocouple found U/S at position 10R. • PT54 probe port plug found U/S at position 10M.

U/S PT54 probe port plug.

- Engine condition satisfactory for continued use
- Replace U/S plug, P/N 9103M46P01, Ref GEK50336 Fig 51 item 5 (quote to follow)
- Dowans to replace U/S thermocouple with own stock.

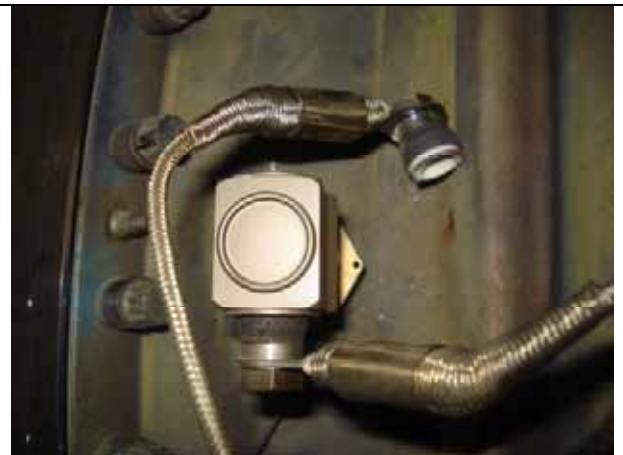
U/S thermocouple.
