General Electric LM2500 Gas Turbine

## **LM2500 SAC Borescope Inspection UNIT TM41**

ENGINE SERIAL NUMBER:  
481-694

### LM2500 SAC BORESCOPE REPORT

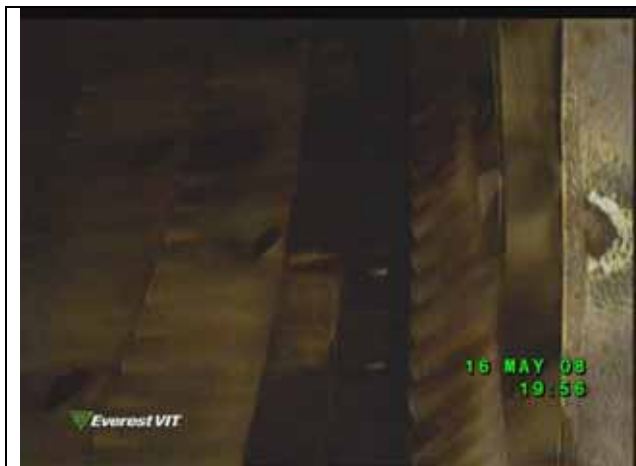
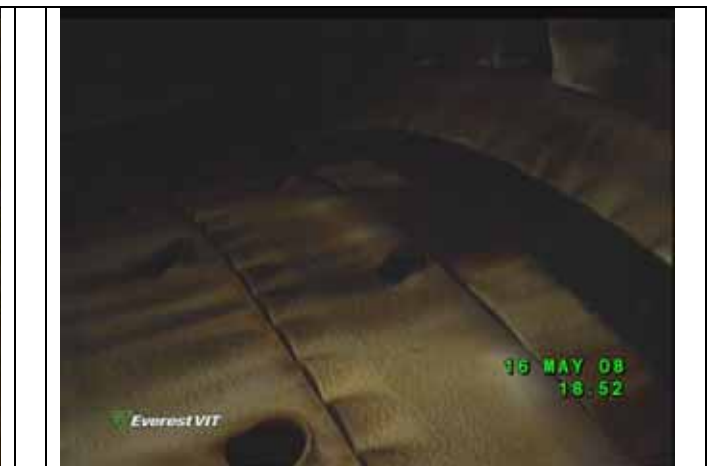
Combustor TBC condition satisfactory	Combustor TBC condition satisfactory

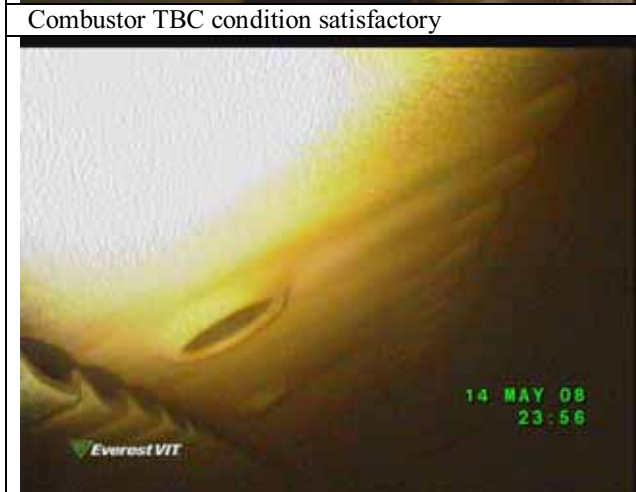
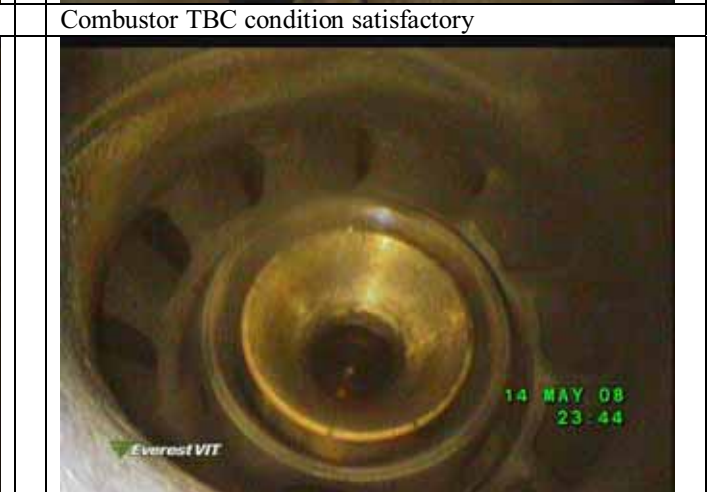
Combustor TBC condition satisfactory	Swirler/Nozzle condition satisfactory

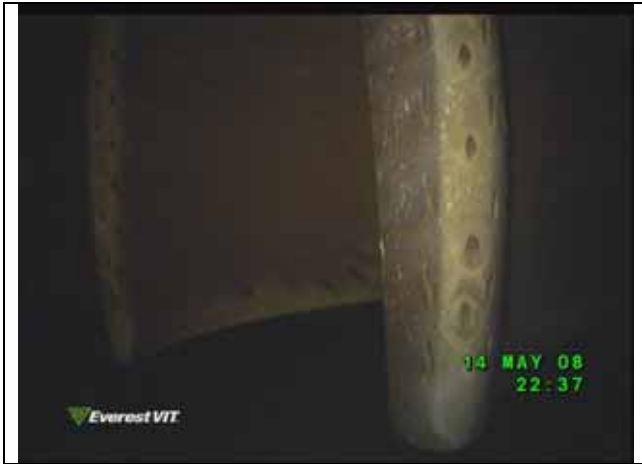
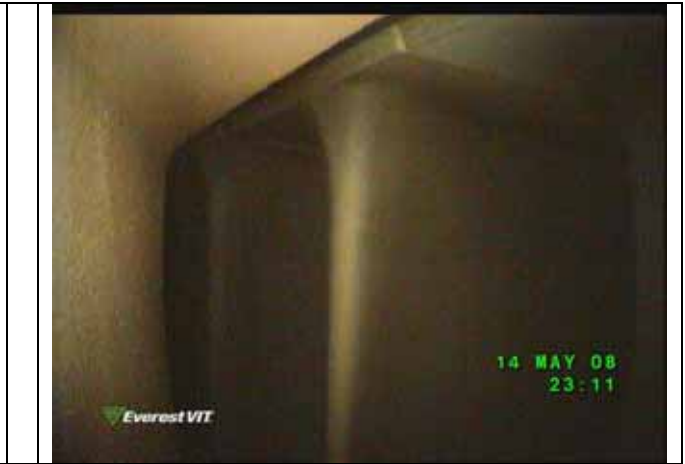
<p>14 MAY 08 23:11 Everest VIT</p>
Stg 1 Blade condition satisfactory.	Stg 2 Blade condition satisfactory.
