General Electric LM2500 Gas Turbine

LM2500 SAC Borescope Inspection UNIT TM 43

ENGINE SERIAL NUMBER:
481-774

LM2500 SAC BORESCOPE REPORT	
Location:	Dar ES Salaam, Tanzania
Purchase order:	TBC, W/O UK80000157
Date of visit:	13-18 May 2008
Purpose:	Borescope inspection in accordance with GEK 97310, Vol. 1, Table 5-4 to Table 5-11
Purpose:	Lube and Scavenge Pump Inlet Screens Inspection and Cleaning in accordance with GEK 97310, Vol. 1, Table 5-3.18
Written by:	Mark Devine
Engine hours:	1483.22
Starts:	N/K
Fuel type:	Dual
Overview:	Engine has no reported defects, acceptable for further operation

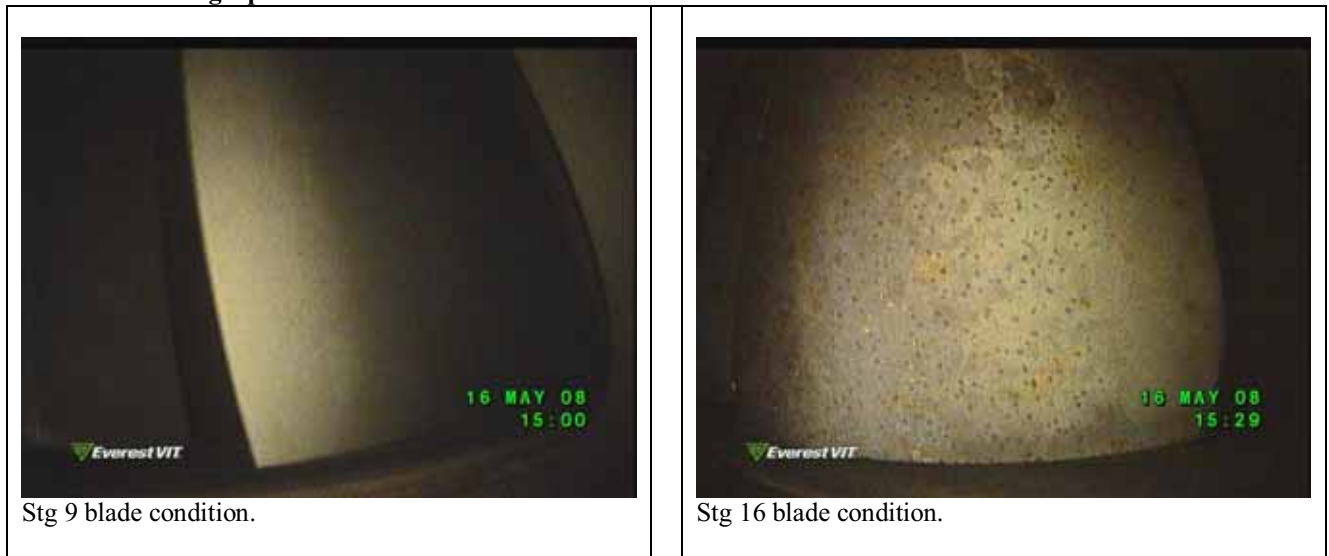
Reference Photographs - HPC Blades and Vanes

Component	Condition
Stages 1 through 9 Blades	<ul style="list-style-type: none"> Stage 3 blades, no damage found. Stage 4 blades, no damage found. Stage 9 blades, no damage found. Acceptable in accordance with GEK 97310 Vol. 1 table 5-4.

Stages 10 through 16 Blades	<ul style="list-style-type: none"> • Stage 10 blades, no damage found. • Stage 15 blades, no damage found. • Stage 16 blades, no damage found. • Acceptable in accordance with GEK 97310 Vol. 1 table 5-4.
Tip clanging contact stages 3-6	<ul style="list-style-type: none"> • No defects found. • Acceptable.
Stator Vanes (all)	<ul style="list-style-type: none"> • No defects found. • Acceptable.
All VSV Vanes	<ul style="list-style-type: none"> • No defects found. • Acceptable.
HPC Rotor and Stator Airflow Path Surfaces	<ul style="list-style-type: none"> • Normal levels of dirt/corrosion present. • Acceptable.

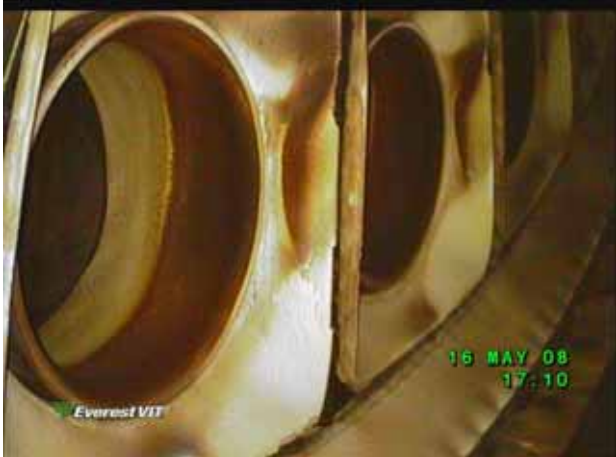
Component	Condition
All Combustor Surfaces	<ul style="list-style-type: none"> General condition good.
Dome Band/Dome Plate	<ul style="list-style-type: none"> Minor thermal barrier coating loss/degradation-acceptable
Riveted Joints	<ul style="list-style-type: none"> No defects found
Trumpet and swirler cups	<ul style="list-style-type: none"> Thermal barrier coating loss/degradation-acceptable.
Dome Assembly	<ul style="list-style-type: none"> No defects found
Igniter Ferrule	<ul style="list-style-type: none"> No defects found
Combustor Cowl	<ul style="list-style-type: none"> No defects found
Inner and Outer Liner	<ul style="list-style-type: none"> No defects found
Fuel nozzle	<ul style="list-style-type: none"> No defects found

Combustor TBC condition satisfactory.	Swirler/nozzle condition.

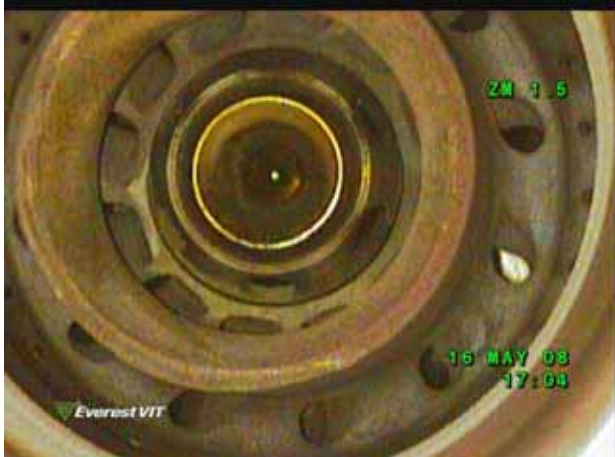
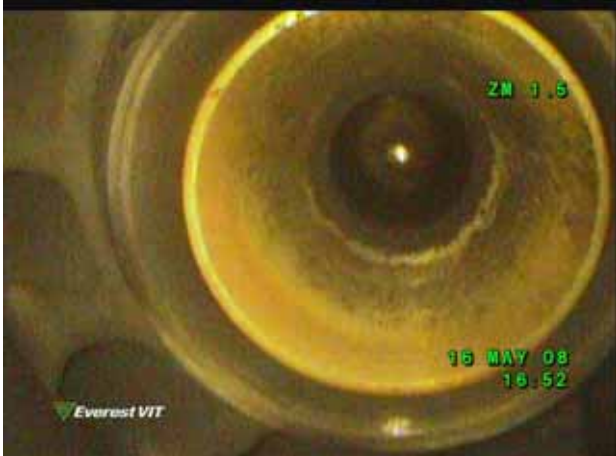
Swirler/nozzle condition.

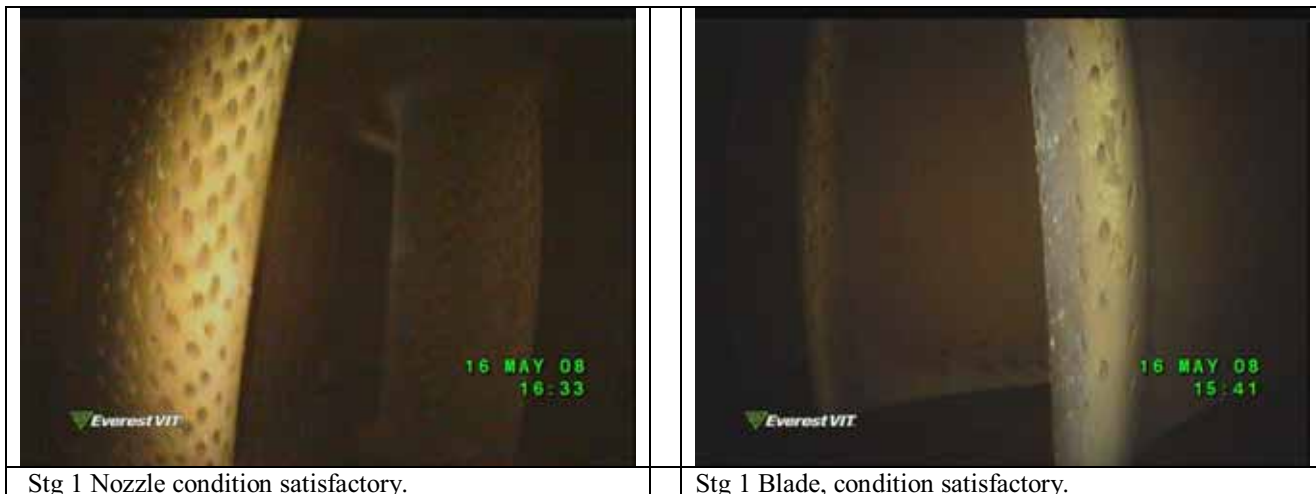
Reference Photographs – HPT assembly

Stg 2 Blade, condition satisfactory.

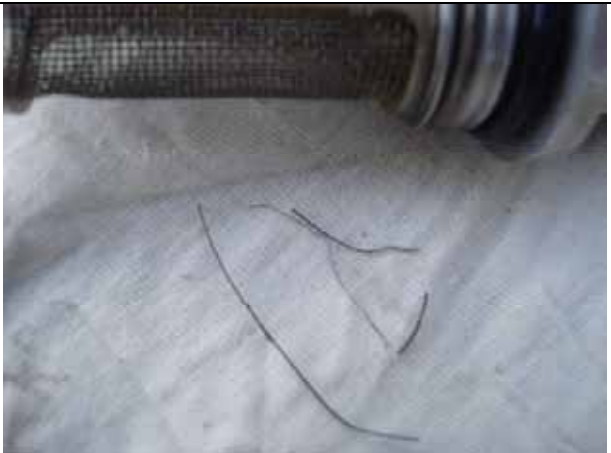
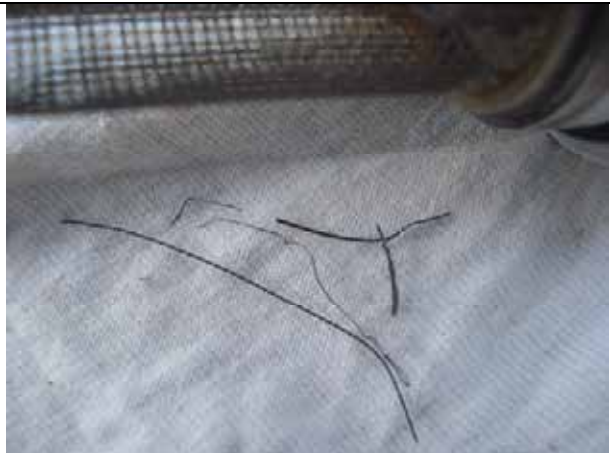
Component	Condition
Lube and Scavenge Pump Inlet Screens Inspection.	<ul style="list-style-type: none"> • C sump screen contaminated with magnetic wire strands. • Remaining screens clear. • Acceptable
Gas Turbine External Inspection.	<ul style="list-style-type: none"> • No defects found.

C sump screen contamination.	C sump screen contamination.

- Regular inspection of L&S scavenge screens recommended
- Engine condition satisfactory for continued use.
