General Electric LM2500 Gas Turbine

LM2500 SAC Borescope Inspection UNIT TM41

CUST – DOWANS

ENGINE SERIAL NUMBER:
481-694

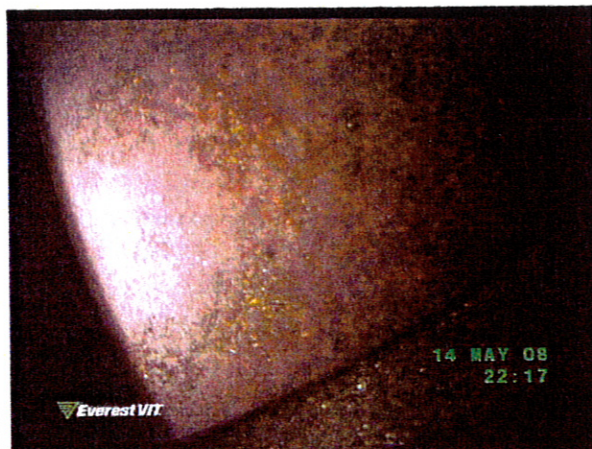
Stages 10 through 16 Blades	<ul style="list-style-type: none"> • Stage 10 blades, no damage found. • Stage 15 blades, no damage found. • Stage 16 blades, no defects found. • Acceptable in accordance with GEK 97310 Vol. 1 table 5-4.
Tip clanging contact stages 3-6	<ul style="list-style-type: none"> • No defects found. • Acceptable.
Stator Vanes (all)	<ul style="list-style-type: none"> • No defects found. • Acceptable.
All VSV Vanes	<ul style="list-style-type: none"> • No defects found. • Acceptable.
HPC Rotor and Stator Airflow Path Surfaces	<ul style="list-style-type: none"> • Normal levels of dirt/corrosion present. • Acceptable.

Stg 16 blade condition

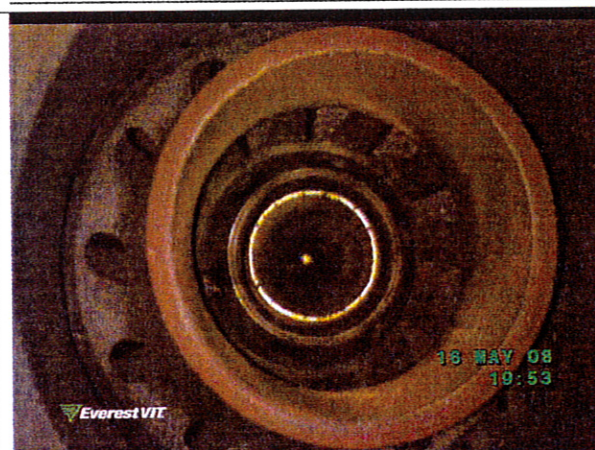
Swirler/nozzle condition satisfactory

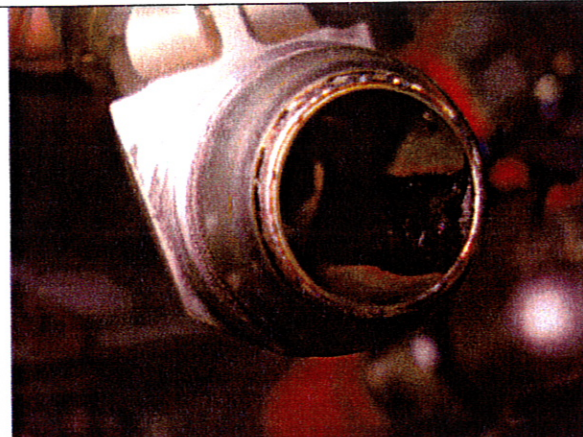
Inner and Outer Liner	<ul style="list-style-type: none"> No defects found
Fuel nozzle	<ul style="list-style-type: none"> 3 fuel nozzles were removed from engine for inspection. #11 pos S/N PHCHN387, #17 pos S/N PHCHN388, #26 pos S/N PHCHN320. One fuel nozzle found with contamination/residue, suspect remnants of liquid fuel running Fuel nozzle #11 position S/N PHCHN387 replaced in accordance with GEK97310 SWP 104 04. Fuel Nozzle installed P/N L31809P10, S/N PHCC2735, customers own stock

Fuel nozzle residue.

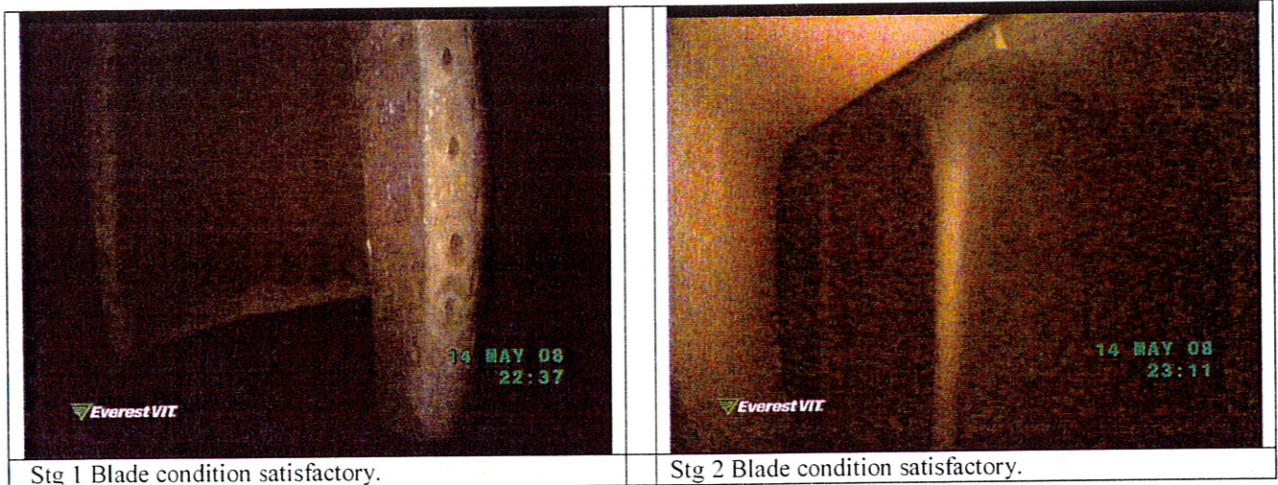
Reference Photographs – HPT assembly

Component	Condition		
HPT Stage 1 Nozzle Assembly	Defect	Location	Findings/GEK limits
	Nozzle airfoil		
	N/A	N/A	No defects found in areas inspected
	Inner and Outer Platform		
	N/A	N/A	No defects found in areas inspected
	General remarks	Condition satisfactory for continued use.	
HPT Rotor Blade-Stage 1	Defect	Location	Findings/GEK limits
	HPT Rotor Blades-Leading Edge Area A		
	N/A	N/A	No defects found
	HPT Rotor Blades-Leading Edge Area B		
	N/A	N/A	No defects found
	HPT Rotor Blade Tips		
	N/A	N/A	No defects found
	HPT Rotor Blade-Trailing Edge Area A		
	N/A	N/A	No defects found
	HPT Rotor Blade-Trailing Edge Area B		
	N/A	N/A	No defects found
	HPT Rotor Blade-Concave Surface Area A		
	N/A	N/A	No defects found
	General remarks	Condition satisfactory for continued use	
HPT Stages 1 and 2 Nozzle Shroud	Defect	Location	Findings/GEK limits
	N/A	N/A	No defects found in areas inspected
	General remarks	Condition satisfactory for continued use

HPT Stage 2 Nozzle Assembly	Defect	Location	Findings/GEK limits
	N/A	N/A	No defects found in areas inspected
	General remarks	Condition satisfactory for continued use	
HPT Rotor Blade-Stage 2	Defect	Location	Findings/GEK limits
	HPT Rotor Blades-Leading Edge Area A		
	N/A	N/A	No defects found
	HPT Rotor Blades-Leading Edge Area B		
	N/A	N/A	No defects found
	HPT Rotor Blade Tips		
	N/A	N/A	No defects found
	HPT Rotor Blade-Trailing Edge Area A		
	N/A	N/A	No defects found
	HPT Rotor Blade-Trailing Edge Area B		
	N/A	N/A	No defects found
	HPT Rotor Blade-Concave Surface Area A		
	N/A	N/A	No defects found
	General remarks	Condition satisfactory for continued use.	
HPT Stage 2 Nozzle Shroud	Defect	Location	Findings/GEK limits
	N/A	N/A	No defects found in areas inspected
	General remarks	Condition satisfactory for continued use

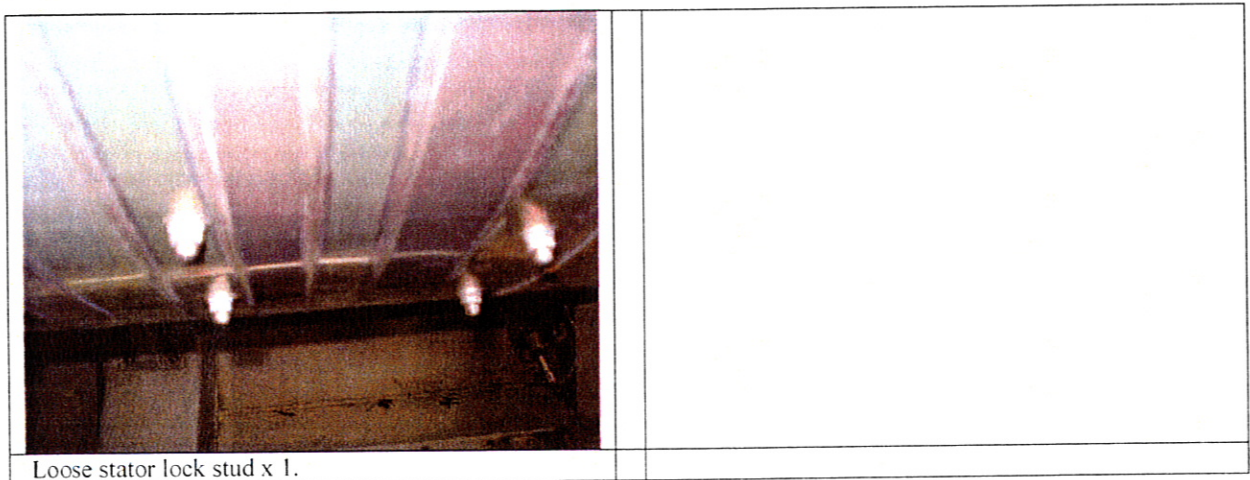
Component	Condition
Lube and Scavenge Pump Inlet Screens Inspection.	<ul style="list-style-type: none"> All screens and magnetic plugs found to be clean.
Gas Turbine External Inspection.	<ul style="list-style-type: none"> Stud loose on power turbine stator case. Unable to tighten without risk of damage/shearing stud. Monitor for continued security, acceptable for continued use.

- Engine condition satisfactory for continued use
- Lubricate the loose LPTS lock in hopes to tighten in situ, if not find suitable application to retain loose assembly to avoid case damage.
- Customer has reported a higher heat rate compared to the other units. The following steps are recommended
 - Inlet inspection
 - Inspection of filtration system (to include differential pressure reading and ensure instrumentation is calibrated) – this is higher than TM43, refer to package limits.
 - Inspect air inlet for dirty filters- replace as required
 - Inspect for on engine pipe leaks
 - Device inspection and calibration
 - Perform VSV system inspection checks in accordance GEK 97310 Vol. 2 WP118 00 and WP 206 00 – recommend full system (VIGV – HP6)
