General Electric LM2500 Gas Turbine

LM2500 SAC Borescope Inspection UNIT TM 43

CUST – DOWANS

ENGINE SERIAL NUMBER:
481-774

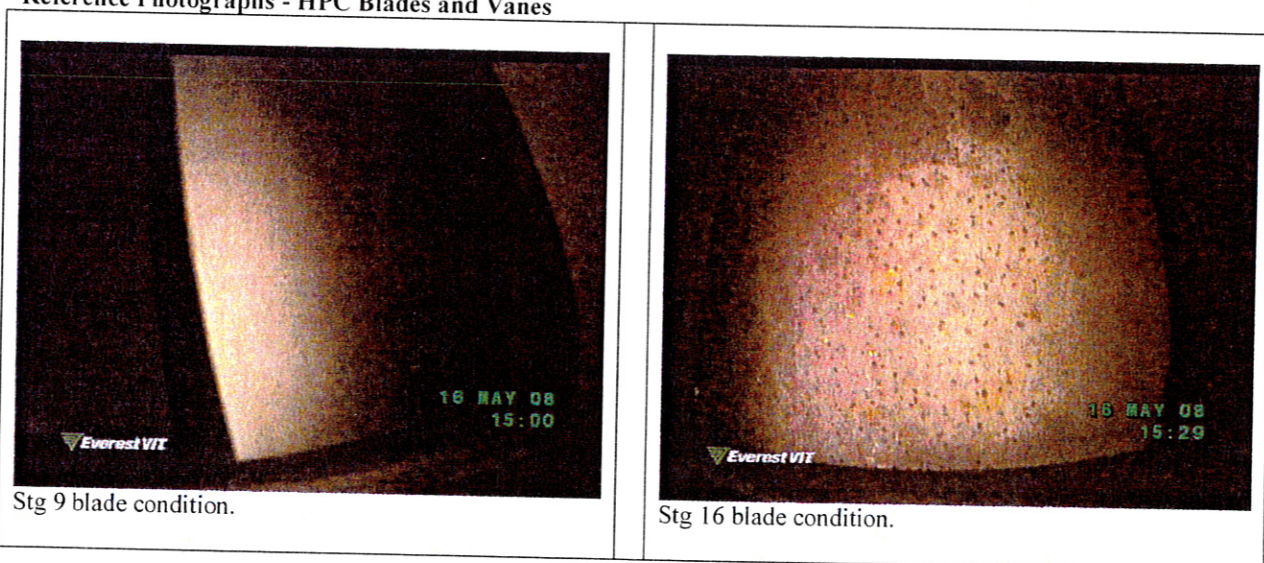
Reference Photographs - HPC Blades and Vanes

Volume 1, Tbl 5-4 – Tbl 5-11	LM2500 SAC Borescope inspection
COMPRESSOR:	
Component	Condition
Stages 1 through 9 Blades	<ul style="list-style-type: none"> Stage 3 blades, no damage found. Stage 4 blades, no damage found. Stage 9 blades, no damage found. Acceptable in accordance with GEK 97310 Vol. 1 table 5-4.

Stages 10 through 16 Blades	<ul style="list-style-type: none"> • Stage 10 blades, no damage found. • Stage 15 blades, no damage found. • Stage 16 blades, no damage found. • Acceptable in accordance with GEK 97310 Vol. 1 table 5-4.
Tip clanging contact stages 3-6	<ul style="list-style-type: none"> • No defects found. • Acceptable.
Stator Vanes (all)	<ul style="list-style-type: none"> • No defects found. • Acceptable.
All VSV Vanes	<ul style="list-style-type: none"> • No defects found. • Acceptable.
HPC Rotor and Stator Airflow Path Surfaces	<ul style="list-style-type: none"> • Normal levels of dirt/corrosion present. • Acceptable.

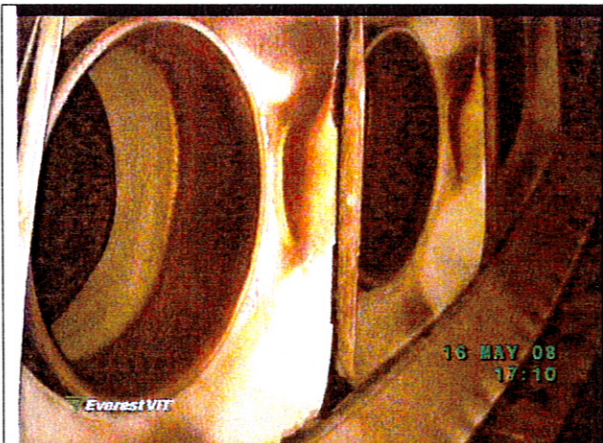
<p>16 MAY 08 17:10 Everest VIT</p>

Component	Condition
All Combustor Surfaces	<ul style="list-style-type: none"> General condition good.
Dome Band/Dome Plate	<ul style="list-style-type: none"> Minor thermal barrier coating loss/degradation-acceptable
Riveted Joints	<ul style="list-style-type: none"> No defects found
Trumpet and swirler cups	<ul style="list-style-type: none"> Thermal barrier coating loss/degradation-acceptable.
Dome Assembly	<ul style="list-style-type: none"> No defects found
Igniter Ferrule	<ul style="list-style-type: none"> No defects found
Combustor Cowl	<ul style="list-style-type: none"> No defects found
Inner and Outer Liner	<ul style="list-style-type: none"> No defects found
Fuel nozzle	<ul style="list-style-type: none"> No defects found

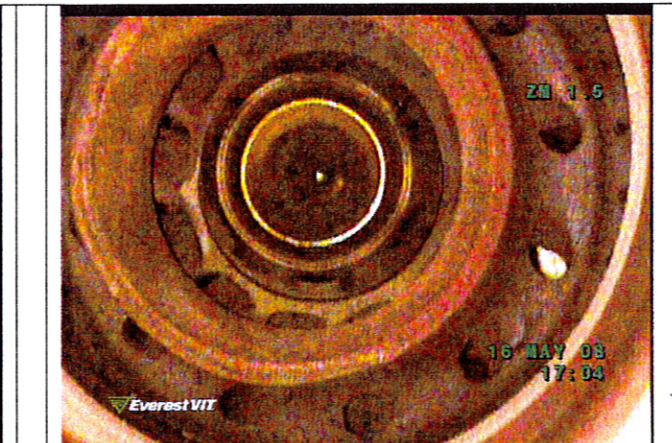
<p>ZM 1.6 16 MAY 08 17:04 Everest VIT</p>
Combustor TBC condition satisfactory.	Swirler/nozzle condition.

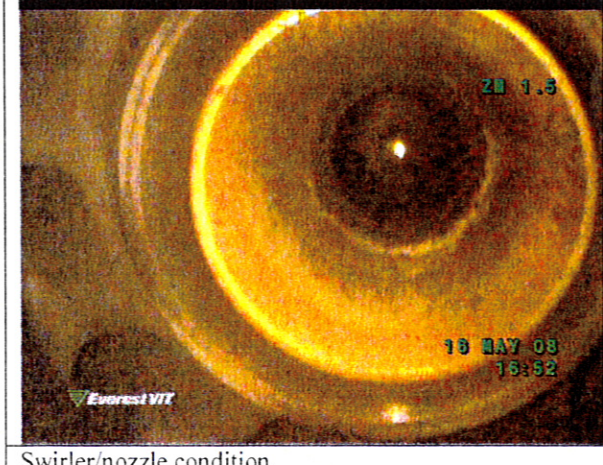
<p>ZM 1.5 16 MAY 08 16:52 Everest VIT</p>	
Swirler/nozzle condition.

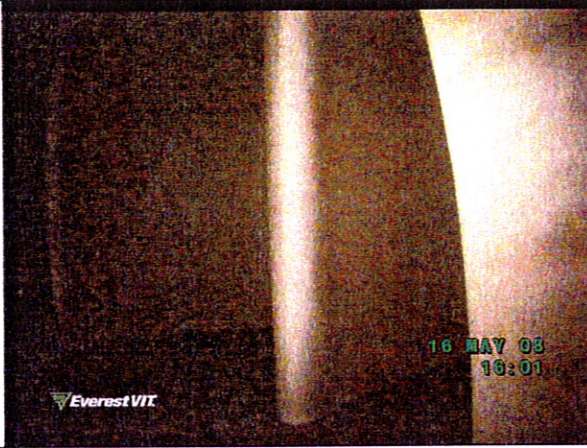
Stg 2 Blade, condition satisfactory.

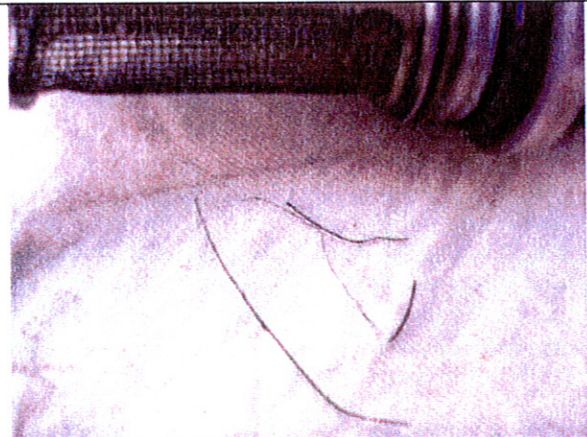
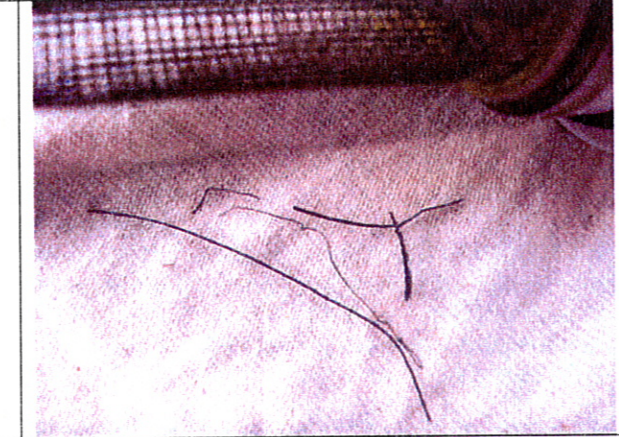
Component	Condition
Lube and Scavenge Pump Inlet Screens Inspection.	<ul style="list-style-type: none"> • C sump screen contaminated with magnetic wire strands. • Remaining screens clear. • Acceptable
Gas Turbine External Inspection.	<ul style="list-style-type: none"> • No defects found.

C sump screen contamination.	C sump screen contamination.

- Regular inspection of L&S scavenge screens recommended
- Engine condition satisfactory for continued use.
