1 PART PLAN AT 34TH FLOOR

<div>One Penn Plaza 250 West 34th st New York, NY 10119 (212) 687-9888 www.wsp.com/usa</div>	CLIENT: FORTIS PROPERTY GROUP,LLC	PROJECT: 161 MAIDEN LANE	REF. DWG. S-340	
	ARCHITECT: HILL & WEST ARCHITECTS,LLP	TITLE: REINFORCEMENT REPAIR FOR DAMAGED SLAB REINFORCEMENT AT 34TH FLOOR	DESIGN BY: JL	CHECKED BY: JL
			DRAWN BY:	DATE: 04.09.2018
			SCALE:	DRAWING No: SSK-52
			PROJECT No: B1310880	SHEET 1 OF 1
			CAD FILE:

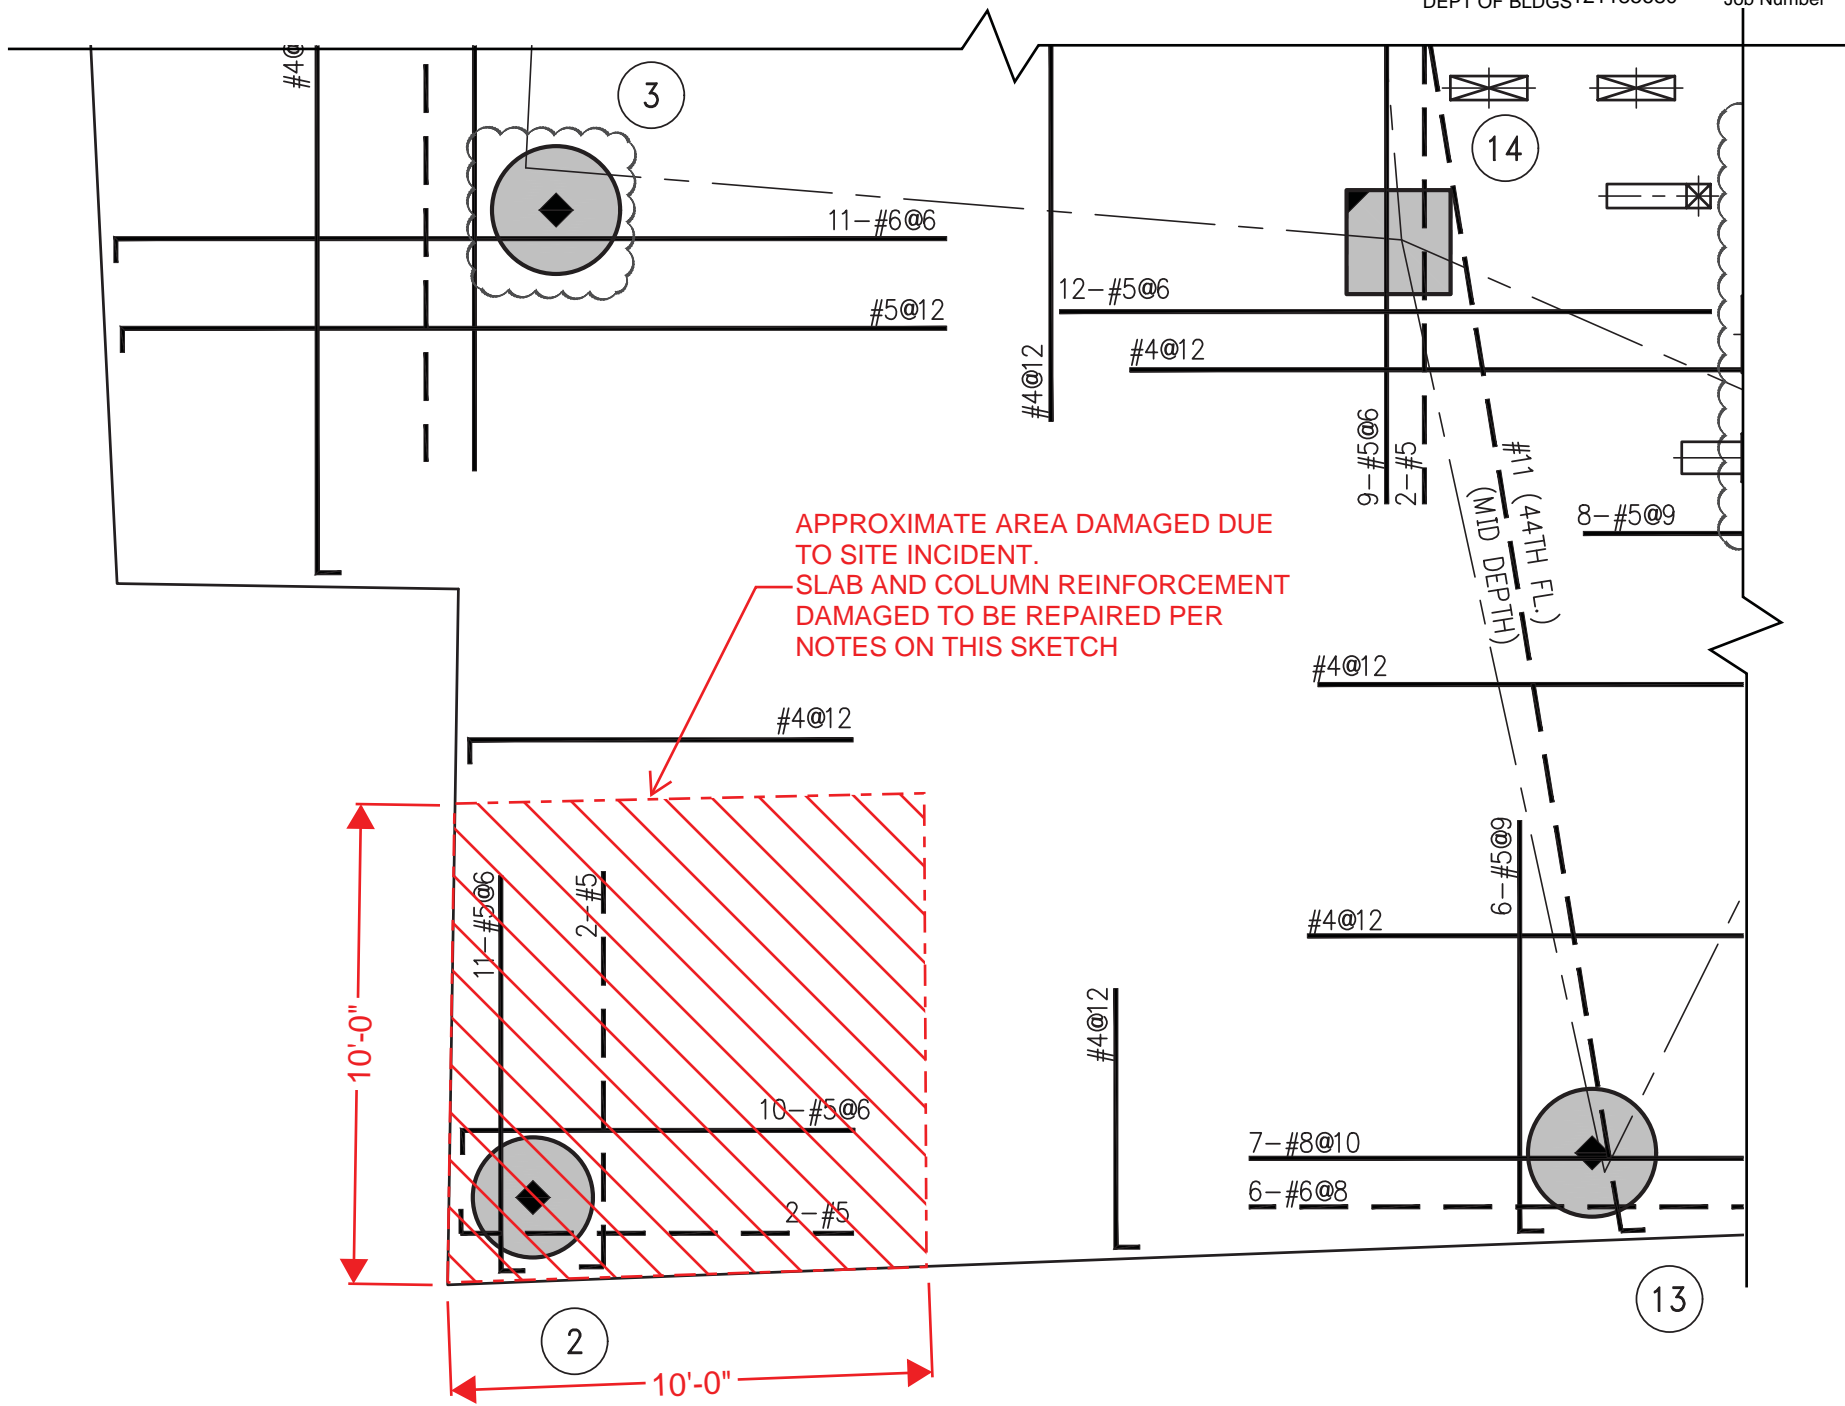
APPROXIMATE AREA DAMAGED DUE TO SITE INCIDENT. SLAB AND COLUMN REINFORCEMENT DAMAGED TO BE REPAIRED PER NOTES ON THIS SKETCH

- NOTES:
- 1. ANY REINFORCEMENT DAMAGED DUE TO THE SITE INCIDENT SHALL BE REPLACED ACCORDING TO DESIGN DRAWINGS.
 - 2. ANY SLAB REINFORCEMENT CUT DURING REPAIR OF FORMWORK SHOULD BE REPLACED ACCORDING TO DESIGN DRAWINGS.
 - 3. REPAIR OF CONTINUOUS BOTTOM BAR ARE ALLOWED TO BE SPLICED AT 1/3 DISTANCE BETWEEN COLUMNS WITH TENSION SPLICE.
 - 4. REPAIR OF CONTINUOUS TOP BAR ARE TO BE SPLICED AT MID SPAN WITH TENSION SPLICE.
 - 5. VERTICAL DOWELS FOR COLUMN 2 THAT ARE DAMAGED SHALL BE REPLACED TO MAINTAIN COMPRESSION SPLICE LENGTH.
 - 6. REPAIRED SLAB AND COLUMN REINFORCEMENT TO BE REINSPECTED AND APPROVED BY REBAR INSPECTOR PRIOR TO CONCRETE POUR.
