## ADSP-218x EZ-ICE Tips and Tricks

Last Modified: 4/30/98

### Introduction:

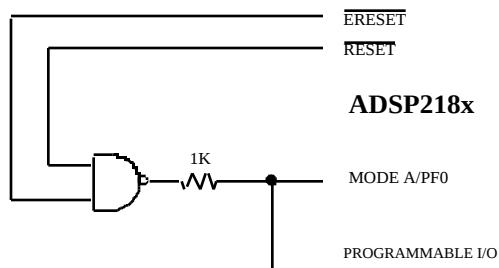
**Figure 1: Active Mode Pin Configuration Example**

Some customers may experience problems using the emulator with 100-pin 218x variants. First, make sure that the mode pins of the DSP are pulled high/low with a 1KW or 2KW resistor. Weaker resistor values may cause the processor to come up in an unknown state during emulation, due to reverse leakage current issues.

If you are using a passive method of maintaining mode information (by tying the mode pins to a specific logic level) then it does not matter that the mode information is latched by an emulator reset. However, if you are using the /RESET pin as a method of setting the value of the mode pins, then you have to take into consideration the effects of an emulator reset.

One method of ensuring that the values located on the mode pins are those desired is to construct a circuit like the one shown in figure 1. The circuit in this figure forces the value located on the Mode A pin to logic low; regardless if it latched via the /RESET or the /ERESET pin. (Please refer to the appropriate DSP processor data sheet for the mode pin assignments for the specific processor in your design.)
